The paper was published in the proceedings of the 7th International Conference on Earthquake Geotechnical Engineering and was edited by Francesco Silvestri, Nicola Moraci and Susanna Antonielli. The conference was held in Rome, Italy, 17 - 20 June 2019.

Ground motion amplifications due to topographic effects during the 2017 Pohang earthquake, South Korea

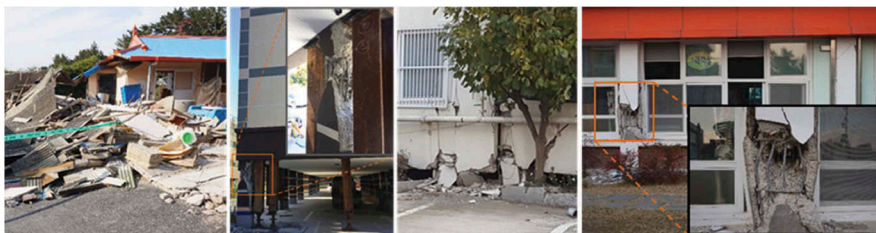
Figure 1. Examples of structural damages caused by the 2017 Pohang earthquake.

An earthquake with a moment magnitude (M) of 5.4 occurred in Pohang city, North Gyeongsang Province on November 15, 2017 at 14:29:31 local time (05:29:31 UTC). The epicenter of main shock is located in Namsong-ri, Heunghae-eup, Buk-gu, Pohang city, North Gyeongsang Province at 36.109°N and 129.366°E with a focal depth of 3 to 7 km (Korea Meteorological Administration 2017). This earthquake is the second largest instrumented earthquake in South Korea, following the 2016 Gyeongju earthquake (M5.5) (National Earthquake Comprehensive Information System (NECIS) 2018). Although the magnitude of the Pohang earthquake (M5.4) was smaller than that of the Gyeongju earthquake (M5.5), the Pohang earthquake caused various structural damages (Figure 1) and geotechnical deformations (Figure 2) which are more severe and prevalent than the damages caused by the Gyeongju earthquake.

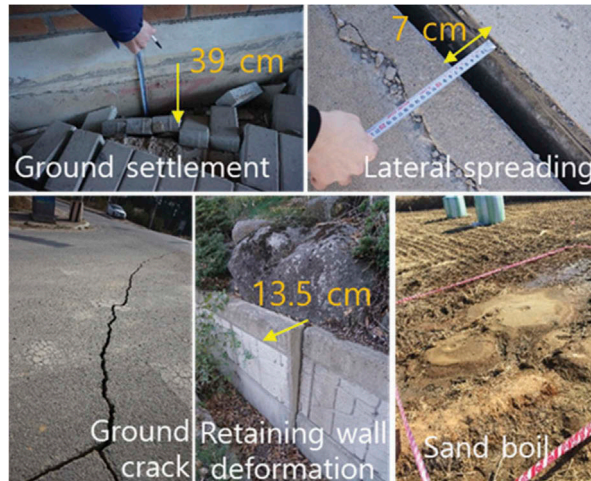
Figure 2. Examples of ground deformations caused by the 2017 Pohang earthquake.

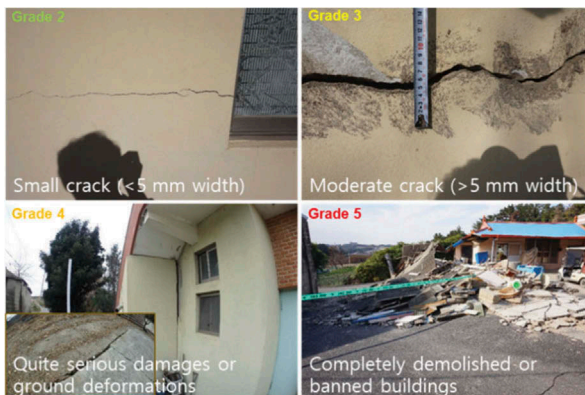
Figure 4. Examples of the criteria used to classify Damage Grade 2 through 5. If no damage is observed, Damage Grade is classified as 1.

We carefully inspected damages of all 65 buildings in the study area and classified the damages into five grades depending on the criteria shown in Figure 4. Among the total 65 buildings, 12, 16, 21, 11 and 5 houses were classified as Damage Grade from 1 to 5, respectively. While 36 buildings among 54 buildings (approximately 67 percent) in the northern part of the study area suffered severe damages (Damage Grades 3-5), buildings in the southern part experienced only minor damages (Damage Grades 1-2) as shown in Figure 5a.

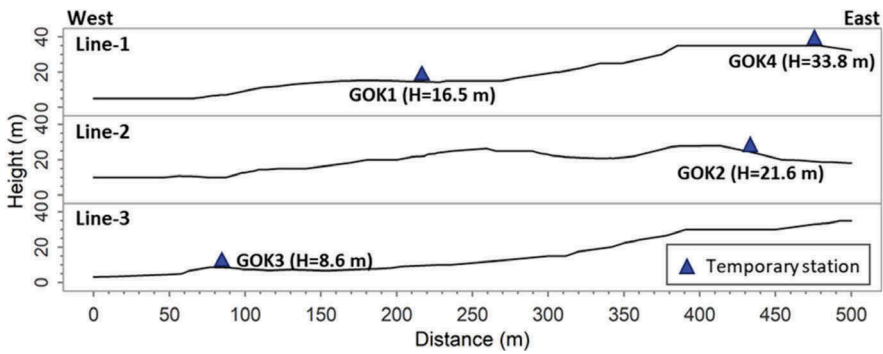
Figure 6. Topographical profiles on the three straight lines in the West-East direction shown in Figure 5a and Locations of the four seismic stations (GOK1-GOK4) on the profiles. The topographic profiles were computed from a 1:5000 digital map.

We measured four aftershock ground motions with a sampling frequency of 200 Hz in EW (East-West), NS (North-South), and UD (Up-Down) directions at the four temporary seismic stations (GOK1 through GOK4) installed in the study area. Information of the aftershocks recorded in this study (e.g., moment magnitude (M), occurrence time, focal depth, epicentral distance to the study area, and incidence angle of seismic wave estimated using the focal depth and the epicentral distance) are in Table 1. Figure 8 show epicenters of the main shock and the four aftershocks and locations of the four seismic stations. Direction from an epicenter of Aftershock 3 to the study area deviate slightly from the East-West direction. However, topographic profiles near the study area along the wave paths from the epicenter of the Aftershock 3 are similar to the topographic profiles in the E-W direction (as shown in Figure 6).

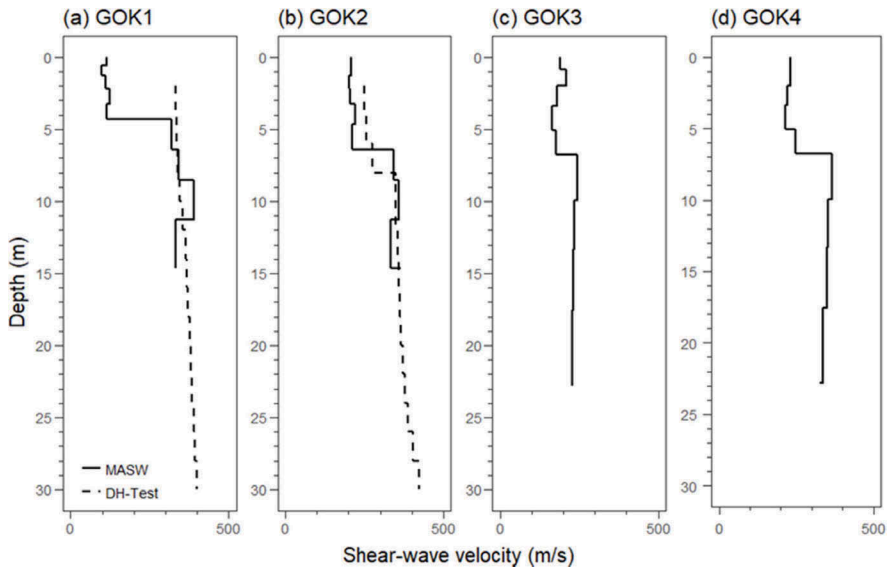
Figure 7. Shear-wave velocity profiles resulted from downhole (DH) tests at sites near GOK1 and GOK2 and from the MASW method at sites near GOK1 to GOK4: (a) to (d) near GOK1 to GOK4.

We conducted field tests, such as downhole test and multi-channel analysis of surface waves (MASW) method, to investigate shear-wave velocity (V_S) near the temporary seismic stations that has an important effect upon ground motion amplifications. Figure 7 shows the V_S profiles resulted from downhole tests conducted at two sites near GOK1 and GOK2, as well as the profiles obtained through MASW conducted at four sites near GOK1 through GOK4. The V_S profile near GOK1 from MASW is approximately 200 m/s smaller than that from downhole test at

shallow depths within 5 m because the test site for MASW (near GOK1) being used as an orchard is covered by soft soils at shallow depths while soils at shallow depths around the site for downhole test (near GOK1) are well compacted. The V_S profiles from the both methods are similar near GOK1 at depths deeper than 5 m, and the profiles obtained from MASW and downhole test near GOK2 show similar values as shown in Figure 7a, b. The V_S profiles near GOK1 through GOK4 generally show small values in a range of 200-400 m/s.

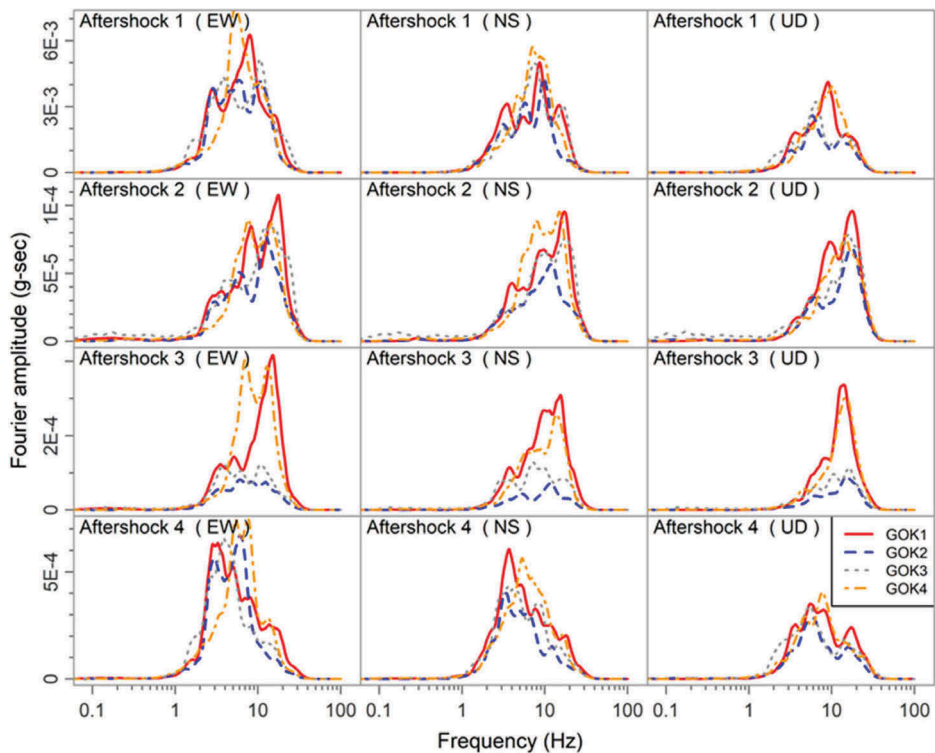
Figure 9. Acceleration response spectra for the ground motions of the four aftershocks (Aftershock 1 to Aftershock 4) measured at four seismic stations (GOK1 to GOK4) in the EW (East-West), NS (North-South) and UD (Up-Down) directions.

We recorded ground motions in the EW, NS, and UD directions at the four stations during the four aftershocks listed in Table 1. Smoothed Fourier amplitude spectrum were computed in the EW, NS, and UD directions using the four aftershock ground motions as shown in Figure 9. We used DEEPSOIL v6.1 developed by Hashash et al. (2016) to compute smoothed Fourier amplitude spectrum to evaluate frequency content of the aftershock ground motions. Peak Fourier amplitudes exist at frequencies in the range of 3-20 Hz which are approximate to natural frequencies of most damaged buildings (1-2-storey) in the study area.

In general, Fourier amplitudes at frequencies of 1-20 Hz at GOK1, GOK3 and GOK4 on the slopes facing to epicenters or on the plateaus are 1-3 times larger than those at GOK2 on the slope facing to the opposite direction, which is consistent with the damage pattern observed in the study area. These ground motion amplifications result from topographic effects considering the similar epicentral distances, V_S profiles, and geological conditions near the four stations. Peak amplifications of all the ground motions at GOK1 and GOK4 (in the northern district) relative to GOK2 (in the southern district) mainly occur at frequencies of 1-20 Hz with spectral ratios ranging from approximately 2 to 5. It is possible that the strong ground motion amplifications at the northern district at frequencies of 1-20 Hz could result in severe damages in the 1-to-2-story houses given the similar range of natural frequencies of the houses.
