The paper was published in the proceedings of the 7th International Conference on Earthquake Geotechnical Engineering and was edited by Francesco Silvestri, Nicola Moraci and Susanna Antonielli. The conference was held in Rome, Italy, 17 - 20 June 2019.

Controlling high hazard slope stability working environments by using digital tools

J. Kupec, C.R. Gibbons, S. Yorke & O. Hoel
Aurecon New Zealand Limited, Christchurch, New Zealand

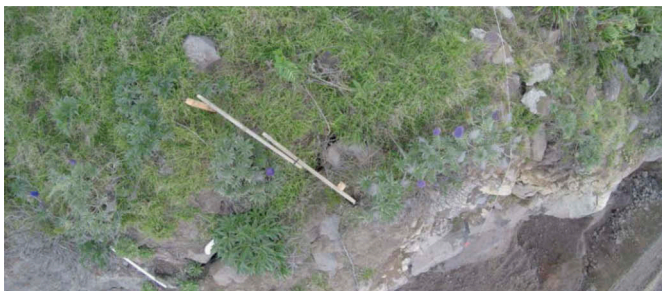
Figure 5. Typical deformation markers on the cliff edge as monitored by UAVs, combining established geotechnical monitoring tools with state-of-the-art remote sensing and survey tools. Note the large cracking of the 80m high cliff edge.

The later adopted UAVs were commercially available ‘hobby’ products that were extensively modified with 3D printed gimbals, high definition cameras and other accessories. As RPAS are much cheaper to deploy, compared to helicopter surveys, the survey frequency increased from once every two months to twice weekly fly overs, thus improving the ability to recognise changes on the landslide mass and cliff faces. The UAV were able to monitor conventional survey markers, stakes in the ground monitoring ground deformation, located close to the cliff edges, thus avoiding sending abseil crews to do this work, refer to Figure 5 below.

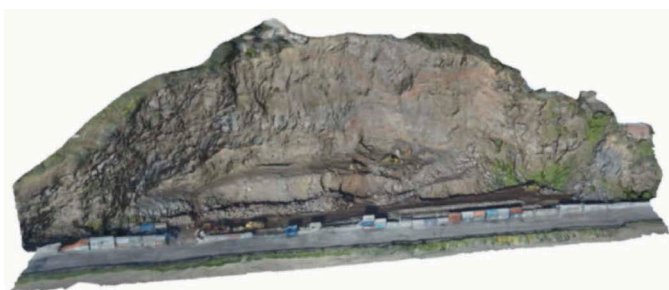
Figure 6. 3D photogrammetry model of the Shag Rock Reserve showing talus debris removal works.

The project team and client quickly realised the potential to generate high resolution 3D photo-grammetry models from the captured 2D images. 3D photogrammetry modelling was used from mid-2015 to generate highly accurate change models. This was particularly useful to record changes in the cliff face after strong aftershock activity, as well as, look at individual areas on the cliff edge, refer to Figure 6 below.

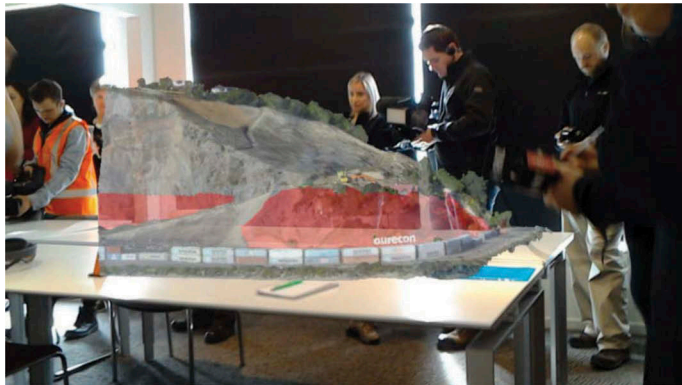
Figure 8. Mixed reality model using Microsoft HoloLens showing as a holographic projection.

The ability to view a 3D model was important for stakeholder information. The project team often worked with national media, updating them on construction progress. As access to the site was restricted we extensively used 3D models. The use of both Mixed and Virtual Reality environments was greatly beneficial to communicate key points to the media and wider public. Figure 8 shows a 3D model projection used for a press conference and media briefing.

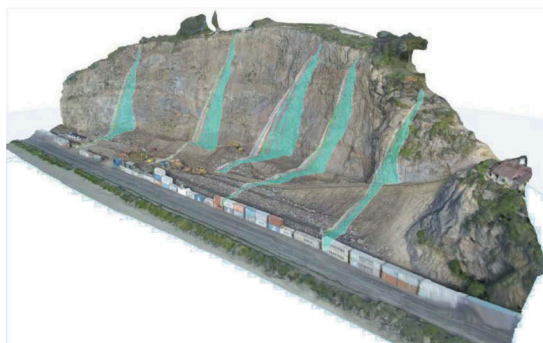
Figure 9. Rockfall trajectories, determined using industry standard 2D analysis, superimposed over the 3D site model.

Further use of 3D model visualisation was the overlay of complex engineering analysis, such as rock fall trajectories. The 'waterfalls' as shown in Figure 9 are rockfall trajectories superimposed over a 3D site model enabling non-experts to visualise the rockfall risk at various areas on the site.
