The use of micropiles for the seismic reinforcement of a waterfront structure

ABSTRACT: The following article presents the case study of the reinforcement of an approx. 300m-long quay wall (mole), located in Talcahuano, Chile. The mole was erected as a gravity wall around 1916 and is constituted by large concrete blocks.

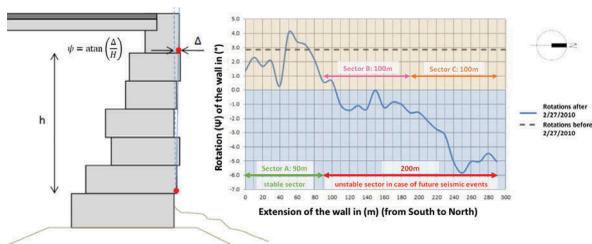
Figure 3. Estimated rotations along the quay wall, based on submarine measurements (modified after PRDW 2010)

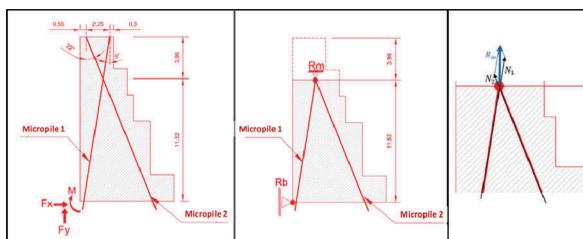
Figure 6. Proposed reinforcement with a group of micropiles for the unstable sectors B and C (PT 2014a)

The analysis was carried out, based on a simplified model as shown in Figure 6. In structural terms, the micropiles “sew up” the concrete blocks, so that the quay wall is considered as a monolithic, rigid element that is anchored to the underground again through the micropiles, which are conceptualized as hinged rods, able to transfer axial forces only.

For the equilibrium analysis, all the forces acting on the wall are transferred to the toe, to obtain the reactions F_x , F_y and M (Figure 6, left).

The reaction (R_m) provided by the micropiles, and the horizontal (base) reaction (R_b) provided by the friction between the wall and the rockfill ($\delta_b = 32^\circ$, PETRUS 2012) can be obtained from the statically determined supported element (Figure 6, middle). Finally, the axial forces acting on the micropiles (N_1 and N_2) can be obtained from the resulting reaction (R_m) (Figure 6, right).

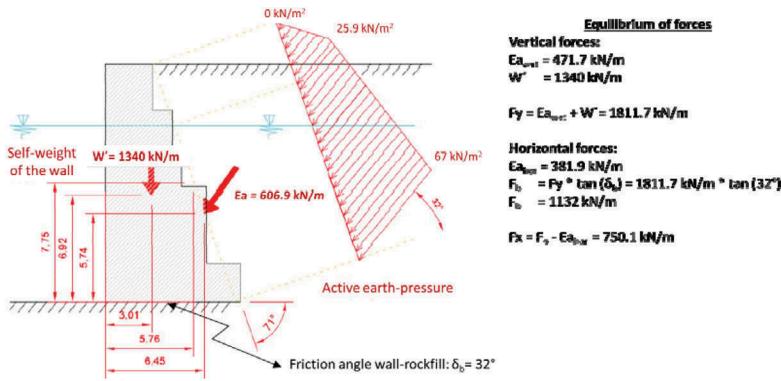
Figure 7. Equilibrium analysis of the quay wall under static load conditions (modified after PT 2014a)

The structural assessment showed that both sectors (B and C) were stable under static loading conditions, mainly influenced by active earth-pressure of a granular backfill acting on the wall as well as its self-weight. Figure 7 presents the estimated static loading condition of the quay wall, from which it can be inferred that in order to verify the equilibrium of forces, the base reaction (Rb) cannot exceed the magnitude of the horizontal reaction (Fx). For the subsequent verifications of the safety against sliding, the admissible base (horizontal) reaction of the quay wall is conservatively limited to the value of $Rb_{adm} = Fx = 750.1 \text{ kN/m}$.

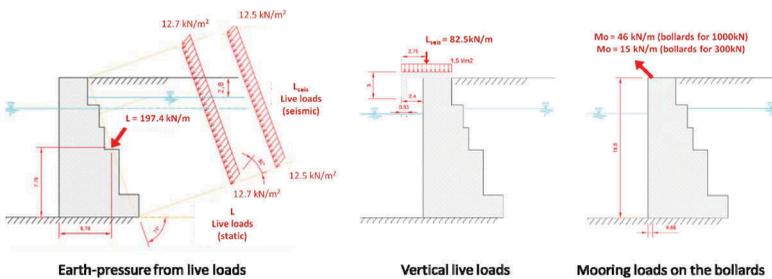
Figure 8. Effects (static and seismic) of live loads (modified after PT 2014a)

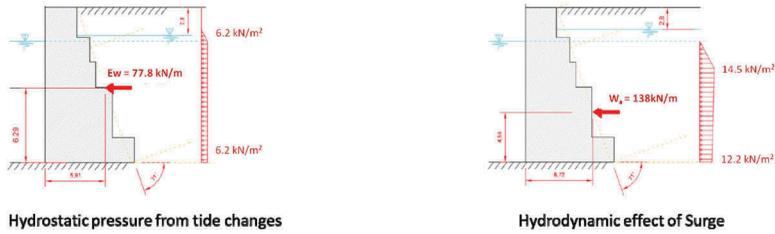
Figure 9. Hydrostatic water pressure from tide changes and hydrodynamic effect of surge (modified after PT 2014a)

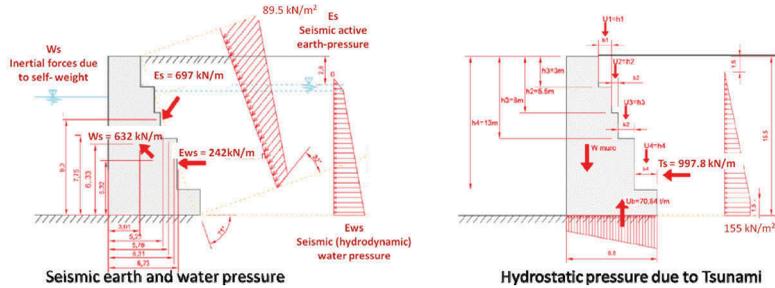
Figure 10. Loading situations from seismic actions (modified after PT 2014a)

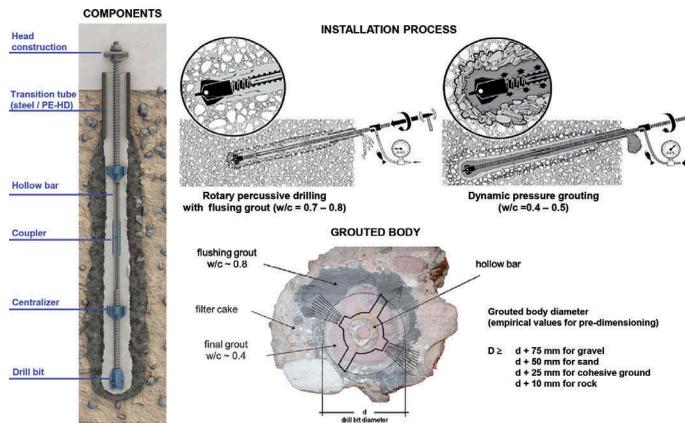
Figure 11. Self-drilling micropiles: components, installation and grouted body (Lopez & Fernandez 2017)

The reinforcement was materialized with self-drilling Ischebeck TITAN grouted micropiles, which consist of continuously threaded hollow bars, made out of seamless fine-grained steel pipes (Grade S460 NH), installed via rotary percussive drilling.

During the drilling process, the micropiles are continuously grouted (dynamic injection), building a rough interlocking at the interface grout-soil, increasing the adherence or skin friction (Lopez & Fernandez 2017). The components, the installation process and a typical cross-section of the grouted body are presented in Figure 11.

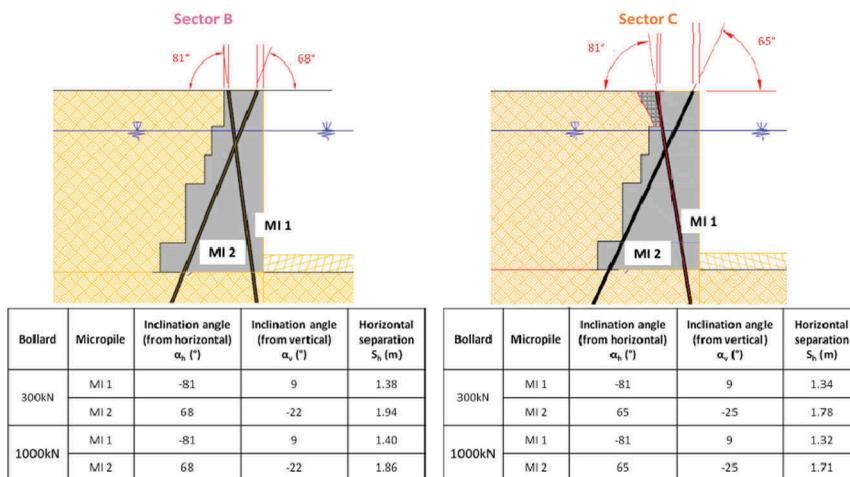
Figure 12. Disposition of the micropiles. Left: Sector B and Right: Sector C (modified after PT 2014a)

The disposition of the micropiles for the sectors B and C (Figure 5) is schematically presented in Figure 12.

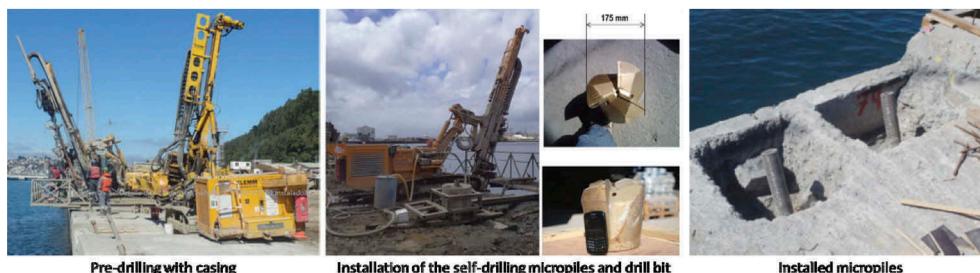
Figure 13. Installation of the micropiles (modified after PT 2015)

- Installation of the self-drilling TITAN micropiles from the top of the quay wall and through the pre-injected boreholes.
- Execution of the micropiles' head connections with the top slab. The mechanical connection is obtained using a washer plate, fixed to the load bearing elements with two collar nuts.

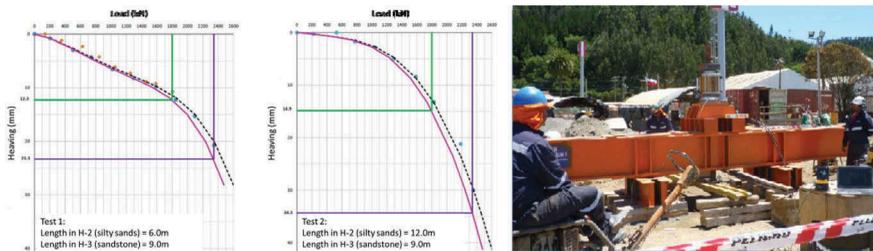
Figure 14. Load tests. Left: Load-displacement curves. Right: Testing structure (modified after PT 2014b)

Early 2014, two suitability load tests (under tension) were carried out to validate the adopted design considerations, especially regarding the skin friction (adherence) values for the natural subsoil (silty sands and sandstone). The installation protocols of the testing micropiles showed a very good agreement between the recorded grout consumption and the expected (average) borehole diameters. A maximum load test of $P_p=2340$ kN was applied to the testing micropiles, with displacements ranging from 25mm to 35mm (Figure 14). The observed load bearing behavior verified satisfactory the structural requirements.
