*The paper was published in the proceedings of the 7<sup>th</sup> International Conference on Earthquake Geotechnical Engineering and was edited by Francesco Silvestri, Nicola Moraci and Susanna Antonielli. The conference was held in Rome, Italy, 17 - 20 June 2019.*

## Influence of dominant site period effects on damages at colonial church

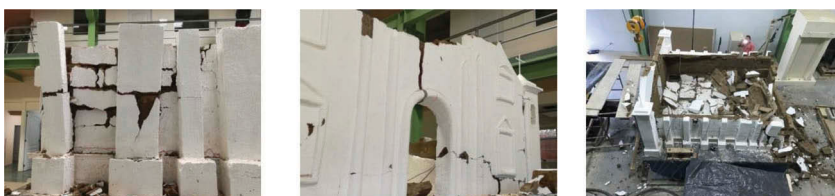
Figure 9. Damage to the Church of San Raymundo

The seismic signal was introduced in the longitudinal direction of the structure, observing damages in the facade since this wall has a tendency to overturn due to its heavy element and greater height which provide inertial forces during the event. Then the model was submitted to the earthquake in a direction perpendicular to the facade, producing flexural cracks in the upper part of the structural element (Figure 15). The rear wall was damaged due to the thrust in the

longitudinal direction due to the fact that it has no restriction against the displacement in a direction perpendicular to its plane because there is no element that provides rigidity to the wall.
