# Challenge to Geotechnical Earthquake Engineering Frontier: Consideration of Buildings Overturned by the 2011 Tohoku Earthquake Tsunami

**Abstract.** A simplified pseudo-static analysis is proposed to estimate the safety factors with time against instability of a building subjected to tsunami loads, based on the results of a 2D shallow water equation. The proposed analysis is used to examine the key factors affecting the performance of buildings. A 3D analysis is also conducted for one building, the performance of which has not been explained by the simplified analysis. It is shown that: (1) if the tsunami hydrodynamic and buoyant forces are the major driving forces, the proposed analysis is capable of predicting the difference in observed building performance; (2) the safety factors against overturning and sliding become minima near when the peak landward and seaward flow velocities occur, while one against uplift around when the peak inundation depth occurs; (3) the instability of building tends to occur when any of the safety factors first becomes less than one, i.e., mostly at the peak landward flow velocity; (4) the hill immediately backward of a building might have induced

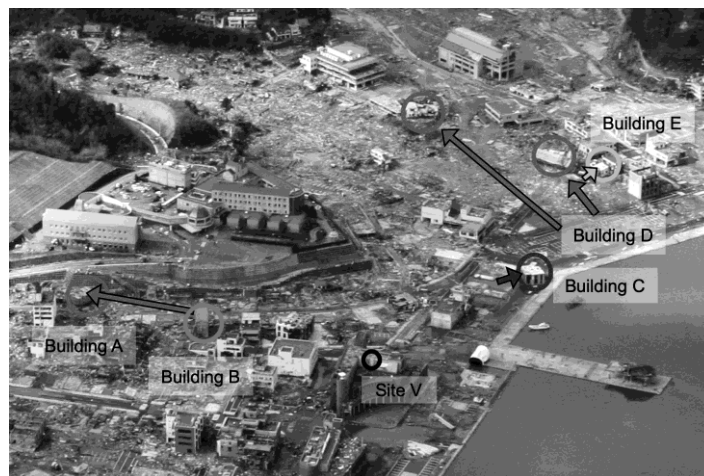
**Fig. 2.** Location and overturning direction of buildings investigated (Photo [2])

Figure 2 is an aerial photograph of the hardest hit area in Onagawa taken after the tsunami [2], which shows the locations of the buildings before and the after the event. Building A and D overturned landward, Building C overturned seaward, and Building E overturned almost in parallel to the coastline, while Building B remained at its original position. Digital recording open for public including the video taken from Site V [9] and photos taken from various places including Sites W and X [10, 15] has shown that Buildings A and D overturned during the first tsunami runup and Buildings C and E by the end of the first tsunami backwash.

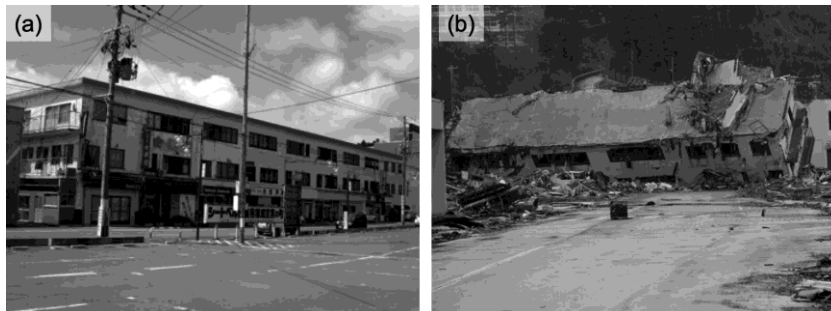
**Fig.5.** Photos of Building D taken before and after tsunami (Photo (a) [15])

Figure 5 shows Building D, a three-story RC building with spread foundation that toppled, split into two or three sections, and drifted landward during the first tsunami runup. While the left section seen in Figure 5(a) was found about 175 m landward from its original position (Figure 2), the right section only about 75 m landward near Building E (Figures 2 and 5(b)).

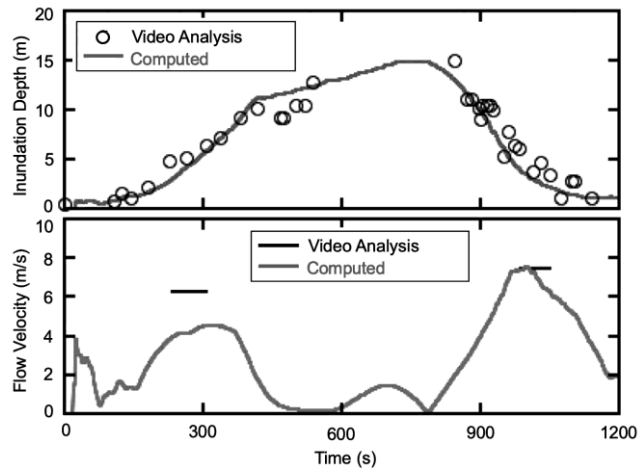
**Fig. 10.** Comparison of computed and observed (a) inundation depth and (b) flow velocity at Site V

The open circles in Figure 10(a) are the inundation depth evaluated from the video recording taken at Site V in Figure 1(b) during the first tsunami runup and backwash (Koshimura et al., [9]). The two solid black lines in Figure 10(b) are the peak flow velocities at around 300 s during the first tsunami runup and at around 1000 s during the first tsunami backwash, estimated from the same video recording [9]. The smoothed time history of the estimated inundation depth plus the elevation of Site V was used as the time history of the sea water level prescribed at the seaside boundary of each analyzed area for the tsunami analysis.

Figures 10(a) and (b) show the computed time history of inundation depth and flow velocity at Site V from the analysis for Area A. The computed time history of

inundation depth shown in Figure 10(a) corresponds reasonably well to the observed one. The computed flow velocities shown in Figure 9(b) also show fairly good agreements with the observed ones at the two instances. A good agreement between the observed and computed values were also found from the analysis for Area B.

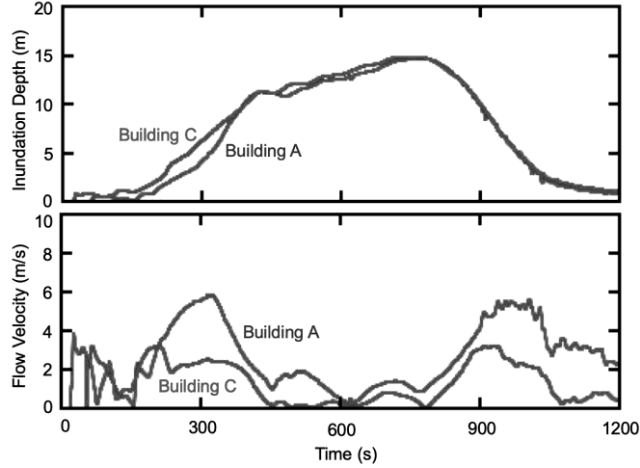
**Fig. 18.** Computed time histories of (a) inundation depth and (b) flow velocity at Buildings A and C

In order to explore the reason for the seaward overturning of Building C, Figure 18 compares the computed time histories of inundation depth and flow velocity at Buildings A and C. The peak flow velocities at Building C are significantly smaller and occur at a lower inundation depth during runup and at a deeper inundation depth during

backwash than those at Building A, probably having led to the seaward overturning of this building. Such variation of flow velocity with time at Building C might have been caused by the presence of a hill immediately located landward of Building C.

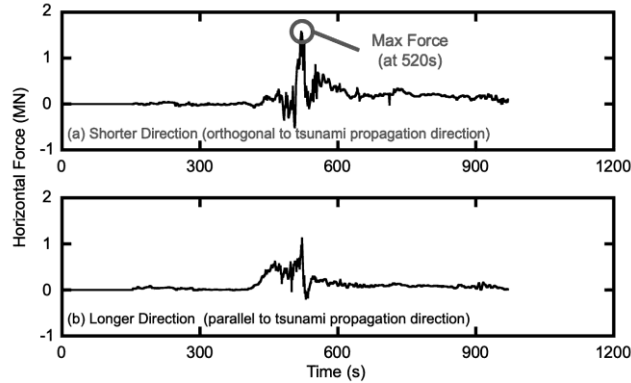
**Fig. 21.** Computed hydrodynamic forces acting on Building E from 3D analysis: (a) shorter direction and (b) longer direction

Figures 21(a) and 21(b) show the computed time histories of hydrodynamic force acting on the shorter and longer directions (orthogonal and parallel to the tsunami propagation directions) respectively of Building E computed by the 3D simulation. Note that the collision impact force of the right section of Building D to Building

E was not computed directly from the 3D analysis and thus is not included in the computed force. Figures 21(a) and 21(b) suggest that the horizontal force at the time of the collision is larger in the shorter direction than in the longer direction.

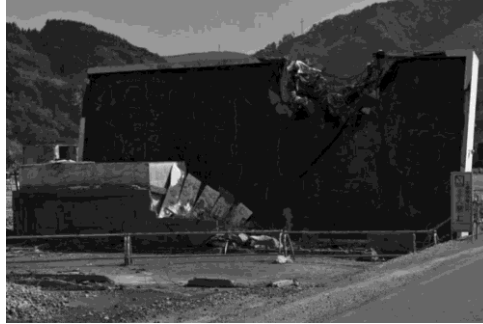
**Fig. 23.** Serious damage observed on the roof of Building E overturned probably due to collision of Building D [3]

Figure 23 shows a photo of the roof of overturned Building E. The serious damage observed on its upper side, previously faced southwest, appears to demonstrate that it was caused by the collision of the right section of Building D having drifted from southwest.
