# Application of Geotechnical Experience for People – Activities after 2011 Tohoku Earthquake

Ikuo Towhata, *Visiting Professor – Kanto Gakuin University, Japan*

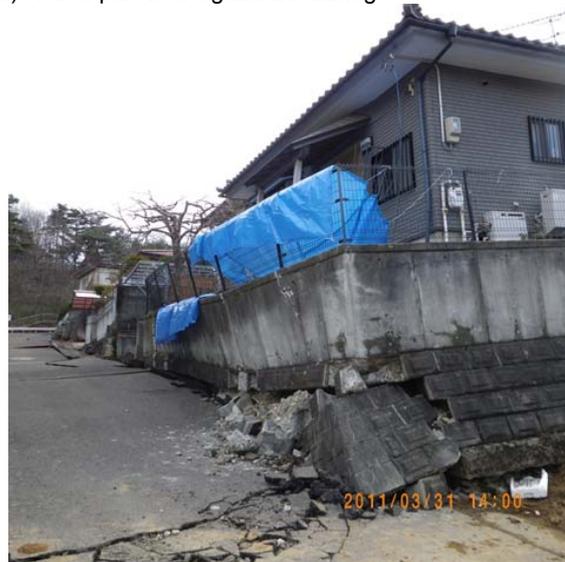
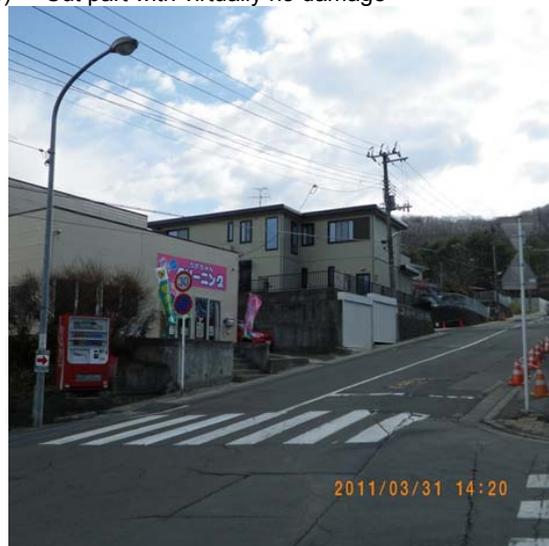
(a) Filled part with significant damage

(b) Cut part with virtually no damage

Figure 1. Different damage extent in residential land in hilly area in Sendai

Figure 1 compares the post-earthquake situation of a residential land near Sendai City after the 2011 Tohoku earthquake. In spite of the distance of merely a few hundred meters, the damage extent was completely different between cut and fill parts.

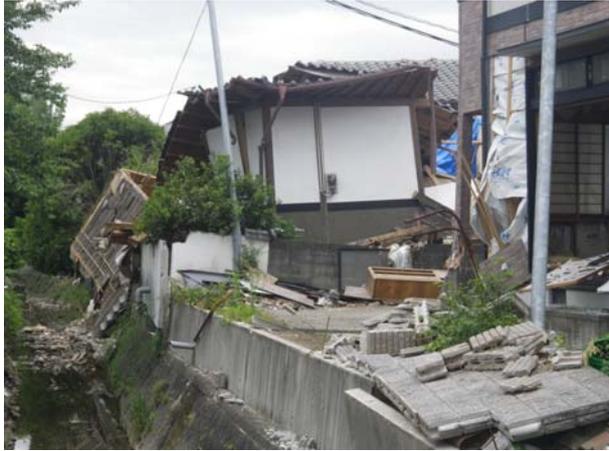
Figure 2. House damage in Mashiki Town in Kumamoto

Similarly, the 2016 Kumamoto earthquake sequence revealed the problem lying in artificial fills. Fig. 2 shows one of the most heavily damaged areas where the residential land is located upon a former small valley. Most probably the original subsoil is a soft valley deposit and the overlying artificial fill is not well compacted as is often the case in such a local community. Thus, most houses in this area was destroyed. Fig. 3 clearly demonstrates that good earthquake resistance of a superstructure is not good enough to avoid damage unless subsoil condition is good. This place is located upon a big residential fill and its slope surface deformed substantially.

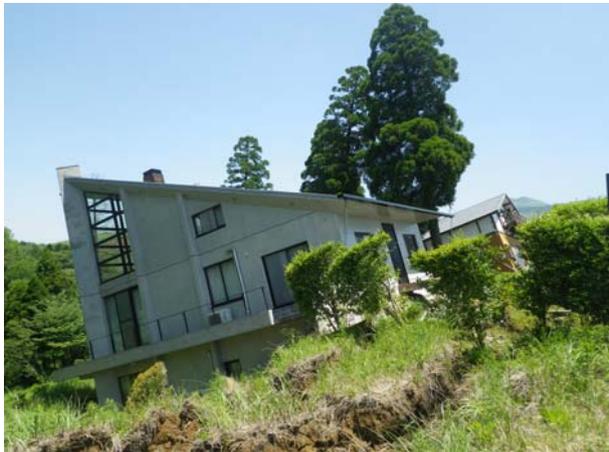
Figure 3. Tilting of house that is located near unstable slope shoulder (Kumamoto)

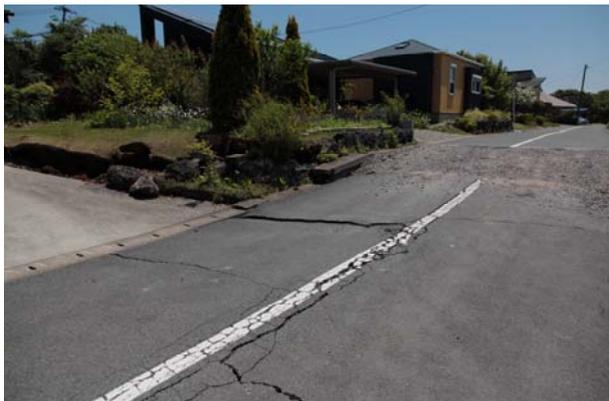
Figure 4. Depression near the center of residential fill in Fig.3 (Kumamoto)

Significant distortion in Fig. 4 occurred in the middle part of the same residential fill as in Fig. 3. As suggested by the distance from the slope shoulder being approximately 200 meters, this depression was induced by a deep-seated sliding that occurred in the fill, probably along the interface between the original slope and the man-made fill. The problem is that the residents cannot afford the cost of reconstruction of the entire fill. They could not assess such a risk before they purchased the land. Similar instability occurred at many residential areas in Kumamoto in 2016. In 2017 the national government will provide

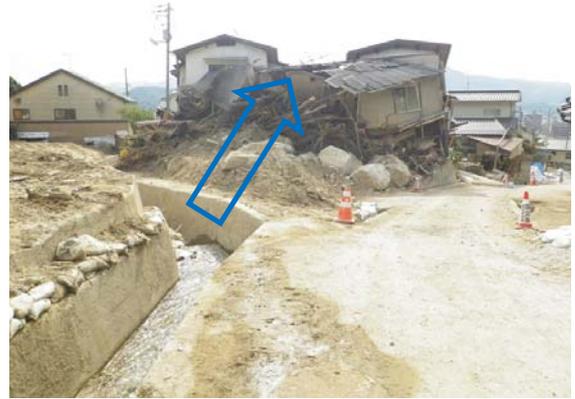
Figure 5. Residential land affected by debris flow during heavy rain (Hiroshima)

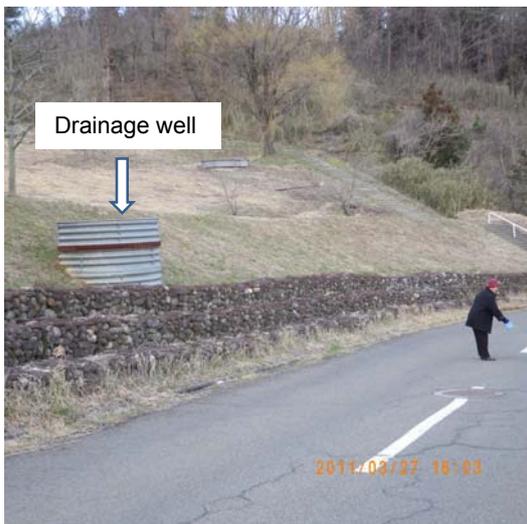
Figure 6. Successful stabilization of slope (Shiroishi)

It is relevant to address several successes of geotechnical engineering during the 2011 earthquake. Fig. 6 shows a slope in Shiroishi near Sendai where an entire sloping residential area collapsed during the 1978 Miyagi-ken-Oki

earthquake. Afterwards the slope was repaired, had drainage facilities installed and had been an open area (no house) until 2011. As shown in Fig. 6, this slope remained intact in 2011 in contrast to the adjacent areas where minor slope failure happened (Fig. 7). Thus, ground water lowering in a vulnerable slope is an effective measure for seismic stabilization.

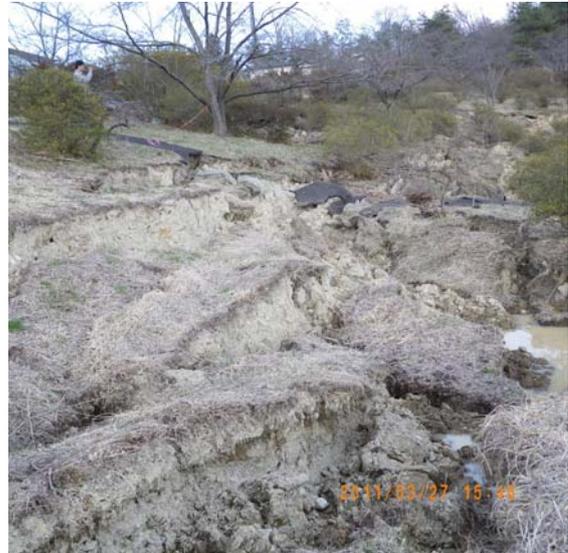
Figure 7. Slope instability near the slope in Fig. 6

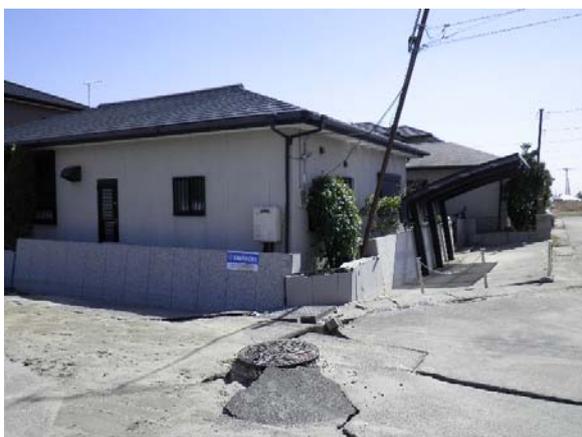
Figure 8. Liquefaction damage of house in Itako

The 2011 Tohoku earthquake caused significant liquefaction problems in recent residential areas. Fig. 8 illustrates subsidence and tilting of a house in Itako City. This area used to be a lake and, in the middle of 20th Century, the lake water was drained and farming land was created. Later, additional soil was filled on the farming land and a residential land was developed. Because the new fill

was sandy (good bearing capacity for houses), not compacted as practiced at many places (for reducing cost and offering low land price), young in age and water-saturated (located in former lake), liquefaction occurred widely and substantially in this area. Liquefaction also affected lifelines embedded in sandy ground. Fig. 9 illustrates the inside of a sewage pipeline in Urayasu City. The pipeline was separated at the connection and liquefied subsoil came in and stopped the flow of waste water.

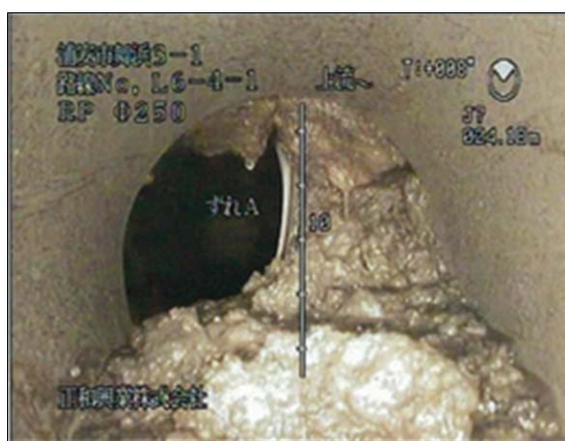
Figure 9. Liquefaction damage of sewage pipe (Urayasu City Government)

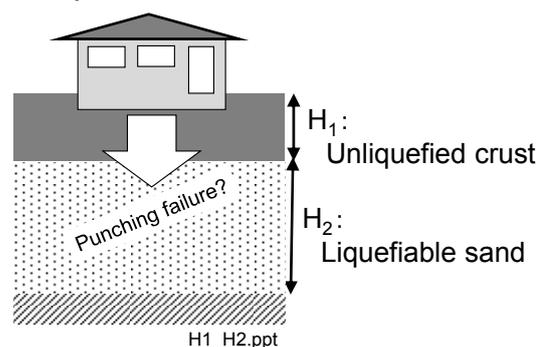
Figure 10.  $H_1$ - $H_2$  diagram

One of the earliest and well-known measures to simply demonstrate the liquefaction proneness is the  $H_1$ - $H_2$  diagram (Ishihara, 1985) in which  $H_1$  stands for the thickness of surface stable soil crust while  $H_2$  is the thickness of liquefaction-prone subsoil (Fig. 10). It is obvious that the greater thickness of  $H_1$  provides more bearing capacity for houses and stability of embedded pipelines, thus reducing the liquefaction damage. It is also expected that the thinner  $H_2$  reduces the damage possibly because vertical settlement and lateral spreading in the liquefied layer are reduced even if punching failure happens in the  $H_1$  layer and house foundation comes into the  $H_2$  layer.

The good point of the  $H_1$ - $H_2$  diagram is the clear meaning of the importance of the  $H_1$  layer, which is the bearing capacity for a house foundation. A shortcoming is the sensitivity of  $H_1$  to a minor change of the factor of safety,  $F_L$ . If  $F_L$  changes from 0.99 to 1.01 near the surface, the  $H_1$  value increases suddenly and the subsoil is considered significantly safer. On the other hand,  $H_2$  is less sensitive to a minor change of  $F_L$ ; increase of  $F_L$  from 0.5 to 0.95 does not change  $H_2$  at all. Considering these issues, a different recommendation diagram was developed (Towhata et al., 2016) and has been set in force by the government.

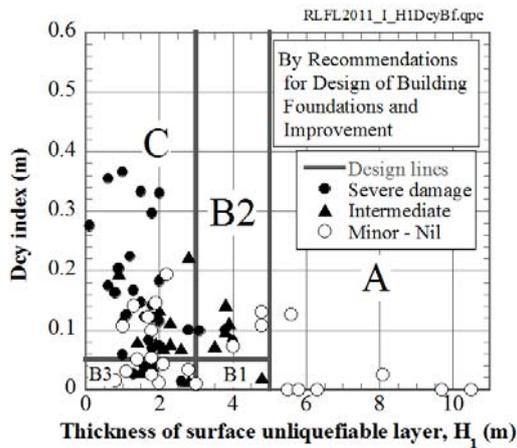
Figure 11.  $H_1$ - $D_{cy}$  diagram for quality evaluation of urban subsoil from liquefaction viewpoint

In Fig. 11, the seismic (liquefaction) performance of subsoil is classified into 3 groups (A, B and C) and the ideas of these three performances are demonstrated in Fig. 12. If subsoil is classified into C group, soil improvement is recommended. The  $D_{cy}$  parameter in Fig. 11 is employed in the Recommendations for Design of Building Foundations (Architectural Institute of Japan, 2001) and is the integration of shear strain amplitude in subsoil;

Hence, it is supposed to be equivalent with the horizontal displacement at the ground surface. The data points in Fig. 11 indicate the observed severity of liquefaction (sand ejecta) in 2011 near the analyzed sites of SPT-N. There is a good consistency between observed subsoil behaviour and the classified groups.

- Seismic performance is assessed by using the input earthquake motion that occurred in 2011. Quasi-three-dimensional dynamic total stress analysis calculated the stress conditions in soil and the factor of safety against liquefaction was evaluated. It was aimed to achieve either  $F_L > 1$  in all liquefaction-prone sand or  $D_{cy} \leq 5$  cm and  $H_1 \geq 5$  m which means Class A in Fig. 11.

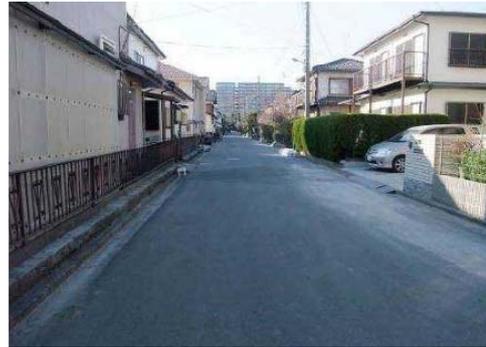
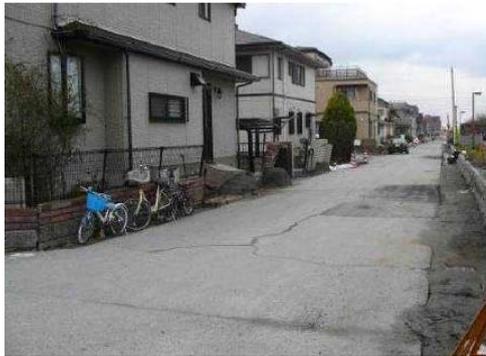
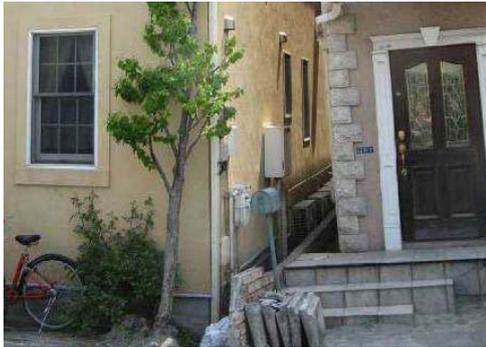
A: Nil – Minor

B: Intermediate

C: Poor

Figure 12. Illustration of three liquefaction performances in residential areas

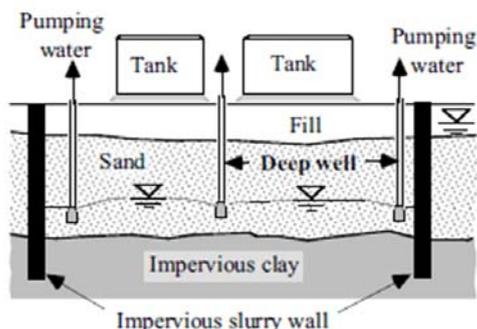
Figure 13. Ground water lowering under existing oil refinery in Kawasaki City near Tokyo

of refinery factory (Fig. 13). Moreover, Tsukiji district of Amagasaki City near Osaka adopted this technology. Therein, liquefaction destroyed houses during the 1995 Kobe earthquake. Afterwards, the damaged houses were removed, new fill was placed at the surface and drainage pipes were installed. Ground water flows under gravity through the pipes into tanks from which water is pumped up and drained into rivers. Because the thick clayey subsoil in Amagasaki City is overconsolidated, minor soil filling and water lowering have not caused consolidation problem (Fig. 14).

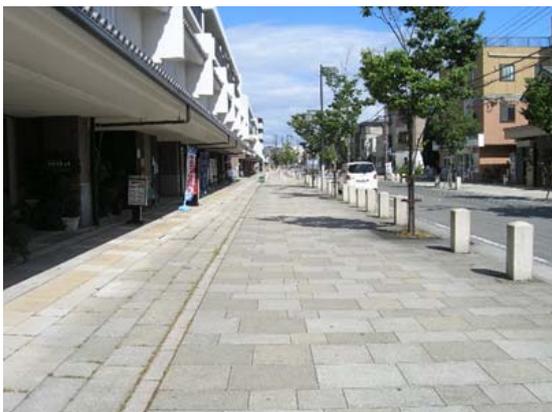
Figure 14. Intact situation in Tsukiji of Amagasaki City after ground water lowering

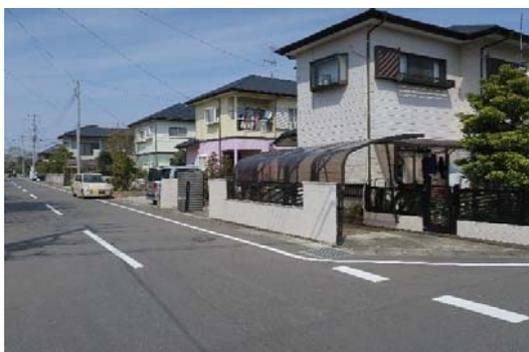
Figure 15 Hinode area of Itako City where ground water lowering was installed (picture taken on April 5, 2017)

Kuki and Itako Cities adopted this measure (Fig. 15). In these cities, the clayey subsoil is thin and consolidation settlement is negligible, or the liquefaction-prone sand is thin and the extent of water lowering is small. The area in Fig. 15 does not show consolidation problem induced by ground water lowering. It was a pity, however, that several cities declined the project because residents did not agree to burden the due costs.

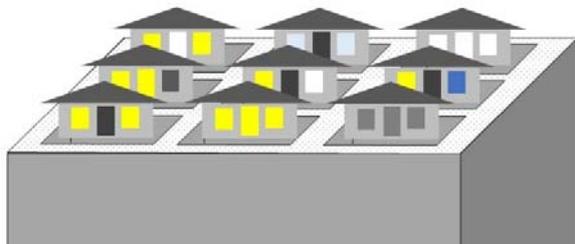
Figure 16. Conceptual sketch of underground grid wall

Urayasu City decided to employ this measure. The underground grid wall are installed from spaces between houses (Fig. 16) and constrain the cyclic shear deformation of sand during earthquakes. Ishii et al. (2017) in this conference provides more detailed information on its soil improvement project. This technology was first validated during the 1995 Kobe earthquake when a hotel building with a grid wall reinforcement remained intact in contrast to substantial liquefaction in the surrounding areas. This technology is more costly than ground water lowering but does not cause consolidation problem in the underlying normally consolidated clay. Because the details are described in Ishii (2017), the present paper addresses additional points only.

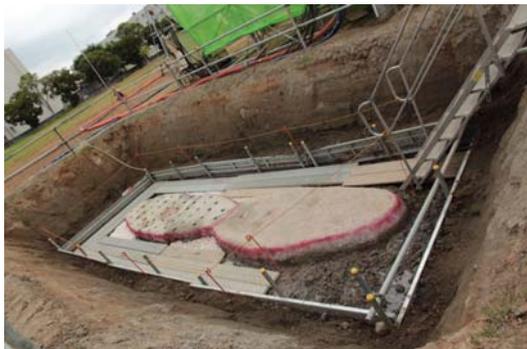
Figure 17. Oval shape of soil improvement

- Walls were constructed by cement mixing. Fig. 17 illustrates a trial construction of two oval segments of underground walls. Such segments were connected with each other to form a continuous wall.

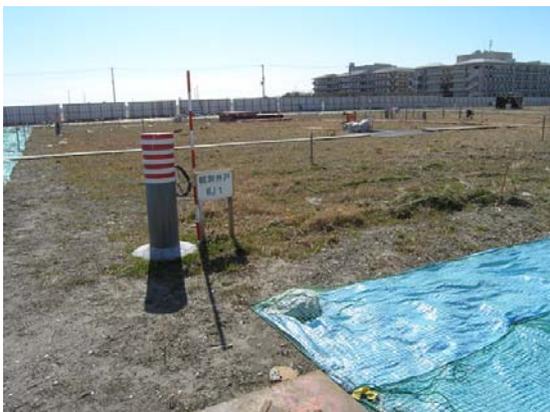
Figure 18. Ongoing water pumping test in Urayasu

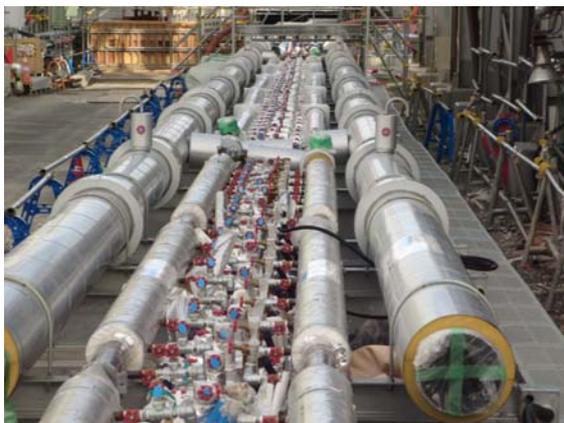
Figure 19. Coolant pipes for construction of frozen soil wall under ground

Heavy discussion was made against the construction of underground frozen walls around the reactor buildings because soil freezing (Fig. 19) has not been used for a long-term (7 years) operation and continuity of the wall was questioned. As per March 2017, soil freezing is said to be completed with possible discontinuity being filled with grouting.

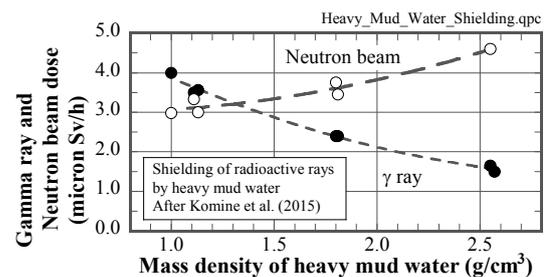
Figure 20. Radioactive shielding effect of heavy mud water (drawn after Komine et al., 2015)

Removal of molten fuel, issue (3), requires the working environment to be safe. It means that local radioactivity has to be reasonably low around the reactor vessels. To achieve this goal, cooling water in the vessels should not leak outwards. To stop this leakage, repairing work has to be conducted for vessels under less radioactive environment. Then, how can we reduce the radioactivity? This is a dilemma. The Japanese Geotechnical Society, as a member of Special Task Force, has proposed the use of heavy mud water for which a special kind of clay with  $G_s > 3$  is mixed with water and placed inside the damaged reactors.

This mud water can fill the complicated space in the reactor vessels and drastically reduce the leakage of contaminated water (because of its low permeability). Further, its high mass density can shield the  $\gamma$  ray while its high water content can reduce the propagation of neutron beam. Fig. 20 illustrates typical results of laboratory tests on the shielding in this mud water. Because the shielding of the two kinds of radioactivity are contradictory to each other (increasing for one beam and decreasing for the other with the change of density), it will be aimed in near future to determine the optimum density of the heavy mud water by assessing the long-term change of the source radioactivity in terms of both  $\gamma$  ray and Neutron beam during the next 40 years in which the decommission work of the abandoned power plant will be carried out. The desired performance here is that the radioactive environment around the damaged reactors are maintained safe so that decommission works may be carried out.
