# Liquefaction-induced Settlement and Tilting of Buildings with Spread Foundation based on Field Observation and Laboratory Experiments

Kohji Tokimatsu  
Tokyo Soil Research, Co. Ltd., Tokyo, Japan  
Kazuya Hino, Kyoko Ohno, Shuji Tamura  
Tokyo Institute of Technology, Tokyo, Japan  
Hiroko Suzuki  
Chiba Institute of Technology, Chiba, Japan  
Yasutsugu Suzuki  
Kajima Technical Research Institute, Chofu, Tokyo, Japan

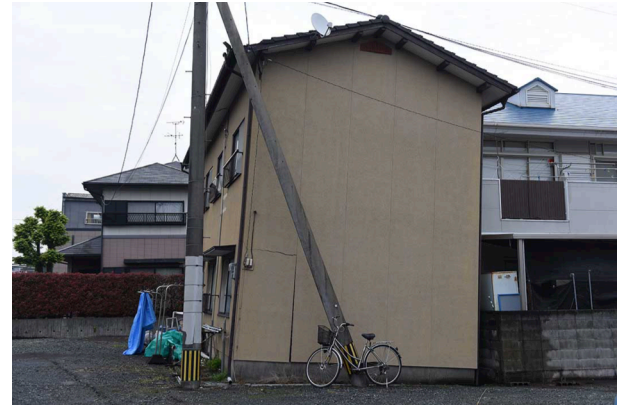
Figure 2. Liquefaction-induced tilt of a 2-story wooden house in Karikusa town

The 2016 Kumamoto Earthquakes, including two major events on April 14<sup>th</sup> and 16<sup>th</sup> ( $M_j 6.5$  and  $M_j 7.3$ ), induced catastrophic damage to infrastructures and buildings in the source region as well as in the Kumamoto plain. Soil liquefaction and related damage also occurred mainly in the Kumamoto plain during both events with more extensively on the second one. Figures 2 and 3 show typical damage to a wooden house and a reinforced concrete building of 3 stories.

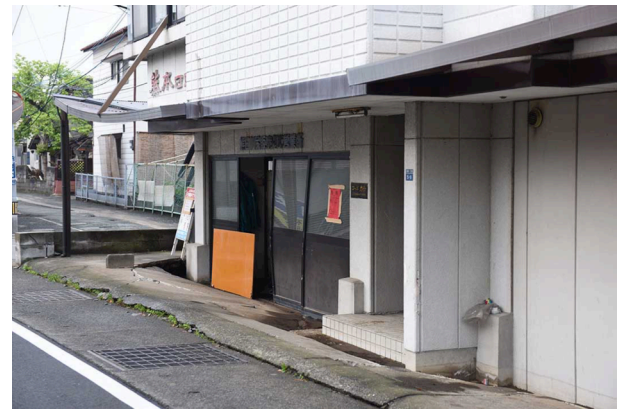
Figure 3. Liquefaction-induced settlement of a 3-story reinforced concrete building in Karikusa town

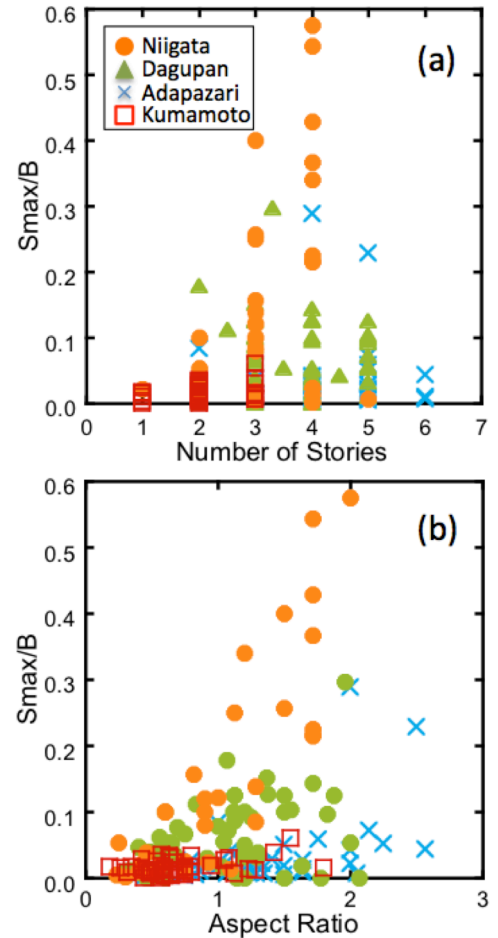
Figure 10. Relation of settlement-width ratio with number of stories and aspect ratio of building

Based on the discussion regarding Figure 9, the relative settlement was normalized with respect to foundation width as well as the thickness of the liquefied layer, each herein defined as settlement-width ratio ( $S/B$ ) and settlement-thickness ratio ( $S/D$ ), respectively. Figures 10 and 11 show their relations with the number of stories and aspect ratio of building. The site-specific trend has fairly well diminished particularly when the settlement was normalized with respect to the thickness of liquefied layer.

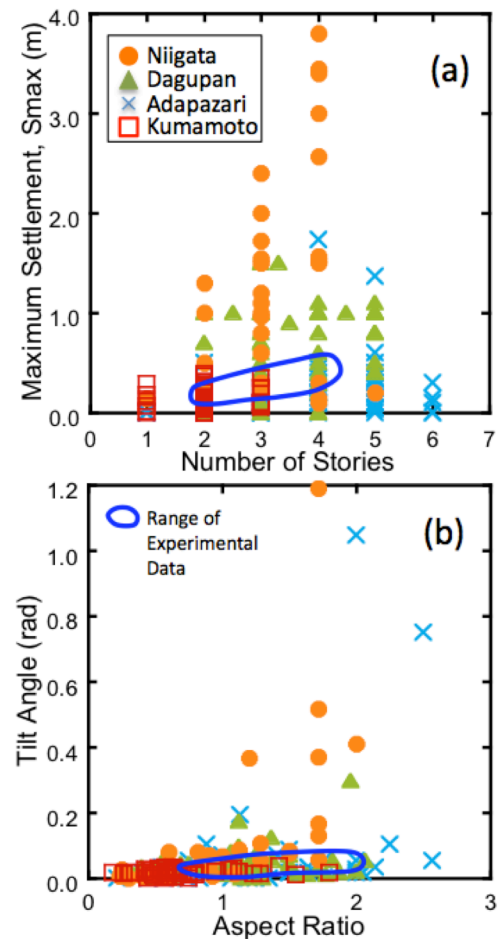
Figure 16 compared the centrifuge data ranges with those observed in the field (Figure 9(a) and 12(b)). The areas

Figure 16. Comparison of centrifuge data ranges with those observed in the field

encircled in solid lines correspond to the test results from the centrifuge experiments. The test results are likely consistent with the field observation but fall on the lower side of the field data, probably due to the difference in soil conditions including density between field and laboratory.

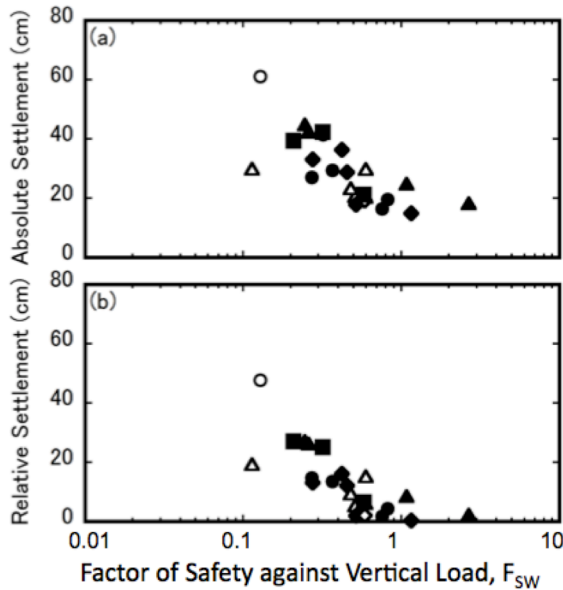
Figure 21 shows the relationship between the safety factor against vertical force and the absolute and relative settlements. There is a well-defined trend in which both absolute and relative settlements decrease with increasing safety factors, with the latter becoming negligible small if the safety factor against vertical force exceeds one.

Figure 21. Relation of safety factor against vertical force with absolute and relative settlements

The fairly well defined trends in Figures 21 and 22 suggest that, although most of the data are based on the tests run with loose sandy deposit having a relative density of 50 %, the safety factors against vertical load and overturning moment are promising indicators to estimate liquefaction-induced damage to building founded on rigid shallow foundations.

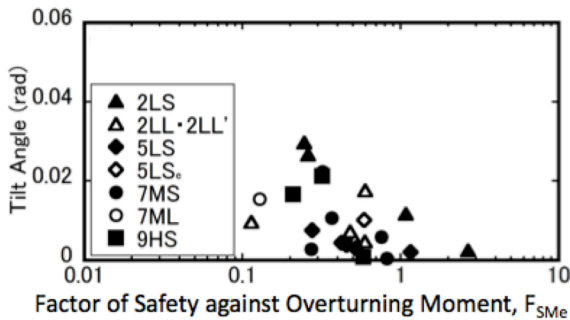
Figure 22 shows the relationship between the safety factor against dynamic overturning moment and the tilt angle of the building. The tilt angle of the building, although scattered, by and large decreases as the safety

Figure 22. Relation of safety factor against overturning moment with tilt angle of building

factor against overturning moment increases and gets almost zero if it exceeds one.
