Overturning of Buildings Induced by Tsunami Run-up At Onagawa in the 2011 Great Tohoku Earthquake

M. Ishida¹, K. Tokimatsu², S. Inoue³

ABSTRACT

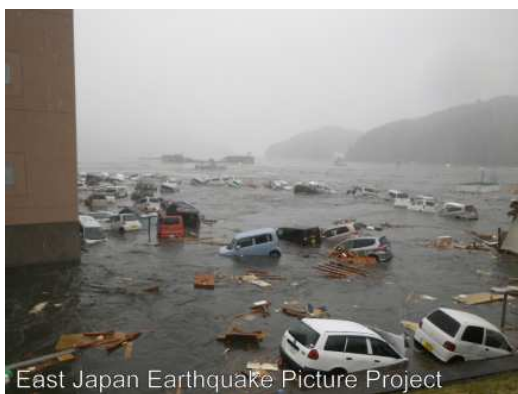
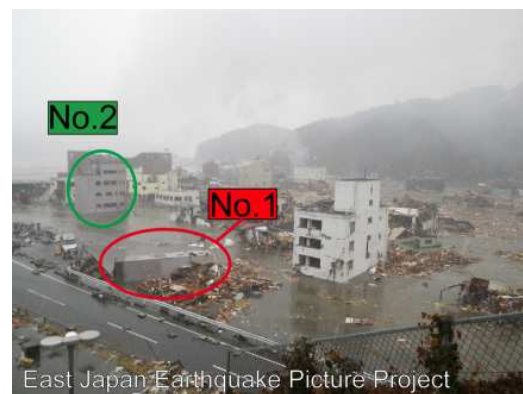
Figure 1 shows the location and overturning direction of the three buildings examined in this study. Buildings No.1 overturned landward, building No.3 overturned seaward, and building No.2 did not overturn and remained at its original position. Figure 2a is a photograph of the first tsunami run-up at its maximum inundation height, and Figure 2b is a photograph taken during the tsunami backwash. Based on the photographs, we conclude that the overturning damage occurred during the first tsunami run-up.

(a) At maximum inundation height

(b) At backwash

Figure 2. 1st tsunami run-up

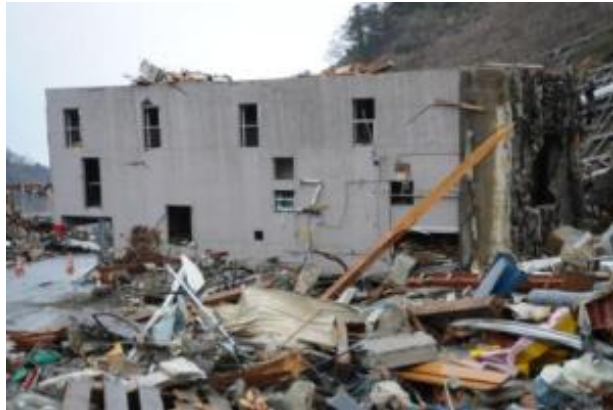
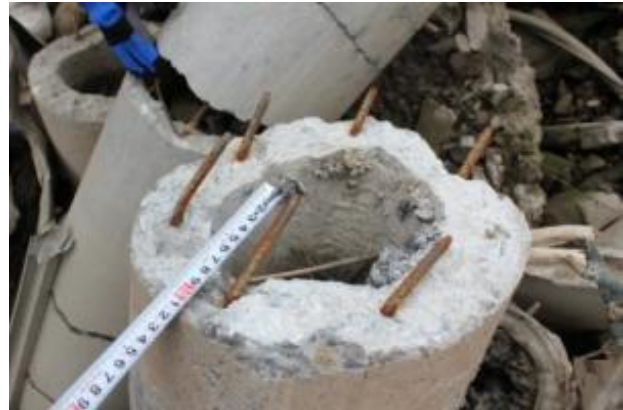
Figure 3 shows building No.1, a four-story RC building with pile foundation that overturned landward and displaced 70m from its original position. The pile foundation had 32 RC piles 4m long and 300mm in diameter, and all piles except one were broken at or near the pile head. One pile was pulled 3m up at its original position, and the exposed steel reinforcement had cut and thinning ends. This type of break is caused by tensile failure, which means that the piles were able to generate pull-out resistance.

(a) After the tsunami

(b) Pile of No.1 at its original position

Figure 3. Damage overview of building No.1

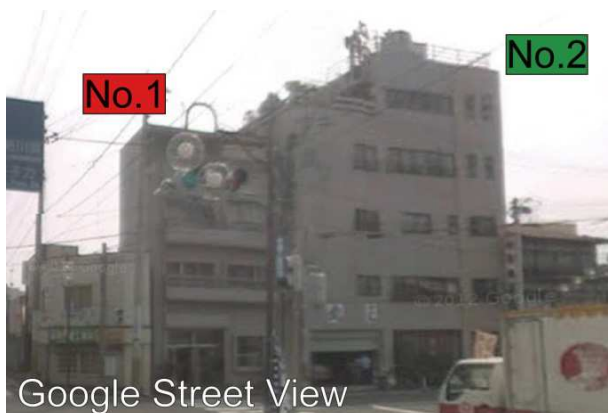
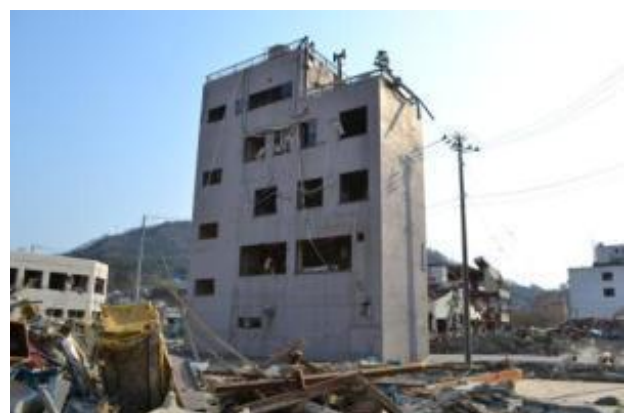
Figure 4 shows building No.2, a five-story RC building with pile foundation that was situated next to Building No.1 but did not overturn or displace. At this site, the ground subsidence indicates soil liquefaction (Tokimatsu et al., 2012). However, because the piles of Building No.1 were able to generate pull-out resistance, we assume in the following discussion that the effects of soil liquefaction on reducing the pull-out resistance of Building No.2 are negligible.

(a) Before the tsunami

(b) After the tsunami

Figure 4. Damage overview of building No.2

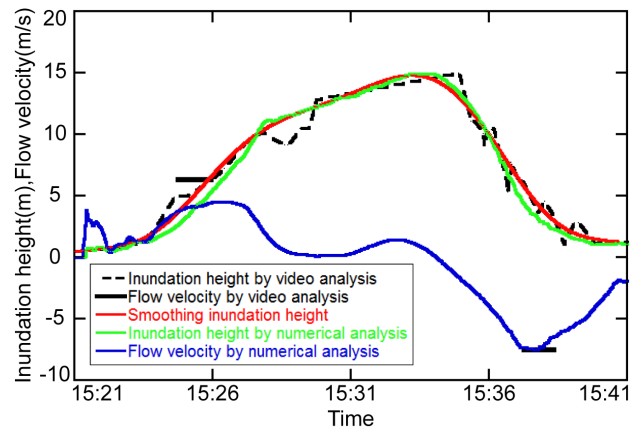
A 2D simulation of tsunami run-up is performed with a shallow water theory (Hirt and Richardson, 1999). Figure 7 shows the calculation area. The lengths of X direction and Y direction are 1530m and 570m, and the mesh size is 10m by 10m. In Figure 8, the broken and solid black lines are the estimated inundation height and flow velocity from video analysis (Koshimura et al., 2012), respectively. The red line is the smoothed inundation height that was used as the input boundary condition to simulate the tsunami wave. Figure 8 also shows the calculated inundation height (green line) and flow velocity in the X direction (blue line) at the point where the video was taken. The inundation height and flow velocity calculated by the simulation correspond well to the values estimated from the video analysis, except at 15:26 when the simulation predicts slightly slower flow velocity than the video analysis. Figure 9 shows the distribution of the inundation height and flow velocity calculated by the simulation. The inundation area shown in Fig.9 by the simulation corresponds well to the actual condition.

Figure 8. Inundation height and flow velocity

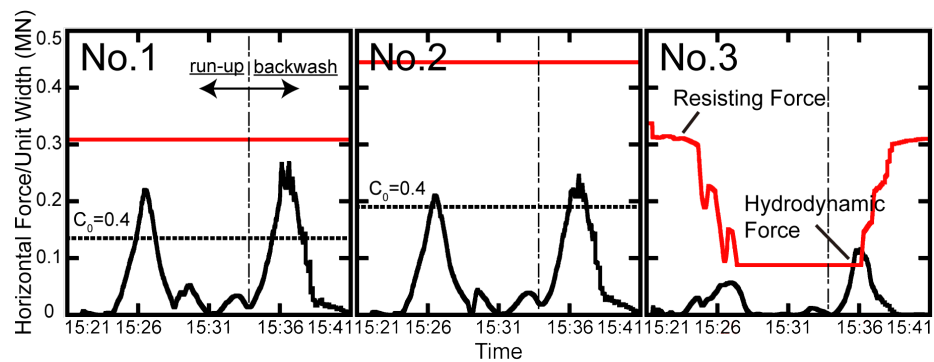
Figures 11-13 show the estimated tsunami load (black line) and building resistance (red line) using these simplified models. Figure 13 shows that for buildings No.1 and No.2, the concrete in the piles break during the first tsunami run-up. Figures 11-13 show that building No.1 failed due to overturning during the tsunami run-up, building No.2 did not fail, and building No.3 failed due to sliding and overturning during the back wash. These results correspond with the observed building performance, where building No.1 failed landward, building No.3 failed seaward, and building No.2 did not fail.

Figure 11. Hydrodynamic Force versus resisting force

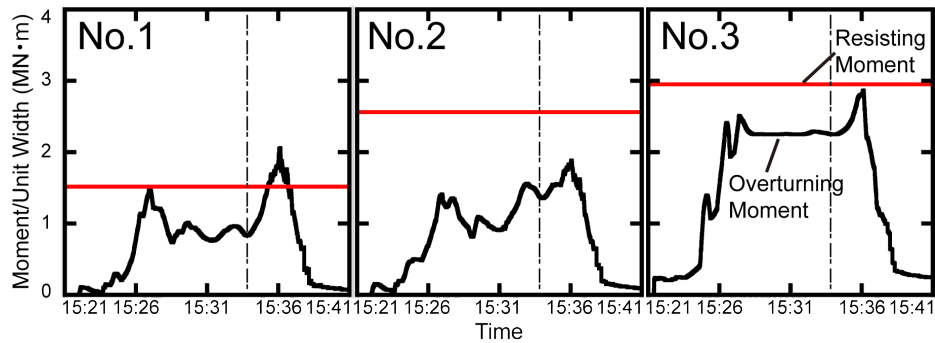
Figure 13. Overturning moment versus resisting moment
