Risk and Rockfall: Observations on the Implementation of Rockfall Mitigation at Residential Properties in the Port Hills

Skinner, M. D.¹, Mote, T.I.² and Cox, J.³

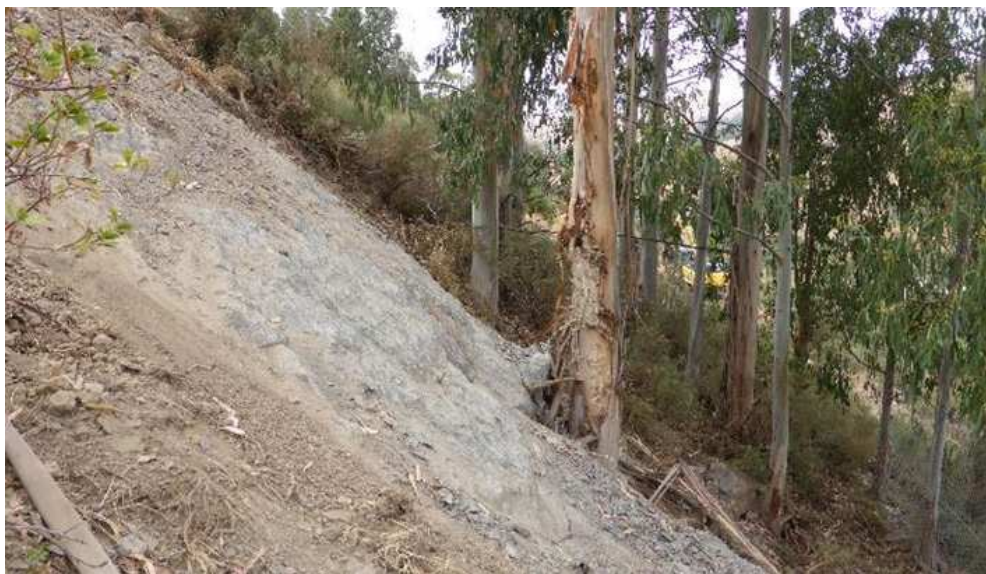
Figure 3. Case study 2: Example of rock source milled back to slope, Bowenvale Valley.

For Case Study 2, the site specific mapping showed a discrete number of rockfall sources above the property. It was considered technically and economically feasible to remove four source zones assessed as presenting a hazard to the property (Figure 3). Access to these properties was not difficult and the volume of material was not excessive. A new access track and the remediation of an old access track were included in the design. The rock sources were mitigated by milling (cutting) them back to an angle approaching the natural grade. This treatment rendered the outcrops to be non-credible sources of boulders, therefore reducing the risk to the property to a non-credible level.
