Liquefaction Resistance of Silty Soils at the Riccarton Road Site, Christchurch, New Zealand

C.Z. Beyzaei¹, J.D. Bray², M. Cubrinovski³, M. Riemer⁴, M.E. Stringer⁵, M. Jacka⁶, and F.J. Wentz⁷

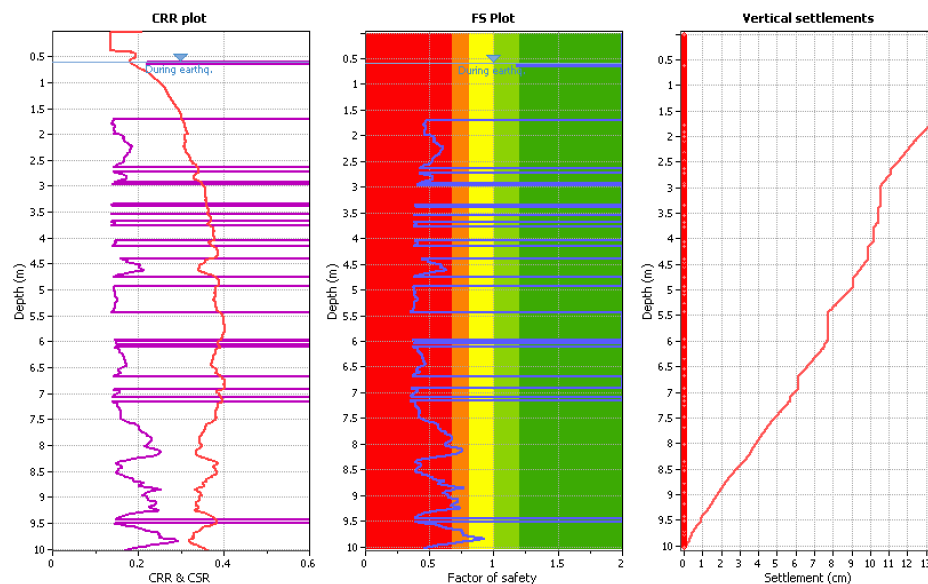
Figure 4. State-of-the-practice liquefaction triggering assessment for the 22 February 2011 event: PGA = 0.37 g, GWT = 0.6 m BGS, $P_L=50\%$, LPI = 19, CPT_36420 (plots exported from CLiq)

The Boulanger & Idriss (2014) CPT method was used to evaluate liquefaction triggering for Site 23. As presented in Figure 4, a significant portion of the profile is susceptible to liquefaction based on this state-of-the-practice method, but in both post-earthquake investigations and later examination of post-earthquake liquefaction observation maps publically available from the CGD, surface evidence of liquefaction was not observed at Site 23.

To compare the laboratory CTX test results shown in Figure 6 with the state-of-the-practice CPT analysis shown in Figure 4, the cyclic resistance ratios (CRR) are compared for an equivalent M7.5 event (i.e., 15 cycles of loading). The laboratory CTX testing curves, overburden corrected to 1 atm, indicate that $CRR \approx 0.26-0.28$ for 5% double-amplitude strain at 15 cycles. Considering a CTX-to-field loading factor of 0.68, the CTX testing field-equivalent CRR for an M7.5 earthquake ($CRR_{7.5}$) is 0.18-0.19. Conversely, CPT-based procedures estimate $CRR_{7.5} \approx 0.11-0.18$ for the liquefiable portions of the soil profile and probability of liquefaction (P_L) range of 15% to 85%. The CTX-based estimate of $CRR_{7.5}$ is near the upper end of the $P_L = 15-85\%$ range of $CRR_{7.5}$ estimated with state-of-the-practice CPT procedures. Considering the uncertainties involved in both laboratory testing and state-of-the-practice methods, the two approaches are reasonably consistent. However, the cyclic resistance estimates from both methods remain far below the cyclic demand imposed by the 22 February 2011 event. Thus, liquefaction would be expected to have triggered in the critical layer.

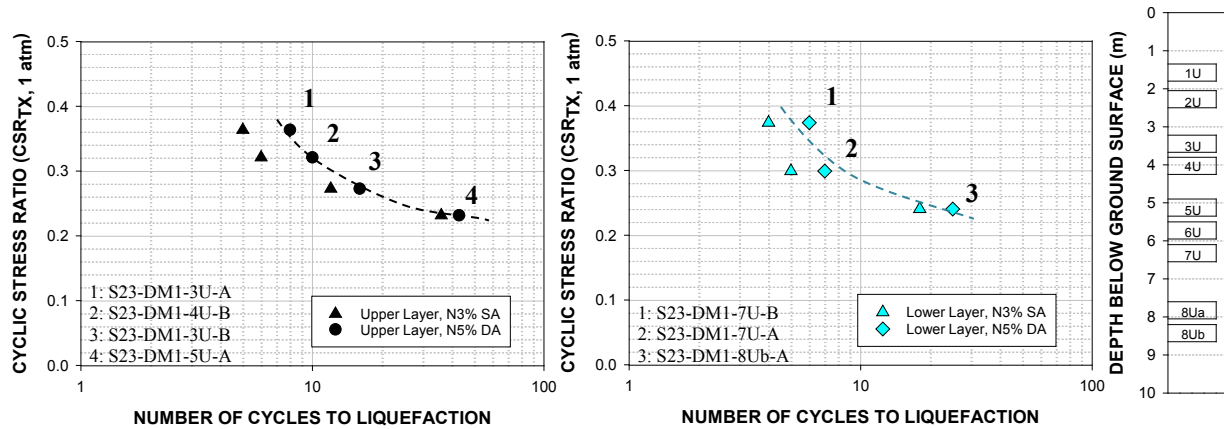
Figure 6. CTX liquefaction resistance results for Upper and Lower layers
