## Reconnaissance Highlights of the 2014 Sequence of Earthquakes in Cephalonia, Greece

Sissy Nikolaou<sup>1</sup>, Dimitrios Zekkos<sup>2</sup>, Domniki Asimaki<sup>3</sup>, Ramon Gilsanz<sup>4</sup>

### ABSTRACT

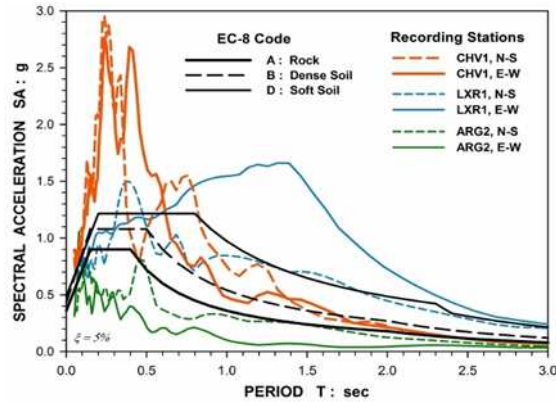
Figure 2. Acceleration spectra from the 2<sup>nd</sup> event, compared to elastic code (EC-8) spectra.

Most of the damage occurred during the 2<sup>nd</sup> event in the Paliki peninsula (Fig. 1). Fig. 2 shows recorded SAs from this event and the Eurocode's (EC-8) elastic SAs. The high amplitudes could be attributed to local site effects, directivity of shaking, and the pronounced irregular topography of the island. The recorded SAs generally far exceeded code-based values, especially between 0.2–0.3 s, the periods empirically expected for 2–3 story Reinforced Concrete (RC) buildings.

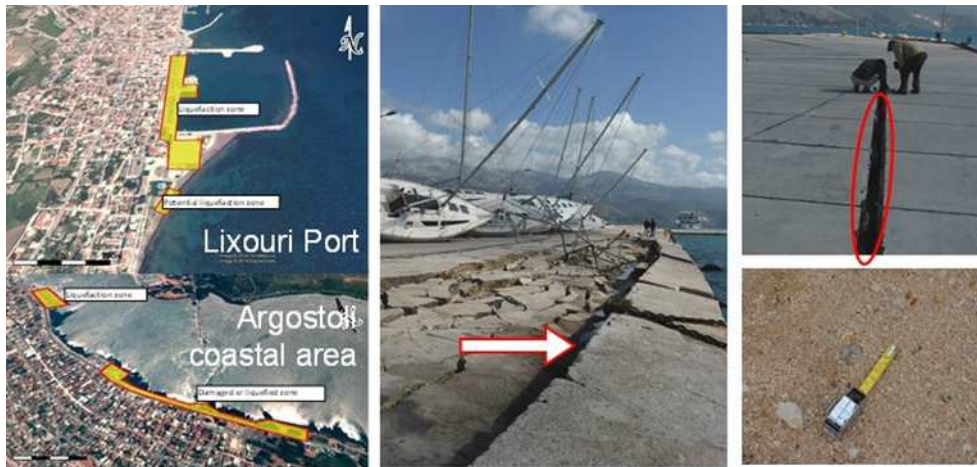
Figure 3. Liquefaction zones at two main ports of Lixouri and Argostoli (left). Lateral spread at Lixouri quay wall (middle); opening of joint at pier and evidence of gravel in ejecta (right).

Additional observations include liquefaction of Holocene coarse-grained sediments, rock falls, and landslides. Widespread, repetitive liquefaction and lateral spreading were observed primarily at the main ports of Lixouri and Argostoli, within 10 km from the epicenters (Figs. 1, 3). Quay walls displaced laterally by as much as 1.5 m in Lixouri and less in Argostoli. Liquefaction manifested at ground surface on soft sedimentary sites as large displacements of pavements, and extensive coarse grained (> #4 sieve) gravel particles were observed in ejecta throughout both ports. The two other ports, Sami and Poros, were farther from the epicenters and experienced minimal damage.

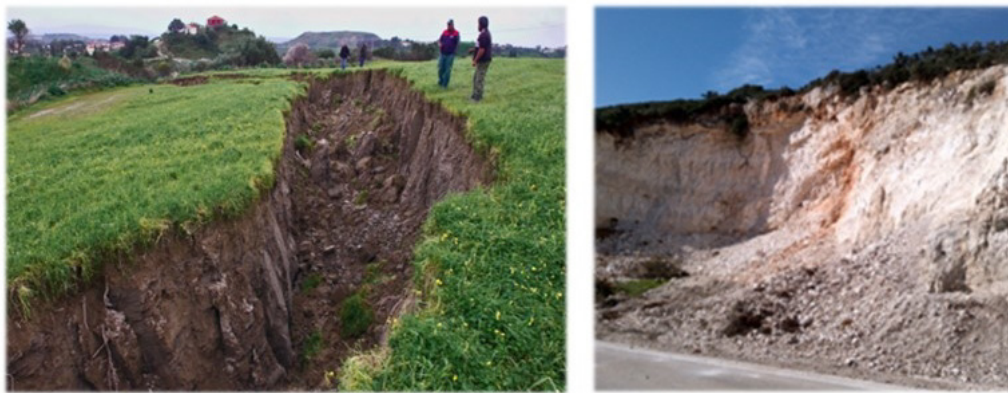
Figure 4. Landslide and rock slope failure examples.

Landslides and rock falls were observed at the west: More than 40 rock shallow slides and a deep-seated bedrock slump in natural slopes were recorded (Fig. 4), as well as numerous dry-stack masonry retaining walls. Two major landslides involved settlements of man-made embankments. Soil-structure interaction effects of differential deformations between pavements and structures were observed (Fig. 5). Still, the relatively mild structural damage in Lixouri's reclaimed area could be partially attributed to a layer of unsaturated fill on top of liquefied layers that acted as a "protective cap."

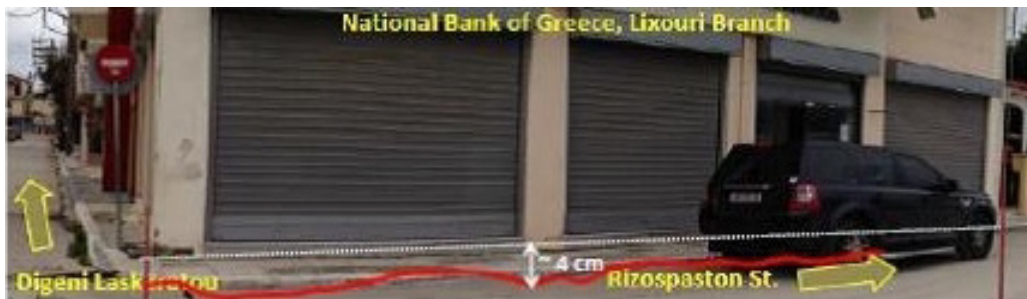
Figure 5. Settlements between the base of the National Bank Lixouri branch and sidewalk.

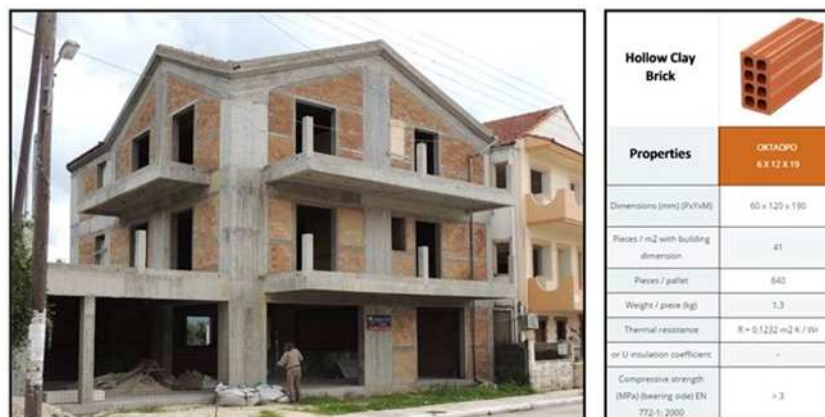
Figure 7. Confined masonry construction (left); properties of infill clay bricks (right).

The predominant structural type (Fig. 7) is a mix of reinforced concrete (RC), masonry infill, and wood roofs, 1–4 stories high. The infill has concrete beams around openings dowelled to the RC structure. This practice is unusual, but was resilient given the fact that in the 2<sup>nd</sup> event SAs peaked at 3 g in Chavriata and 1.5 g in Lixouri, exceeding max elastic code values by 1.25 to 2.5 (Fig. 2). Depending on the design Response Modification Factor (R) factor, the recorded SAs could have generated actual seismic loads that were higher than design by an astounding factor of 2.5–8.5 (for R of 2–3.5). Reconnaissance data have already initiated resiliency studies (Nikolaou et al., 2015).

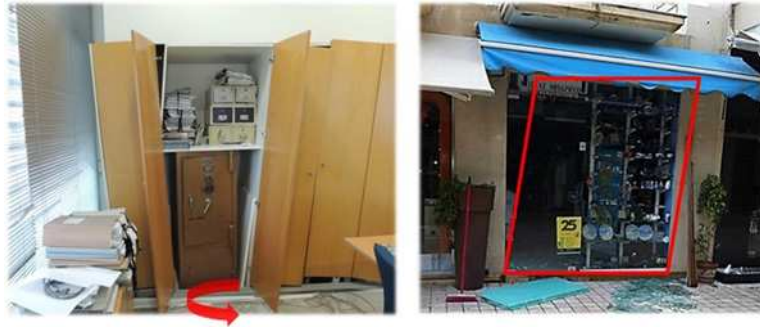
Figure 8. Nonstructural damage: Sliding and rotation of bank vault (left); glazing failure (right).

Nonstructural component deficiencies included inadequate bracing/anchorage to structure, roof tile collapse, lack of fence foundations or design for interstory drift, lack of seismic stoppers for rolling storage racks, absence of flexible joints in piping, lack of floor/wall connections of heavy furniture, bookcases and bank vaults, and unsecured objects (Fig. 8). This affected the everyday life and economy, but serious injuries or loss of life were avoided.

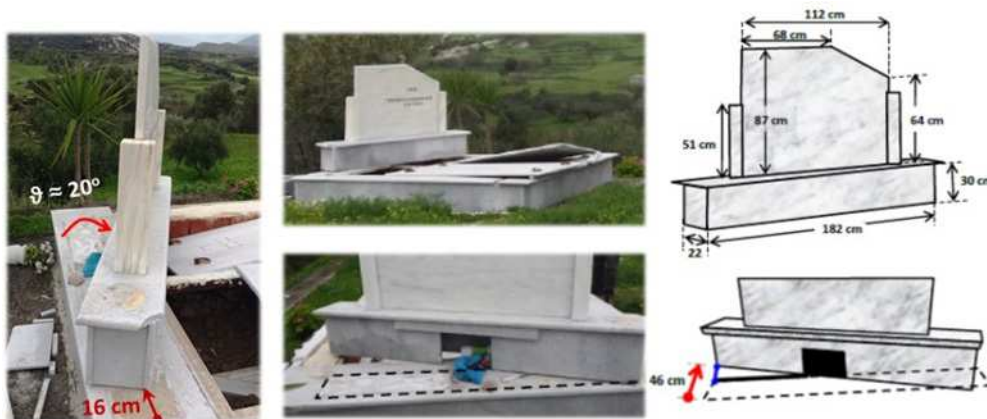
Figure 9. Photos and sketches with dimensions and displacement of a rotated headstone.

In stark contrast with the overall excellent building performance, extensive damage was observed in the 18 cemeteries of the Paliki peninsula and 9 others on the island. The main cause of tomb damage was toppling on the grave marble slab. Other failure patterns included slippage, vertical separation, and/or rotation of blocks and tombstones without toppling (Fig. 9). The toppling rate was surprisingly low in the fault vicinity and concentrated in the peninsula at a rate of ~67% of objects toppling, and dropped to ~20% on the main island and zero at the east. Controlling factors were block geometry and near field directivity effects. Since cemeteries are built on a hill, topographic amplification likely contributed. Information in the GEER/EERI/ATC report can contribute to research on the highly nonlinear seismic block behavior.

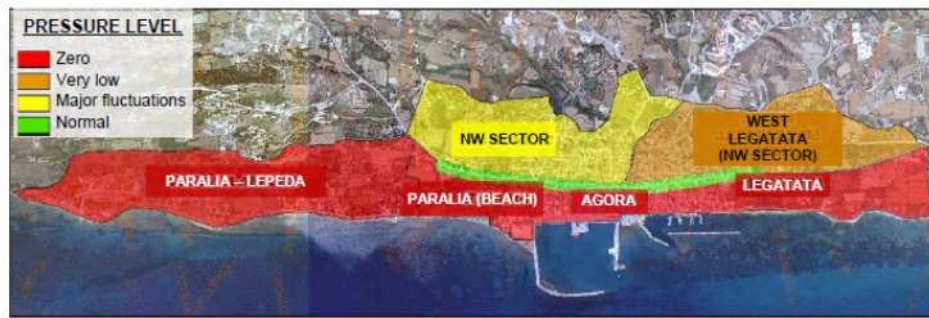
Figure 10. Rapid network assessment at the end of the first day, 2/6/14 (EYDAP, 2014).

The potable and wastewater networks suffered notable damage mainly due to the 2<sup>nd</sup> event. The Athens Water Supply & Sewerage Co. EYDAP responded rapidly with field and repair teams and provided their report for incorporation in the GEER/EERI/ATC findings. Since electronic mapping of the network was not available, EYDAP develop a GIS map of 36,191 m of water pipes based on available maps and Digital elevation models (DEMs) from satellite data. The assessment of the first day (2/6/14) is shown on Fig. 10: **Green** – normal operation; **Yellow** – significant fluctuations in pressures; **Orange** – very low pressure; and **Red** – zero pressure. The properties of the water pipe network are shown on Table 1. Damage was found to be concentrated to the Asbestos Cement Pipe network.
