Liquefaction Assessments in the Central Business District of Christchurch, New Zealand

J. D. Bray¹, C. Markham², M. Cubrinovski³

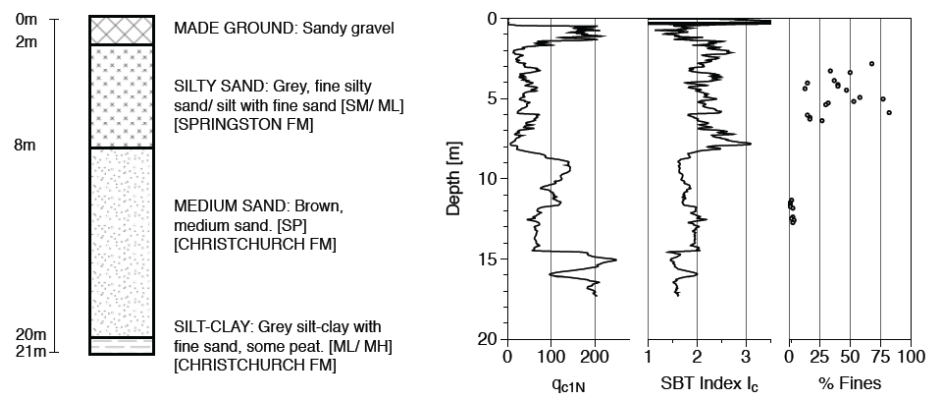
Figure 3. Log of borehole K1 and adjacent CPT Z1-B4 profile in Zone 1. The locations of borehole K1 and CPT Z1-B4 are indicated on Figure 2 (from Bray et al. 2014a).

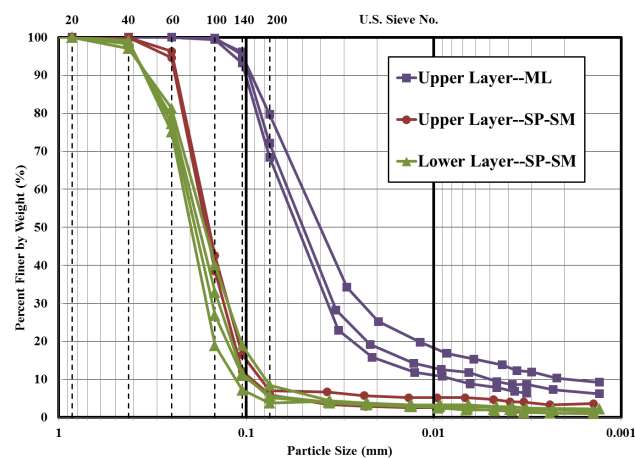
Figure 8. Grain size distribution of CTH triaxial silt and sand specimens

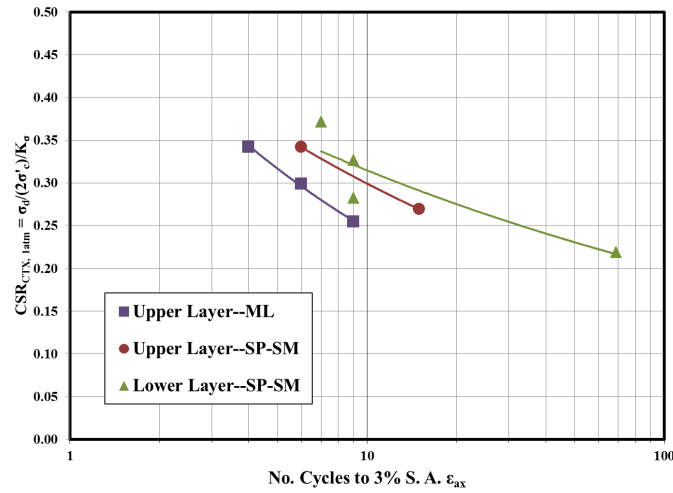
Figure 10. CTX test results at the CTH site

Figure 10 provides a summary of applied cyclic stress ratio ($CSR_{CTX,1atm}$) versus the number of cycles to 3% single amplitude axial strain ($N_{c-3\% \text{ S.A. } \epsilon_{ax}}$) for all CTX specimens tested from the CTH site. The interpreted cyclic resistance ratio (CRR) curves for these tests indicate that the upper silt is the weakest of the three layers studied, followed by the upper SP-SM material. The deeper silty sand represents the strongest of the material tested. This trend of the upper portion of the subsurface consisting of a slightly weaker, finer material overlying a stronger coarser material was also observed at the sites discussed below.

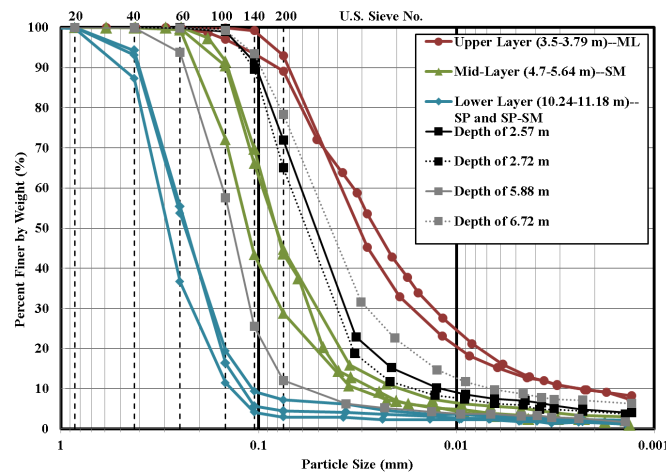
Figure 12. Grain size distribution of FTG-7 soils

Figure 12 provides the grain size distribution plots of triaxial specimens tested from the FTG-7 site. In general the upper portion of the subsurface profile consists of both silts and silty sands (ML and SM material), which is consistent with the CPT data provided in Figure 11. Specimens tested from a depth of 10 to 11 m classified as sand to sand with silt (SP and SP-SM). Figure 13 provides a summary of applied cyclic stress ratio ($CSR_{CTX,1atm}$) versus the number of cycles to 3% single amplitude axial strain ($N_{c-3\% S.A. \epsilon_{ax}}$) for CTX specimens tested from the FTG-7 site. CRR curves were interpreted based on similar grain size distribution of the tested specimens, as well as depth grouping (i.e., specimens close to each other with regards to depth).

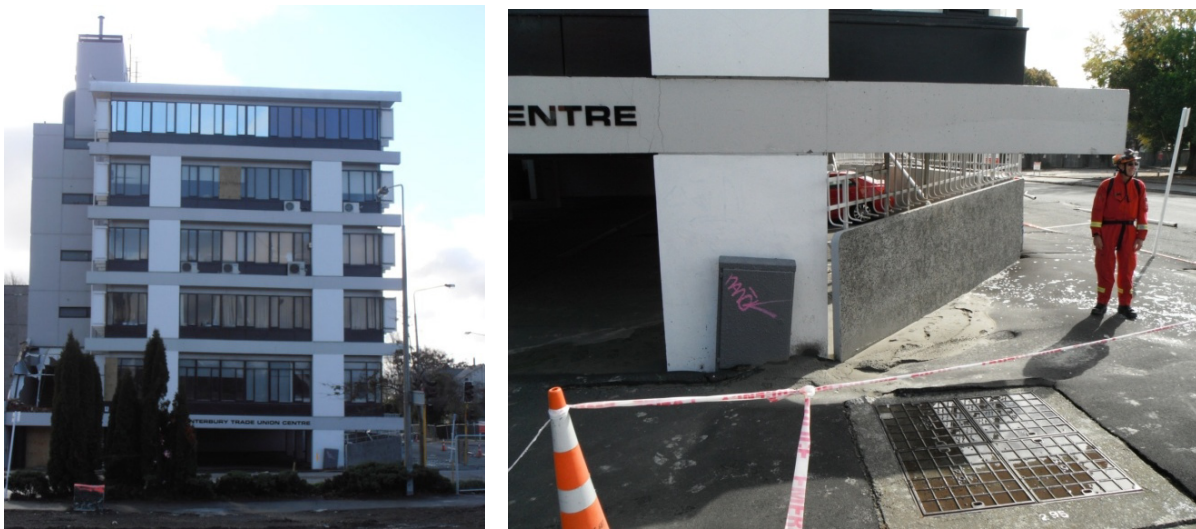
Figure 14. View of south side of CTUC building and close-up view of its SE corner after the Christchurch earthquake (from Bray et al. 2014a).

Severe liquefaction of the foundation soils during the 22 FEB 11 Christchurch earthquake induced significant total and differential settlements of the building, leading to structural distortions and cracking (Cubrinovski et al. 2011a). The building tilted to the east 0.4-0.5 degrees. Differential settlement of the southeast corner of the building produced most of the structural damage. Several of the beams on the south side of the building were cracked near the beam-column connections. The building settled more on its south side than on its north side and more on its east side than its west side. Approximately 20 cm of the 25 cm of differential building settlement along the eastern side of the building was measured across its two southernmost spans (angular distortion $\approx 1/50$), which is consistent with the observed cracking of structural beams. Damage to the building was negligible during the other CES events.

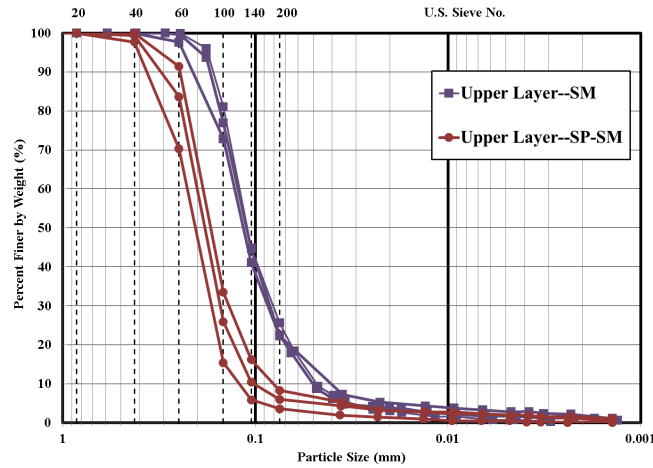
Figure 16. Grain size distribution of CTUC building site soils

sample of the lower sand was obtained (at a depth of about 13.67 m). Index testing on the test specimens revealed that the upper layer of silty soil comprises a layer of silty sand (SM) from a depth of 2.75 to 3.40 m and a layer of sand and sand with silt (SP and SP-SM) from a depth of 3.41 to 4.05 m. The grain size distributions of the retrieved soils are shown in Figure 16. A summary of the applied stress normalized cyclic stress ratio ($CSR_{CTX, 1atm}$) versus the number of cycles to 3% single amplitude axial strain ($N_{c-3\% S.A. \epsilon_{ax}}$) for CTX specimens tested from the CTUC site is shown in Figure 17. The resulting cyclic resistance ratio (CRR) curves indicate that the finer sub-layer of SM material is slightly weaker than the coarser SP and SP-SM material.

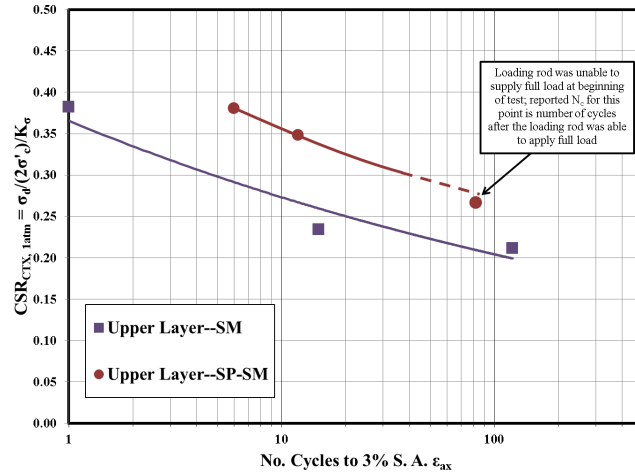
Figure 17. Results of CTX testing at CTUC site; mid-depths of specimens are reported.

One of the key findings of the CTX testing is the presence of two distinct layers of soil that have slightly different liquefaction resistances in the upper critical layer of soil in the SE corner of the site. This was not as clearly evident based on the CPT results (i.e., the q_t and I_c profiles shown in Figure 15 are relatively constant for the upper layer of liquefiable material). The laboratory testing results coupled with the CPT interpretations provide data and insights for researchers investigating the seismic performance of the CTUC building during the Canterbury earthquakes.
