Deep excavations in singapore marine clay

J.N. Shirlaw

ABSTRACT: Significant areas of the financial and commercial districts of Singapore have been constructed over deep deposits of near normally consolidated marine clay. Numerous deep excavations have been required for urban development and the supporting infrastructure. The design of these excavations needed to consider basal stability and (for walls taken to hard strata) net active forces below excavation level. A number of innovative solutions to these problems have been applied. Solutions have included the use of underwater excavation, lime piles, deep soil mixing and the formation of buried slabs using jet grouting. Generally, these have been successful. However, there have been a number of major excavation failures over the last 10 years. Examples of successful excavations are contrasted with some of the failures, and the causes discussed.

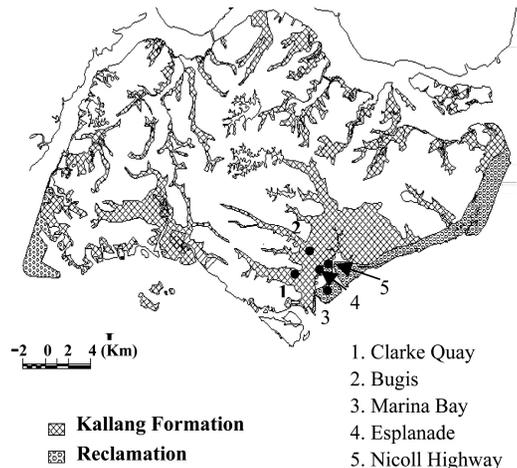
Figure 1. Singapore, showing areas of Kallang Formation deposits and recent reclamations.

Figure 1 shows the areas of Singapore where the Kallang Formation is encountered, and the areas of post war reclamation, which are underlain by soils of the Kallang Formation.

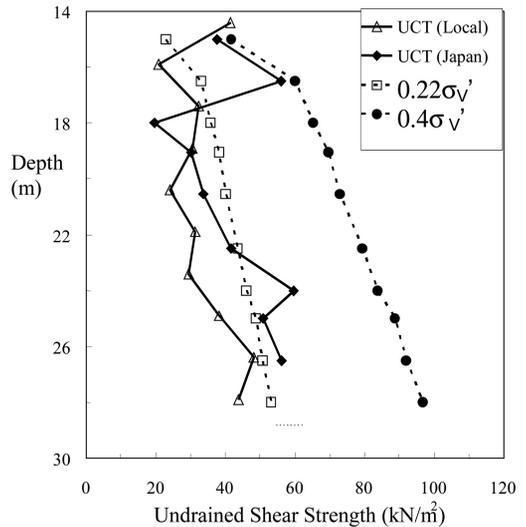
Figure 2. Effect of sampling method on undrained shear strength (UCT) for SAC clay.

about 0.22 (Figure 1). Samples tested after isotropic or Ko consolidation gave a higher ratio, of about 0.3, as did tests in extension. Data from Direct Simple Shear (DSS) tests, reported by Cao et al., gave a lower strength ratio of 0.18 (for the UMC) and 0.23 (for the LMC). Typically, vane tests give an undrained shear strength ratio of about 0.25, in terms of current effective stress. This ratio takes into account the small degree of overconsolidation found in areas other than the more recent reclamations. Tan et al report that the ratio between the undrained shear strength and the maximum past effective consolidation pressure (p'_c) is 0.21, based on both DSS and field vane tests. The design of excavations is commonly based on the results of field vane tests.

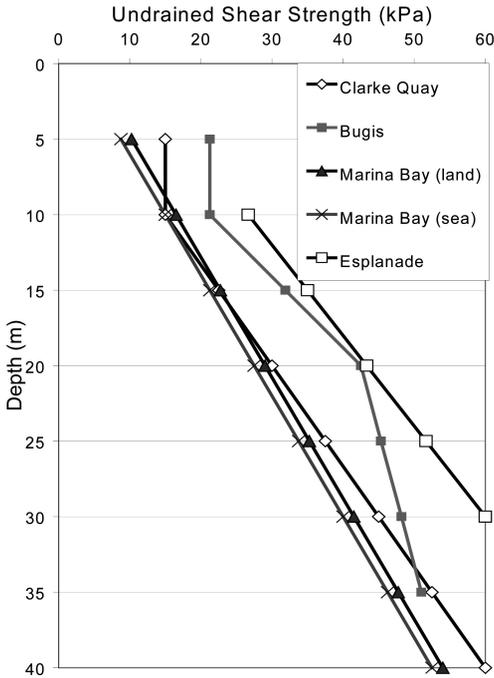
Figure 3. Undrained shear strength/depth profiles in the marine clay at various sites in Singapore, as used for design.

The design shear strength profiles in Figure 3 are after the application of vane correction factors of 0.85 (for Bugis), 0.81 (for the Esplanade), and 1 at the other sites.

The undrained shear strength/depth profile for Clarke Quay (Fig. 3) is typical of those commonly used for design in Singapore, in areas other than those that have been recently reclaimed. 'Recent' in this context refers to areas that have been reclaimed in the last 25 years; due to the thickness and low permeability of the clay, primary consolidation generally takes 25 years or more to take place.

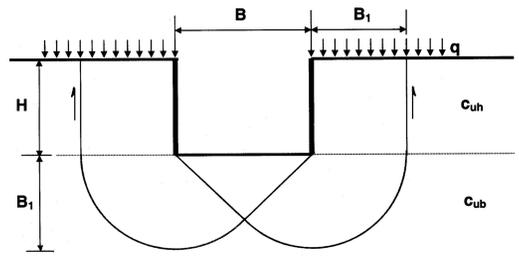
Figure 4a. Terzaghi's method (1943).

Terzaghi's method (1943) catered for wide excavations with the width (B) greater than the depth (H). The failure mechanism is shown in Figure 4a. The failure surface extends from the ground surface to a depth of $0.7B$ below the formation level or to the top of the underlying hard stratum whichever is shallower. Wall penetration beyond the formation level is ignored. The effect of wall stiffness is not considered. Even though it is developed under plane strain condition, it is applicable to wide excavations of rectangular shape. The factor of safety F_s can be computed using Equation (1).

$$F_s = \frac{5.7 c_{ub} B_1}{\gamma H B_1 - c_{uh} H} \quad (1)$$

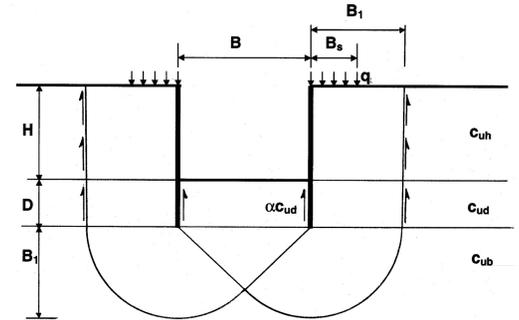
Figure 4b. Modified Terzaghi's method (Wong and Goh, 2002).

When a very stiff wall is used, the clay has to flow around the toe into the excavated area. Wong & Goh (2002) extended Terzaghi's method to accommodate this phenomenon as shown in Figure 4. The extension is based on Equation (2) where all the resisting forces are on the nominator and the driving forces at the denominator.

$$F_s = \frac{5.7 c_{ub} B_1 + c_{uh} H + (1 + \alpha) c_{ud} D}{\gamma H B_1 + q B_s} \quad (3)$$

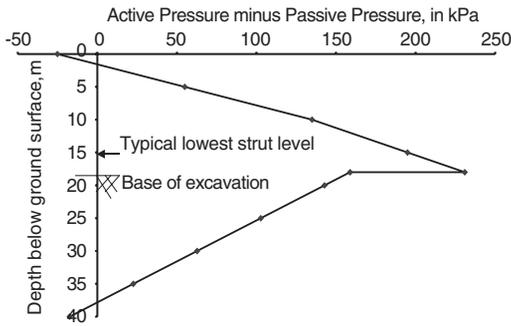
Figure 5. The 'net active' pressure on the wall of an 18 m deep excavation. The undrained strength profile used is that for Clarke Quay in Figure 3.

Figure 5 shows the calculated net active pressure (the active pressure minus the limiting passive pressure) below the base of a long, 18 m deep excavation, for the Clarke Quay strength/depth profile, assuming marine clay to a depth of 40 m. The calculation is based on:

$$\text{Net Active Pressure} = \gamma H + q - N_{cb} c_u \quad (4)$$

Where q is the design surcharge and the other terms are defined above. It can be seen that there is a net active pressure on the wall almost throughout the marine clay, even below the base of the excavation. In the passive zone the wall has to transfer this load, upwards

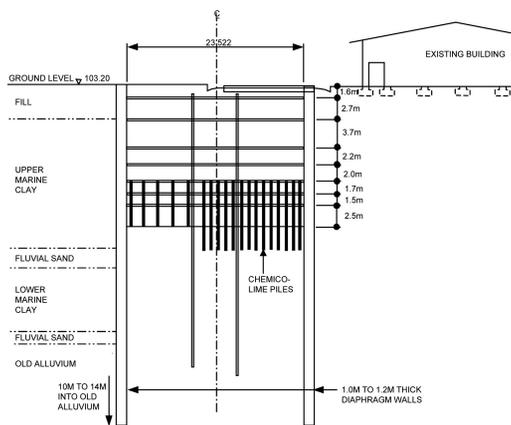
Figure 6. The excavation support system for Bugis Station.

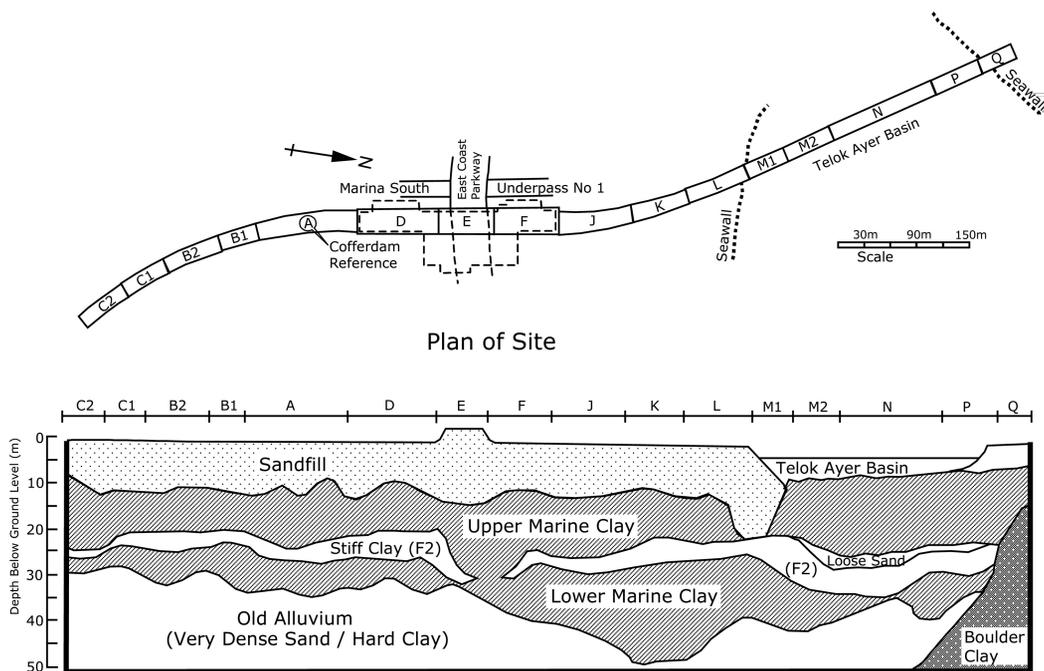
Figure 7. Marina Bay Station and tunnels (after Clarke & Prebaharan, 1987).

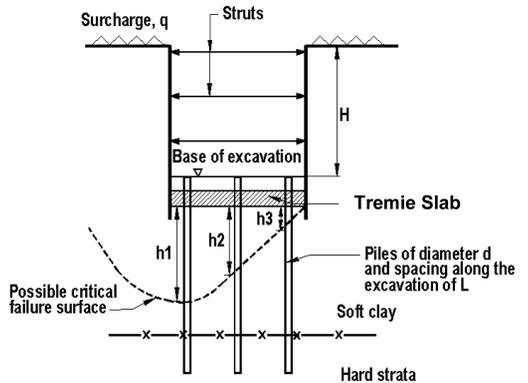
Figure 9. Basis for the estimation of uplift pressures on the tremie slab, Marina Bay Station.

h, h_1, h_2 and h_3 are as defined in Figure 9, and depend on the critical failure surface for the particular ground conditions and excavation geometry at the site

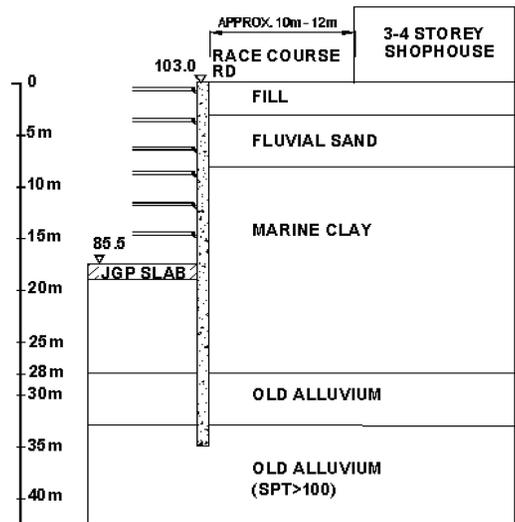
Figure 10. Jet grout slab used as a buried strut, cut-and-cover tunnels along Race Course Road.

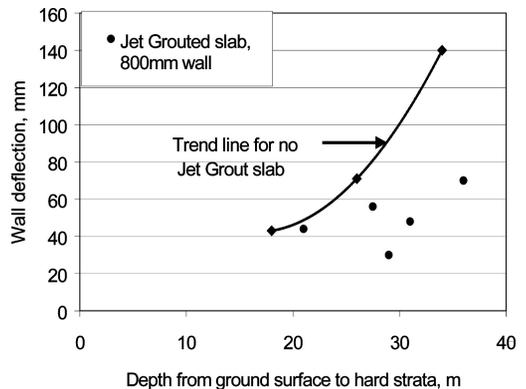
Figure 11. A comparison between the recorded deflections for 17.5 to 18 m deep excavations, with and without a single jet grout slab just below the base of the excavation.

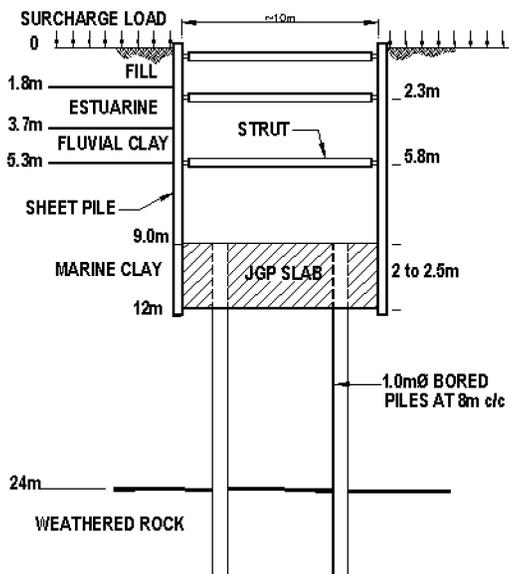
Figure 12. The ‘floating’ retaining system, Entrances 1 and 2, Clarke Quay Station.

marine clay. The excavation was carried out in the dry, using 3 levels of strutting as well as the jet grout slab (Fig. 12). The design of the jet grout slab was based on equation 5, previously used of the tremie slab at Marina Bay. Measurements of the heave of the slab during excavation gave a value of only 3 mm. Further details of the design and construction issues for jet grouted slabs are given in Shirlaw et al (2000a), Shirlaw et al. (2000b) and Shirlaw (2003).

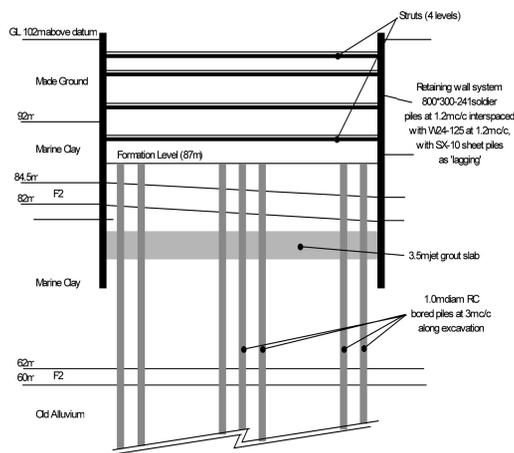
Figure 13. An example of a ‘floating’ wall system, used for part of the KPE construction.

Similar ‘floating’ retaining systems, but for deeper excavations, have since been used for some of the excavations for the Kallang and Paya Lebar Expressway, which commenced in 2002. One example is shown in Figure 13. The excavation was much larger than those

of the entrances at Clarke Quay. The width of the excavation was 40 m and the depth 15 m. In this case the monitored heave on the jet grouted slab, at the end of excavation, was 47 mm. The position of the jet grout slab was chosen to ensure that the grouting was in the marine clay and not in the stiff intermediate (F2) clay. The column diameter that could be achieved in the stiff clay was significantly smaller than that in the marine clay. In order to form a slab by installing multiple, overlapping columns, it was considered advantageous to ensure that the slab was in the marine clay.

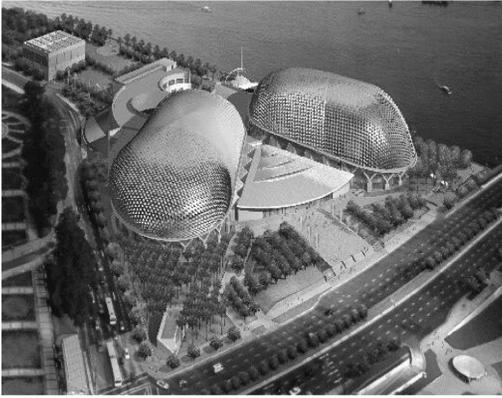
Figure 14. Artist's impression of the completed project.

The Esplanade – Theatres on the Bay is touted to be the landmark of Singapore with the two unique domes as shown in Figure 14. It is a world-class cultural and arts centre. The 1,600-seat concert hall boasts the biggest reverberation chamber in the world and the 2,000-seat theatre has an adjustable proscenium arch and orchestra pit with two full-sized ancillary stages. The arts centre covers an area of about 18,000 m² and has the shape of a segmented semi-circle with a radius of about 90 m (Fig. 15).

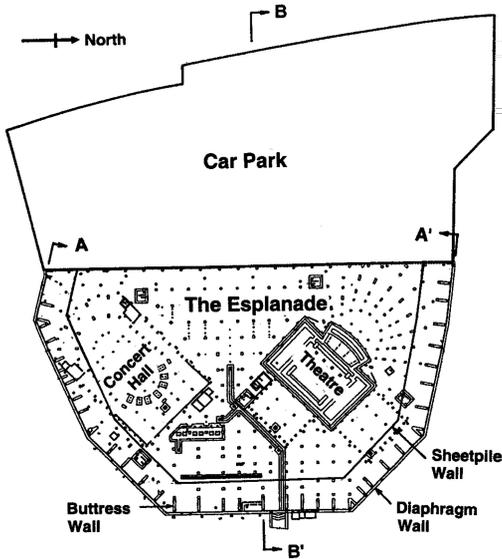
Figure 15. Site plan and layout of car park and centre proper.

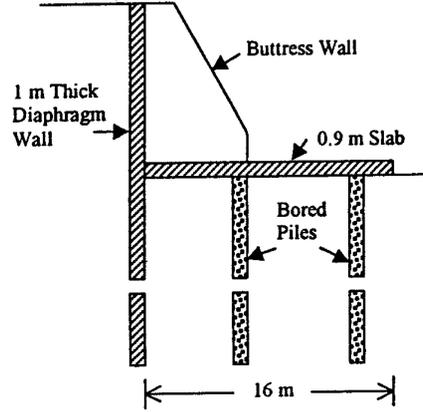
Figure 16. Configuration of permanent wall.

The buttress wall was designed to provide permanent support to the diaphragm wall to resist the earth pressure. The buttresses were 1 m thick and 6 m wide, and spaced at 8 to 10 m. A continuous waler beam connected all the buttresses at mid-height of wall. The buttresses acted partly as a wall stiffener and partly as a medium to transfer the soil pressure to the base slab and then onto the supporting bored piles as illustrated in Figure 16. The construction sequence is summarised below:

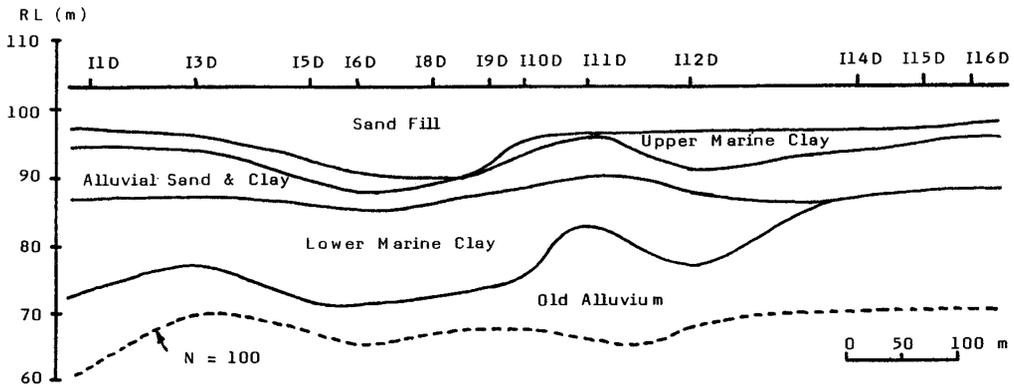
Figure 17. Soil profile along the perimeter of excavation from south to north (Section A-A').

The ground water level was about 2.5 to 3.0 m below surface. The soil condition was very variable across the site. The soil profile along the perimeter is shown in Figure 17. The fill consisted mostly of gravelly sand to clayey and silty sand with thickness varying from 4 to 15 m. The average standard penetration blow count (SPT ‘N’) was about 10. The thickness of upper marine clay varied from 0 to 5 m and the lower marine clay had a thickness up to 20 m near the southwest corner. Marine clay was absent at the northwest corner. The

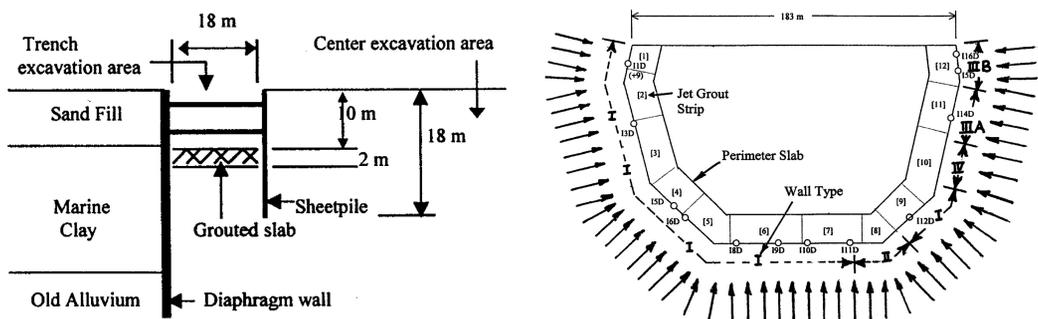
Figure 18. Perimeter concrete slab (16 m wide and 0.9 m thick) at formation level acting as a compression ring.

The final design took advantage of the semi-circular shape by constructing a 16 m wide concrete slab around the inner perimeter of the site butting against the diaphragm wall at formation level. It was intended

for this concrete slab to act as a compression ring to keep the diaphragm wall in-place as illustrated in Figure 18.

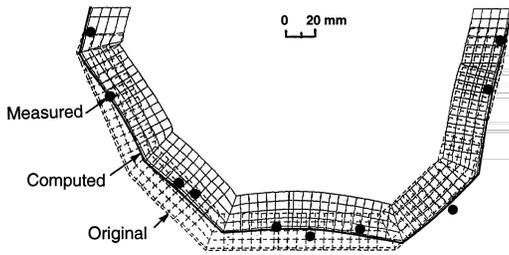
Figure 19. Computed and measured deflections.

At the end of trench excavation, the maximum inward wall deflection varied from 20 to 33 mm. The displacement increased to 27 to 50 mm during the construction of pile caps and buttresses. Since the wall was pushed outward during jet grouting, the net wall deflection was relatively small at this stage.

was to minimize movement of the installed piles. The maximum wall deflection due to excavation in the central area alone varied from -5 mm (outward) to $+25$ mm (inward). When combining with deflections during trench excavation, the total deflection after jet grouting varied from 37 to 65 mm. Due to further excavation work at the lyric theatre and local pile caps, there was an increase in movement by about 3 to 5 mm. If the wall movements due to jet grouting were taken into consideration, the final wall deflection from the original vertical position varied from 29 to 70 mm.

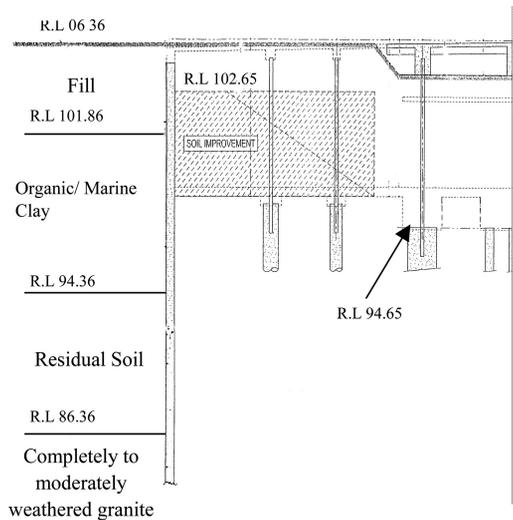
Figure 20. Use of deep soil mixing to provide an improved berm, HDB Centre at Toa Payoh.

To reduce the likely movement during the excavation to provide some additional room for the construction of the diaphragm wall, the berm was improved using lime columns to provide adequate support to the

retaining wall to limit movement (Fig. 20). The existing soil needs to be improved only a little. The main chemical improving agent used is quick lime (CaO), which absorbs water from the surrounding causing the lime to swell and formed slaked lime (Ca(OH)_2). According to Tan et al. (2001), the process of slaking leads to a volume expansion which in turn causes a lateral consolidation effect on the soil adjacent to the lime columns, and moisture content in the soil is reduced. As a longer term chemical effect, the calcium ion in the slaked lime are then absorbed by the negatively charged surface of clay minerals, thereby acting as the cementing agent leading to the improved strength of the soil. The shear strength of the original soil is around 15 kPa. The shear strength of the individual pile is about 150 kPa and the shear strength of the composite treated soil is improved to 20 to 25 kPa. More importantly, the Young's Modulus of the composite soil was improved to 8 MPa, significantly higher than the value of the original unimproved marine clay, which will be about 1 to 2 MPa. However, such improvement is considered low compared to more conventional soil improvement technique such as jet grouting mainly because of the very wide spacing between columns. The measurement during construction indicated that the final resultant movement was just over 10 mm. This indicates that the choice of a low intensity improvement was just right for this job.

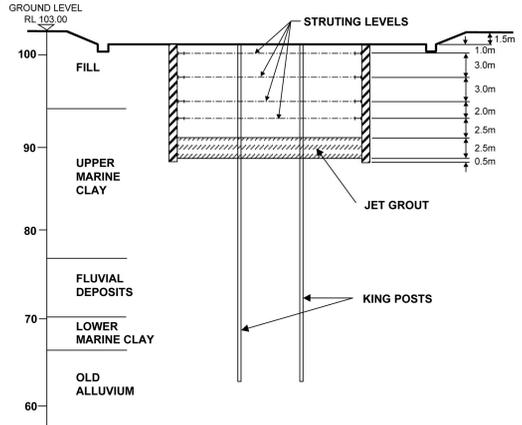
Figure 21. The excavation for the Central Services Tunnel (after Lim & Tan (2003)).

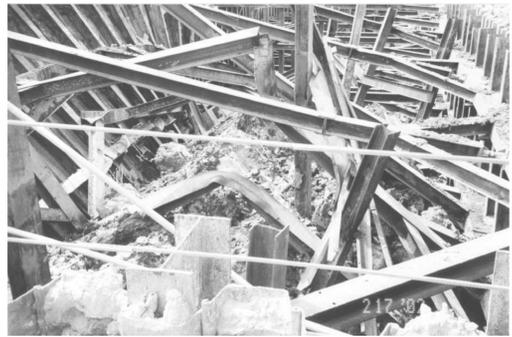
Figure 22. The failed section of the excavation for the Central Services Tunnel, showing the failed base just above the jet grout slab and the north wall rotated inwards.

The failure occurred during excavation for the fourth level of strutting (Lim & Tan 2003). The jet grout slab suffered a failure in bending along the centre of the excavation over a length of about 50 m. Buckling of the jet grout slab was accompanied by the king posts punching upwards, effectively taking out the strutting system, and accompanied by inward rotation of one wall of the excavation. Photographs taken after the failure are shown in Figures 22 and 23.

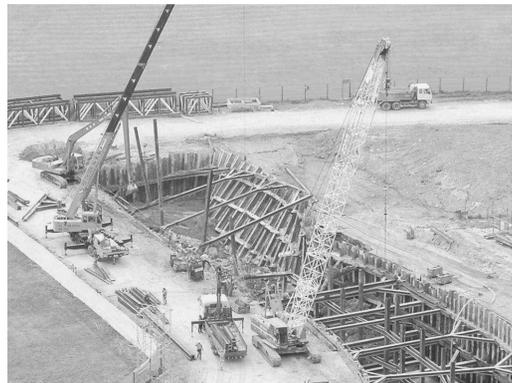
Figure 23. The failed excavation during recovery. Note the kingposts in the failed section, some of which had been pushed upwards by 3 m, and the rotational failure of the retaining wall.

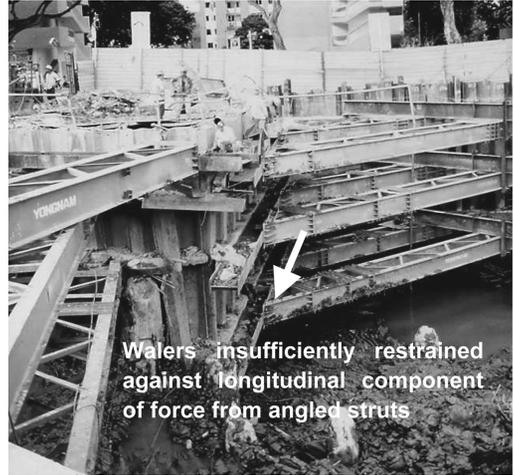
Figure 24. The walers in this photograph had moved longitudinally, allowing the wall to deflect by over 600 mm.

This problem, involving the axial component of force, in walers, from angled struts, is a common cause of excavation failures in Singapore, and is not limited to marine clay.

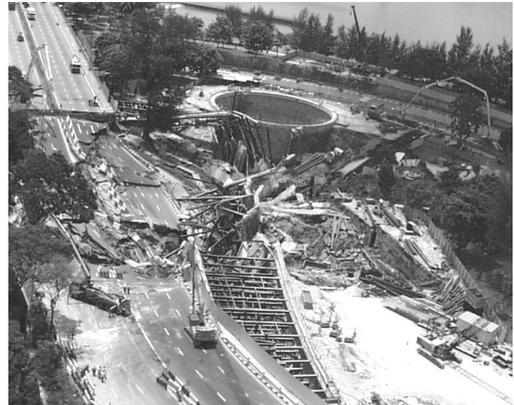
Figure 25. Nicoll Highway area after the collapse.

On the 20th April 2004 a section of cut-and-cover tunnel near Nicoll Highway collapsed, killing four people working at the site (Fig. 25). The Committee of Inquiry into the collapse commenced in August 2004 and issued a final report on 13th May 2005. The following brief summary is based on the final report (Magnus et al., 2005), of the Committee of Inquiry and on a report in the *New Civil Engineer* (Mylius 2005).
