Ten years of bored tunnels in The Netherlands: Part II structural issues

K.J. Bakker

A. Bezuijen

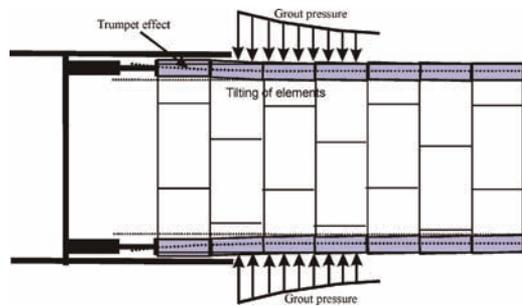
Figure 1. Trumpet effect in tunnel ring construction.

ring needs to be built onto the end of a former ring that already has undergone some loading and deformation from the tail void grouting while it partially has left the tail of the TBM, see Fig. 3. The further deformation is characterised by the trumpet shape of the tubing that develops, see Fig. 1, with the inevitable related stress development in the lining. The trumpet shape and the high jacking forces lead to local stress concentrations and irregular deformations in the lining and occasional slipping between the different tunnel elements. The slipping of elements was blamed to the use of a bituminous material called Kaubit in the ring joint.

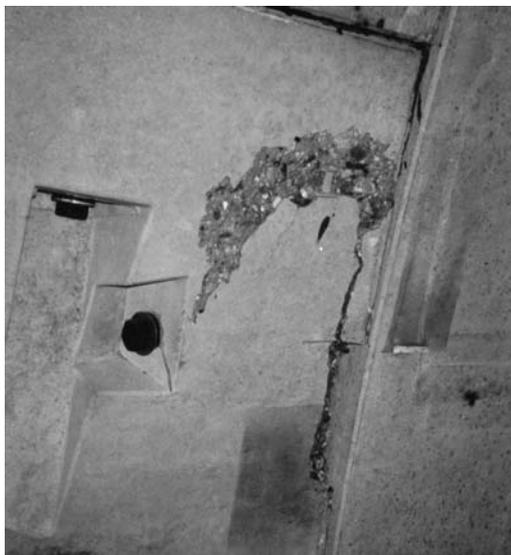
Figure 2. Damage to the Dowel and notch sockets.

Characteristic to the damage was cracking and spalling of concrete near the dowel and notches see Fig. 2. Quite often the damage was combined with

Failure of the dowel and notch system, see Fig. 2. led to spalling and in some cases to leakage. In the cases that leakage was observed this must have been correlated to damage to the notch at the outer side of the lining, creating a shortcut to water penetrating behind the rubber sealing there.

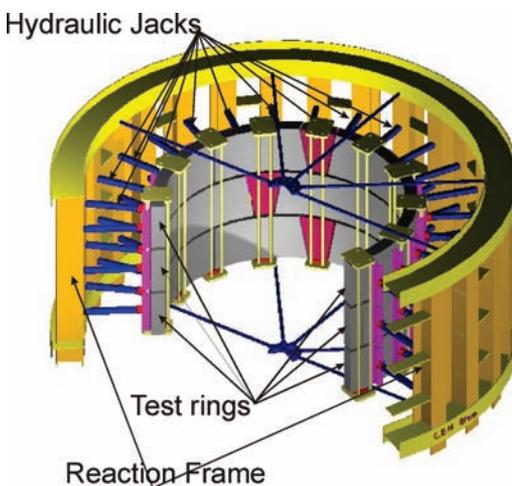
Figure 3. Large-scale tunnel ring testing in the Stevin Laboratories at Delft University (the diameter of the (gray) inner ring is 8.3 m).

Besides this technical measure, the evaluation was the trigger for the undertaking of fundamental research into lining design that included large scale physical testing of tunnel tubing at Delft University see Fig. 4. In this project that was a combined effort of physical and numerical testing, the details of assembling tunnel segments into subsequent tunnel rings and these into a tube were investigated. Amongst others the main results of the project were reported by Blom (2002),

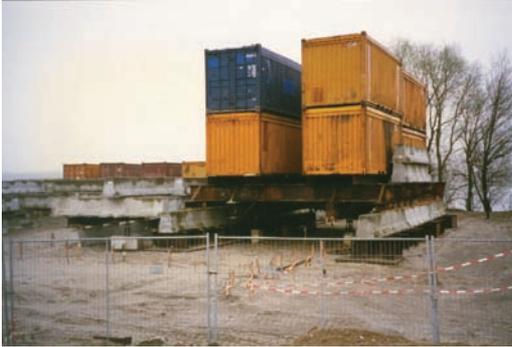
Figure 4. Test site for the Pile-tunnel interaction test.

A trial field with loaded piles and pile configurations was installed in the area near and above the track of the TBM, see Fig. 4. One of the main concerns was that due to an increase in pore pressure the effective stresses around the pile tip might be affected and that a release in isotropic stresses might trigger a drop in pile bearing capacity.

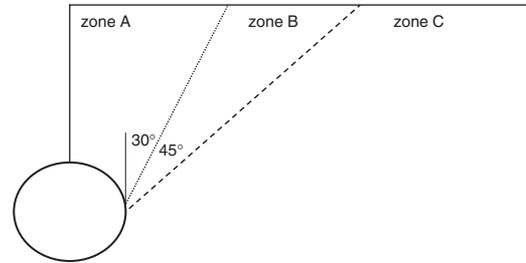
Figure 5. Zones that indicate different effects on pile foundations.

However, reasoning and analysis is one thing; measuring and validation is another; based on the field measurements and physical model research in Delft and Cambridge Kaalberg et al. (2005), proposed a zoning as shown in Fig. 5, with the following indicators; a zone "A" above the tunnel where the settlement of a pile is expected to be larger than the soil displacements. A zone "B" adjacent to the tunnel, with an inclined influence line, where the pile will follow the soil deformation at the tip of the pile, and further a zone "C", outside Zone B, where at soil surface level the settlement of the pile will be less than that of the soil surface. This zoning proposal more or less coincides with the

- 4 No proof was found that tunnel driving, in normal operation, might give cause to loss of bearing capacity of piles. Settlements in general are related to the settlement of the ground and the position of the pile toe with respect to the zones indicated in fig. 5.

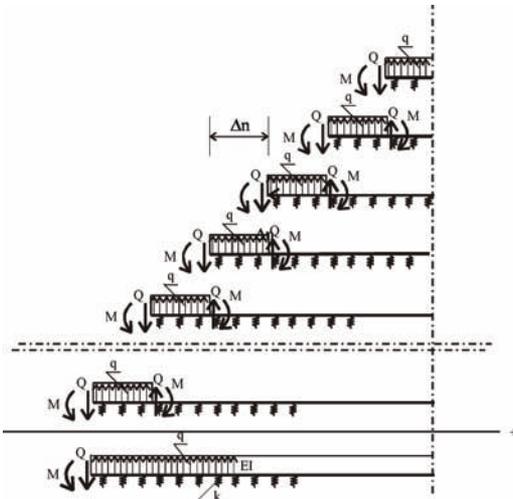
Figure 6. Conceptual model for the analysis of beam effects in the tube of a bored tunnel by Boogaards (1999).

The main conclusion with respect to this effect was that this issue can be properly analysed with a relatively simple model based on the concept of a beam with an elastic bedding and a series summation, such as developed by Boogaards & Bakker (1999), see Fig. 6 and later on applied by Hoefsloot (2002). See Fig. 7 for a comparison between model outcome and measurements from the 2nd Heineoord tunnel.

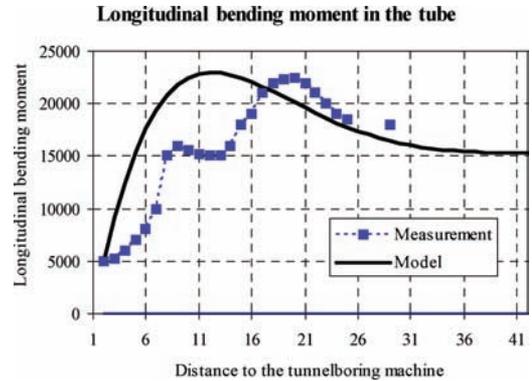
Figure 7. Longitudinal bending moment due to the construction forces measured and calculated acc. to Bogaards model.

However, using generally accepted parameters, the measured deformations are much higher than according to these models. Recently, Talmon et al. (2008) have presented results that may explain the lower stiffness that are found in the measurements (the lining stiffness can be lower due to only local contact between the elements and the soil stiffness reduces due to unloading of the soil around the tunnel), but these are not yet generally accepted.
