The response of piled buildings to deep excavations

M. Korff

ABSTRACT: This paper explores the influence of the piled foundation on the building response to excavation-induced deformations. The influence of the type of foundation, the position of positive and negative skin friction zones, and the flexibility of the piles is evaluated with respect to both horizontal and vertical soil deformations. Case histories from the Netherlands are included from Amsterdam (North South Line) and Rotterdam (a building adjacent to the Willemspoortunnel). Most of the buildings are founded on timber piles ranging in length from 12–17 m. Conclusions are drawn about the interaction between the piled building and the soil deformation.

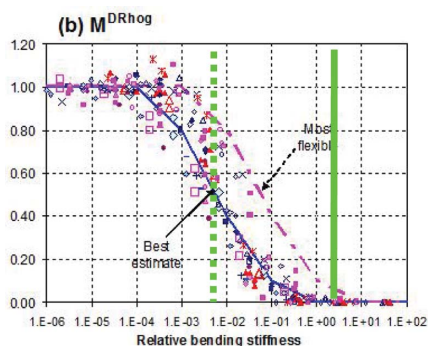
Figure 8. Design curves from Goh (2010), modified modification factor for hogging with results for Witte Huis in green lines (solid for walls, dashed for slab and floors).

The estimated relative bending stiffness values are calculated and presented in Table 1 and Figure 8.

In reality very little hogging deformation was observed, which is consistent with the estimated relative bending stiffness based on the walls (allowing for openings) leading to a modification factor of 0. The interaction based only on the individual slabs and floors underestimates the relative bending stiffness for this building. Methods for frame structures such as presented by Goh (2010) and Potts & Addenbrooke (1996) are not considered realistic for this type of masonry bearing structures.

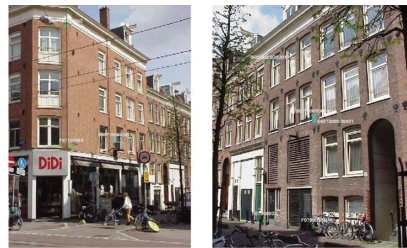
Figure 10. Historic buildings at Ceintuurbaan station (dated 1880–1920).

The buildings considered, see Figure 10, are built with masonry walls, wooden floors and timber pile foundations, reaching into the First Sand Layer at about 12 m below the surface level. Based on several pile load tests in the historic centre it is known that the wooden pile foundations have low factors of safety of around 1.0, if negative skin friction is assumed over all but the first sand layer.
