Monitoring dataset of deformations related to deep excavations for North-South Line in Amsterdam

M. Korff

F.J. Kaalberg

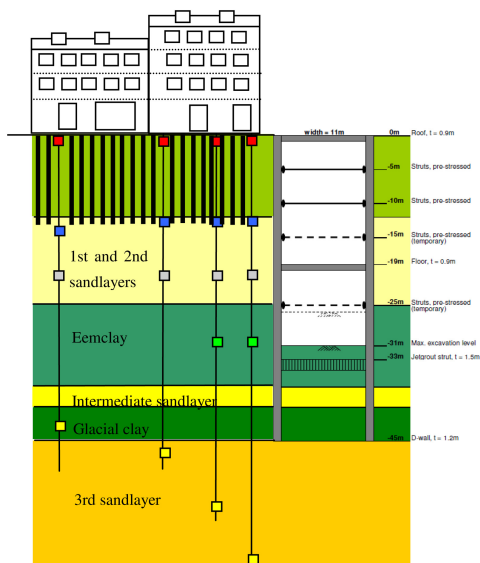
Figure 5. Cross section of Ceintuurbaan Station with soil profile and extensometer locations.

Inclinometers and extensometers and surface measurements are placed to a distance of 50 m away from the diaphragm wall and a maximum depth of 65 m. Each station has 4 cross sections with subsurface measurement perpendicular to the station, see Figure 5 for an example of a cross section at CTB Station and Figure 6 for details of one of the arrays at Rokin station.

The extensometers are placed at NAP -1.5 m, NAP -13 m, NAP -22 m and NAP -30 m and the deepest anchors are fixed at NAP -73 m closest to the excavation to NAP -49 m further away from it.

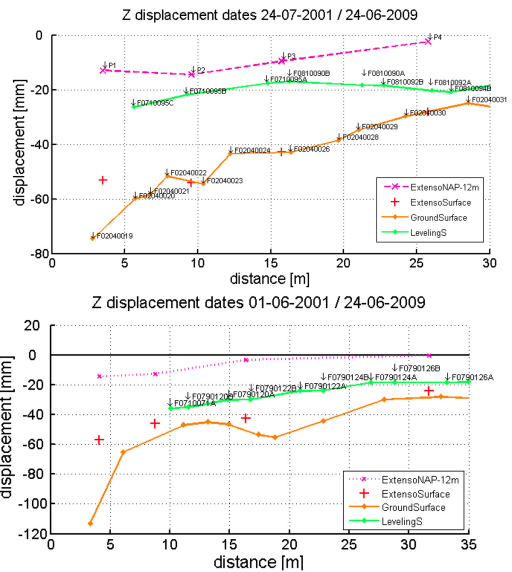
Figure 9. Ground and building displacements for (a) CS13044 and (b) CS13110 (at Ceintuurbaan) in the period 2001–2009.

Figure 9 shows the manual building displacements (LevelingS) compared to the soil displacements at surface (GroundSurface) and pile tip level (ExtensioNAP-12 m) for a series of buildings with old timber piles. The buildings settle more than the foundation layer, but less than the soil at the surface. The oldest foundations (Figure 9b) show the largest settlements.
