Shrinkage Cracking in Physical Model of Undisturbed Expansive Clay Slope subjected to Wet-Dry Cycles

A.C. Amenuvor, G-W. Li*, Y-Z. Hou & W. Chen

ABSTRACT: The strength and stability of expansive soil slopes is strongly influenced by shrinkage cracking resulting from multiple wet-dry cycles. This study investigates the structural and crack development in a physical model of undisturbed expansive clay slope under five of wet-dry cycles. The model is 150 cm long, 80 cm wide and 80 cm high, and has slope inclination of 1:1.7. The surface distribution of crack networks was monitored with a digital camera and the images obtained were analysed using image processing technique to quantify the surface crack parameters in terms of crack intensity factor (CIF). The CIF increased and stabilize at 15% in the third cycle. CIF also increased linearly with decreasing water content to stabilize at water content of 9%. Changes in suction occurred to a depth of 28 cm, and the maximum suction increased with increasing cycle number. Vertical cracks whose bases are connected by near horizontal cracks or cracks parallel to the slope developed to a maximum depth of 28 cm.

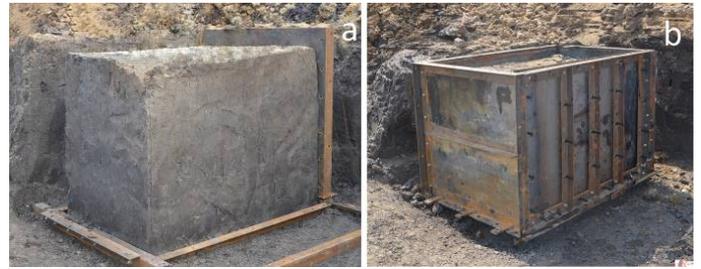
Figure 1. Soil extraction in the field: (a) trimmed soil; (b) trimmed soil in model tank

The soil used in the experiment was extracted from the Yangtze river - Huai river canal construction project site from a depth 7 m below the surface. In order to extract the soil with minimal soil disturbance, a 3 m x 2 m area containing the soil of interest was first marked out. An excavator was then used to carefully dig the material around this area to a depth of 2 m, leaving an isolated 12 m³ of intact clay. This isolated volume of soil was then carefully trimmed down, to the desired 1.5 m x 1 m x 1 m size to fit into the model tank. Figure 1 shows the soil extraction process.
