The Behaviour and Influence of Desiccation Cracking on a Full-Scale, Vegetated Infrastructure Embankment

R.A. Stirling, S. Glendinning, C.T. Davie
School of Engineering, Newcastle University, UK

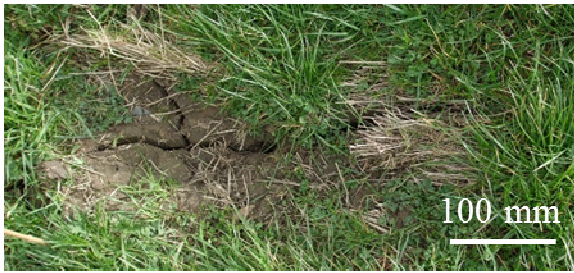
Figure 3 shows a crack seen on the embankment (Crack 4 – Figure 1). Linear cracks with limited branching are almost exclusively seen in this context and indicate the significant influence of vegetation presence, likely a result of root mass reinforcement.

Figure 3. Typical linear cracking style on vegetated slope infrastructure in UK.

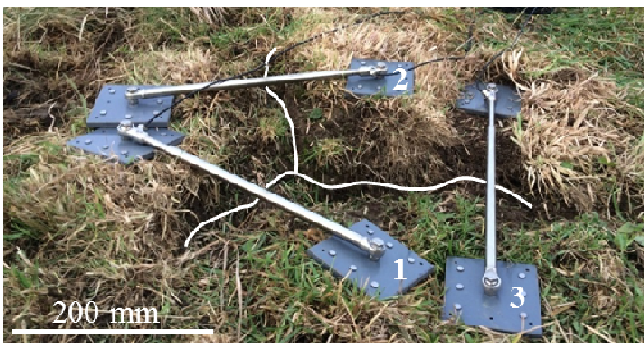
To understand the behaviour of desiccation cracks at full-scale on vegetated infrastructure slopes, linear transducers were installed across an active crack site (Figure 4). The site selected was crack 9 shown in Figure 1. This crack is positioned towards the centre of the south facing ‘poorly’ compacted panel and as such is considered to not be influenced by any boundary effect as a result of embankment construction. Crack surveying identified this crack as being representative of typical crack activity.

Figure 4. Transducer configuration at monitored crack site.

The three stainless steel transducers had a 200 mm stroke range and were capable of operating between -40 to $+150^{\circ}\text{C}$ using contactless (inductive coil) sensing. At the time of installation, grass cover was cut back to expose the crack, as depicted in Figure 4 by the white line. PVC plates fitted with six 80 mm spikes were used to fix each transducer end to opposing sides of the crack. Care was taken not to place the fixings too close to the crack aperture so not to disturb the crack as well as to leave sufficient travel to accommodate either direction of movement following installation.
