# Moisture Movement and Mechanisms of Desiccation Crack Development in Engineered Clay Fills

O.O. Eminue, C.T. Davie & R.A. Stirling

**ABSTRACT:** Desiccation cracking is a common phenomenon observed in clay soils subject to drying/wetting cycles. It has implications for clay fill infrastructure (e.g. railway embankments) as cracks can lead to rapid water infiltration, increased pore pressures at depth and hence slope instability. This issue may become more prevalent for UK infrastructure as climate projections predict warmer, drier summers and shorter but more intense rainfall. However, the precise mechanisms controlling crack evolution are not well understood and complex interactions of soil, atmosphere and vegetation must be considered. This study combined field observations with laboratory experiments to address these issues. Field observations of a full-scale embankment tracked the evolution of crack locations and dimensions through the seasons. These were correlated with height, aspect, material density, environmental and soil conditions. Laboratory experiments consisted of cyclic drying/wetting tests within a controlled environmental chamber with crack evolution monitored

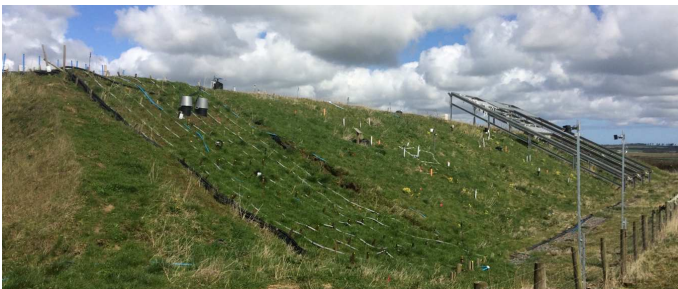
Figure 1. BIONICS Full-scale embankment test site, Newcastle University.

The field investigation consisted of regular walkover surveys carried out on a full-scale, instrumented embankment test site (BIONICS, Newcastle University - Hughes et al. (2009) - Figures 1 & 2). The embankment, which is constructed of Durham Boulder Clay runs roughly East-West and is constructed in panels with different levels of compaction; *well-compacted*, representative of modern construction practice, and *poorly-compacted*, representative of aging UK infrastructure of ‘end-tipped’ construction.

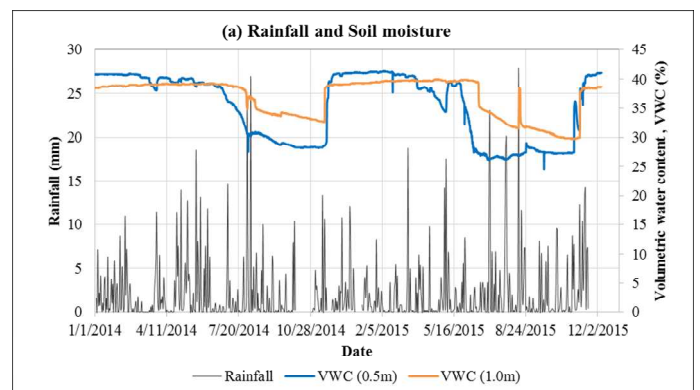
Figure 6. Correlation between rainfall and (a) soil water content (b) pore water pressure, at mid-height on the embankment in the engineered panel BS (well compacted) of the south slope – See Figure 2

The changes in soil hydrology were accompanied by corresponding changes in the soil water potential (or suction), the two soil parameters being interrelated through the effect of capillarity in unsaturated soil. Characteristically, periods of high soil moisture corresponded with high pore water pressure (or low suction) and vice versa, and this correlated with rainfall and sunshine events respectively, indicating a direct response of the soil to prevailing weather conditions (Figure 6).

Crack opening occurred in late spring as rainfall significantly reduced leading to decreasing soil moisture towards the onset of the dry months. During this period, suctions in the near soil surface increased and reached a maximum in the summer period, both in 2014 and 2015 respectively (Figure 6b). The crack geometry properties correspondingly reached their maxima during the summer period (Eminue 2018).

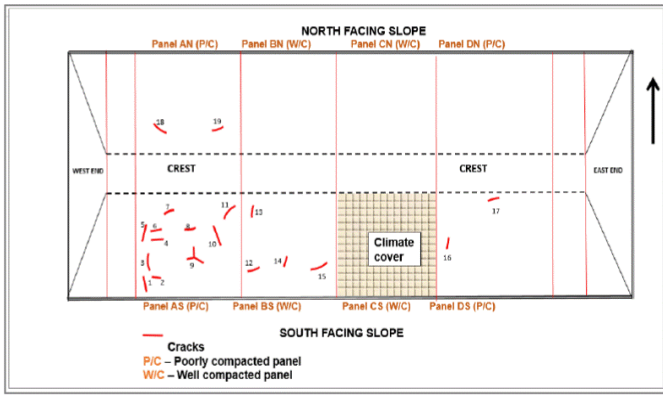
Figure 7. Crack distribution on the BIONICS embankment

The embankment also displayed different cracking behaviour connected to the impact of wet and dry conditions, location/geometry and engineered condition. Figure 7 shows the most prominent cracking occurred in the poorly compacted panel of the south slope (Panel AS) (i.e. most exposed to wind and sun).

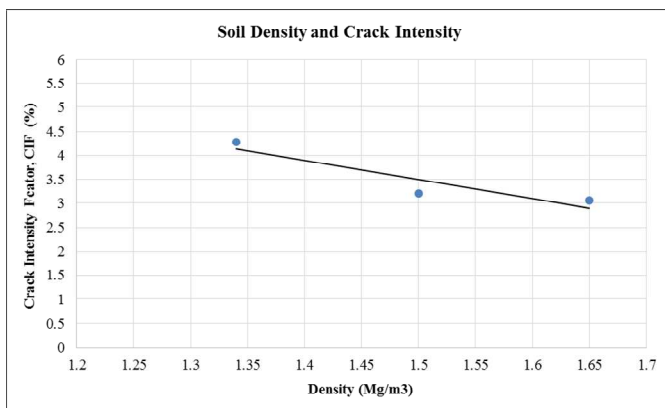
Figure 8. Changes in cracking intensity with soil density (NB – plot shows mean values of two repeats at high and low density where the individual results were so close together that they cannot be separated on the graph, indicating very strong repeatability)

Furthermore, image analysis of the time-lapse photography obtained from the soil cracking experiments carried out in the laboratory confirmed consistently decreasing cracking intensity factor as the soil density increases (Figure 8). This is possibly because of the potential increase in mechanical strength as the compaction of the soil structure increases. Under the effect of hydrologic stress generated by restrained shrinkage in the soil during drying, the low-density soil would experience more cracking than the high-density soil.

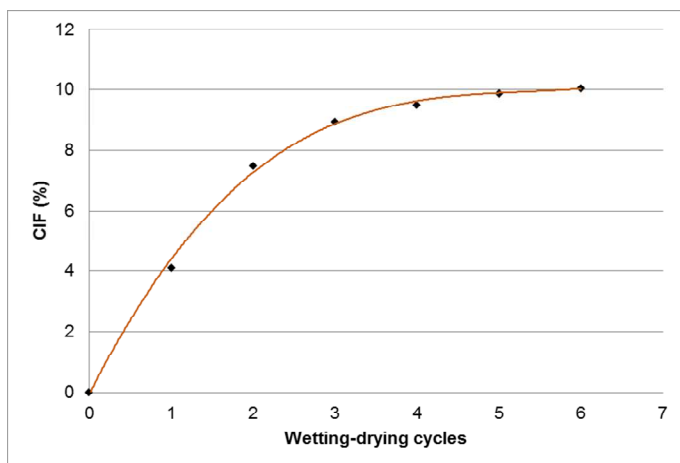
Figure 10. Cracking development with multiple cycles of drying and wetting

To characterise the effects of the cyclic wetting and drying experienced by infrastructure slopes during seasonal climatic variations all of the laboratories test samples were exposed to at least two cycles of drying and rewetting. In the tests involving different soil densities, thicknesses and plasticity, the cracking intensity was found to be higher in the second cycle (Figure 7). Wetting generally reduces the soil strength as interparticle bonds are broken under increased pore water pressure. This combined with the previous crack history renders the soil more susceptible to mechanical failure. However, it was also found that this increase in cracking under cyclic drying and wetting does not continue indefinitely as testing up to 6 cycles showed that the crack intensity tended to level towards a constant value after the third cycle (Figure 10).
