*The paper was published in the proceedings of the 11<sup>th</sup> International Symposium on Field Monitoring in Geomechanics and was edited by Dr. Andrew M. Ridley. The symposium was held in London, United Kingdom, 4-7 September 2022.*

## Distributed optical fiber systems for monitoring the serviceability strain response of an Italian concrete arch dam and its foundation

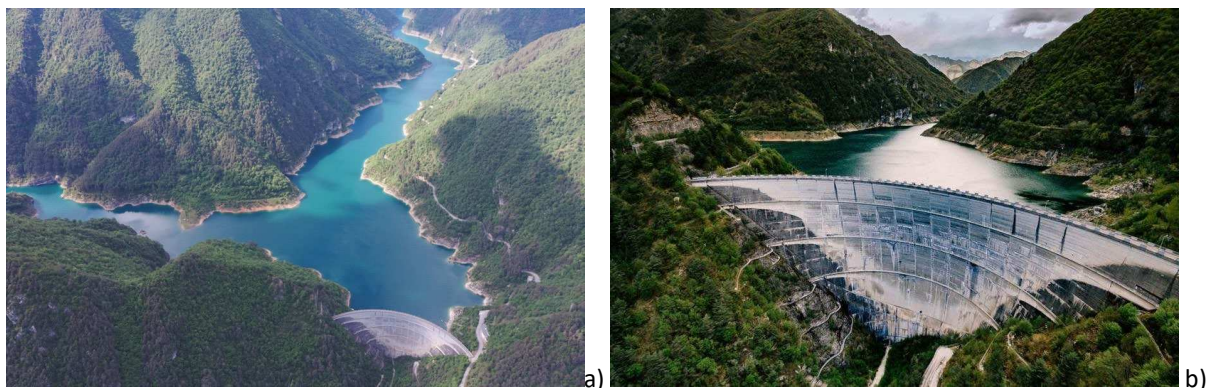
**Figure 1:** a) Aerial view of the dam and the Valvestino lake; b) Valley facing of the dam.

The hydroelectric power station (Figure 1), known as Ponte Cola dam, is located in the valley of the Toscolano torrent in S. Maria Valvestino, about 9 km from its outlet in Lake Garda (North Italy). The dam, built between 1960 and 1962, has the purpose of storing the energy that can be drawn from the basins of the Toscolano and S. Michele streams and has a reservoir corresponding to an energy reserve of  $45 \times 10^6$  kWh. The dam extends from an altitude of 124 m a.s.l., corresponding to the lowest point of the foundation, up to an altitude of 505 m a.s.l. corresponding to the crown, whose length in development is equal to 282 m.

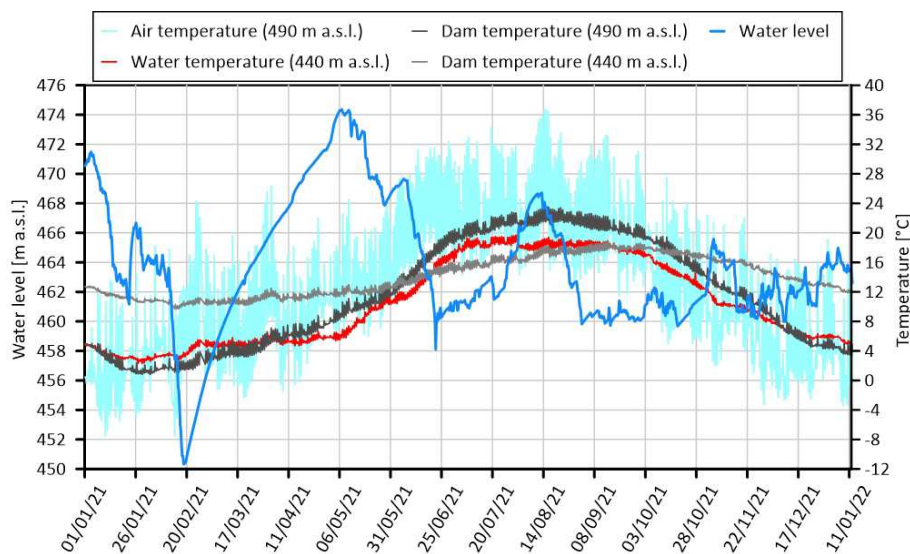
In summary, Figure 2 shows an example of the trend of temperatures that characterize the environment around the dam and the dam itself. In particular, in the plot there is reported the air temperature measured by a probe located on the downstream face at 490 m a.s.l., which shows the high variability both in the night-day cycle ( $\Delta T=20^{\circ}\text{C}$ ) and in the seasonal cycle ( $\Delta T=25^{\circ}\text{C}$ ). The water temperature is also reported, measured upstream of the dam at an altitude of 440 m a.s.l., a position which is always located below the water level, which never dropped below 440 m a.s.l. in the considered period. Although the trend is consistent with the measurement of air, it is evident that the temperature fluctuates very little in the short term (day-night variation  $\Delta T < 2^{\circ}\text{C}$ ), and, in the long term, it presents a lower amplitude ( $\Delta T=15^{\circ}\text{C}$ ) respect the external air: moreover, it responds to the ambient temperature variation with a slight delay. The temperatures of the dam body are then reported through two sensors, installed at 490 and 440 m a.s.l. respectively. The lower altitude sensor is characterized by approximately constant temperatures in the short term, and shows little variable temperatures ( $\Delta T=7^{\circ}\text{C}$ ) even in the summer-winter cycle. On the other hand, the dam temperature at 490 m a.s.l. is more variable, where the smaller thickness of the dam allows the concrete to be more affected by environmental conditions. The thermal response is similar in amplitude and shape to the response provided by the probe in water.

**Figure 2:** Measurements of temperature and water level in the reservoir for the period 01/2021 – 01/2022.

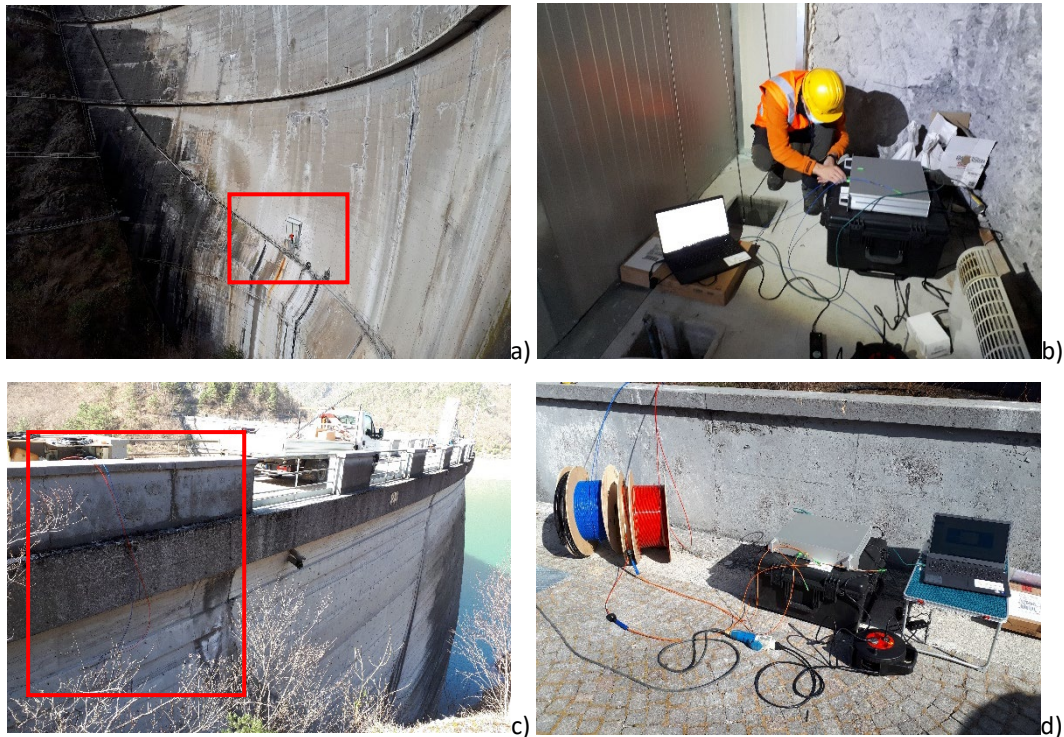
**Figure 4:** a) Position of the niche with respect to the dam body; b) preliminary measures in the fibers installed in the dam foundation; c) Localization of the crowning fibers; d) preliminary measures of the crowning fibers.

Some preliminary manual measurement campaigns were carried out after the installation of the sensors (Figure 4). Subsequently, two long period surveys with automatic interrogation of DFOS was performed in August 2021 (26 days) and in November-December 2021 (27 days), once the sensors fibers were connected, through standard communication cables, to a single central measurement station located in the control house of the dam. From here with the interrogator can interrogate all the 4 fibers, two for the strain and the other two for the temperature measurements, each requiring two channels of the interrogator, in double-ended configuration. In this way, it was possible to automatically record the data on a digital memory, without interruptions and without the need for the presence of an operator.

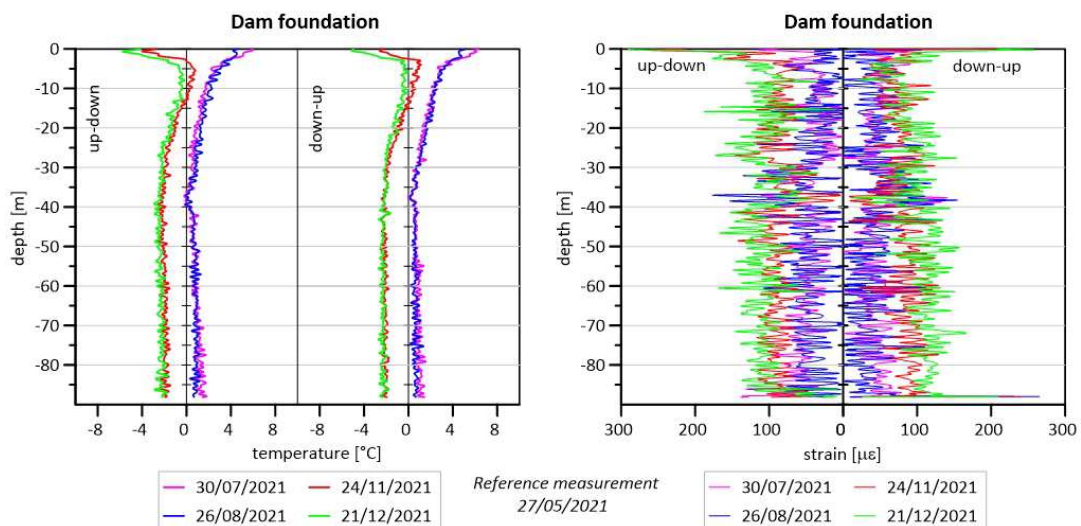
The data of the fibers in the foundation are shown in Figure 5. For ease of interpretation, only 4 measurements are reported, two for each period. The information is obtained as relative measurement with respect to a first reference one, carried out on 27/5/2021. In fact, the measurement allows to express the strain with respect to a measurement considered as a reference. As anticipated, the measures are reported in "up-down" and "down-up", which generally show a great consistency one with each other. The graph on the left allows to immediately

confirm the higher temperature measured in July and August, compared to the May reference, while it shows a general cooling of about 2-3 degrees in the winter period if compared to the reference taken in May. The upper 5 meters of fiber are strongly affected by the external temperature, while from 30 m downwards we observe an almost constant temperature, approximately for all the measurements. The deformation measurements, on the other hand, show a very low strain (less than  $10^{-4}$ ) along the entire depth investigated by the sensor, but due to this low level of strain a clear trend is barely identified.

**Figure 5:** Measurements of temperature and deformation measured for the fibers in the dam foundation.

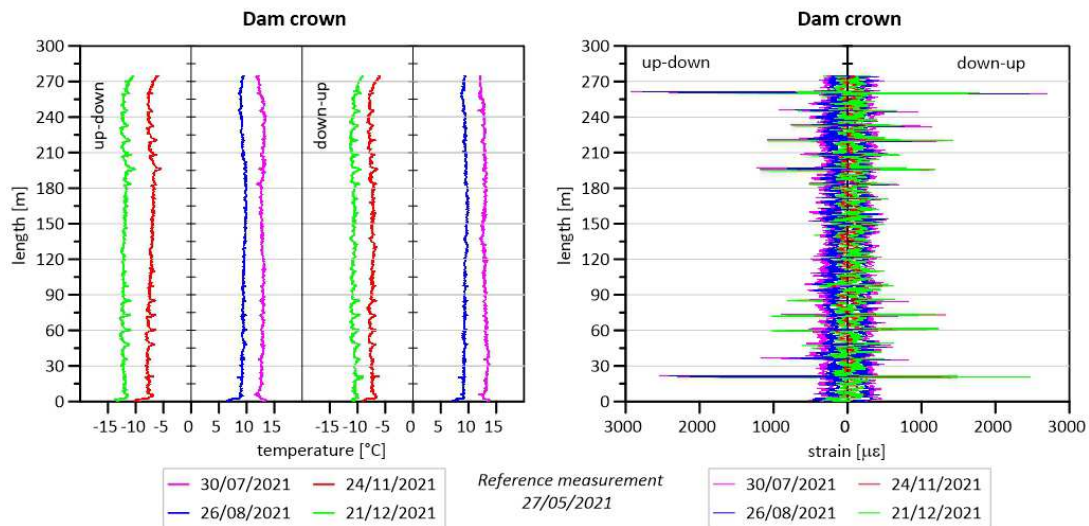
The fibers at the crown (Figure 6) show an approximately constant temperature along the entire extension (a little less than 300 m) of the fiber, for each date considered. In this case, the increase in temperature of about 7 °C and 12 °C in the two summer days is even more evident compared to May 2021, while a decrease of 8 °C and 11 °C in the winter measurements is observed. Although the measurement is approximately constant, small

peaks are noted with an interspace of about 10-12 m. Some of these peaks are also found in the strain profiles, and they are located at the thermal dilatation joints present in the concrete structure. Globally it appears that the strains of the crown are much more significant than those in the foundation, confirming a greater effect of environmental loads in this dam portion. The summer measures show greater dilatations, concentrated especially at the dilatation joints, which are then reduced in the winter campaign, as it can be expected.

**Figure 6:** Measurements of temperature and deformation measured for the fibers in the dam crown.

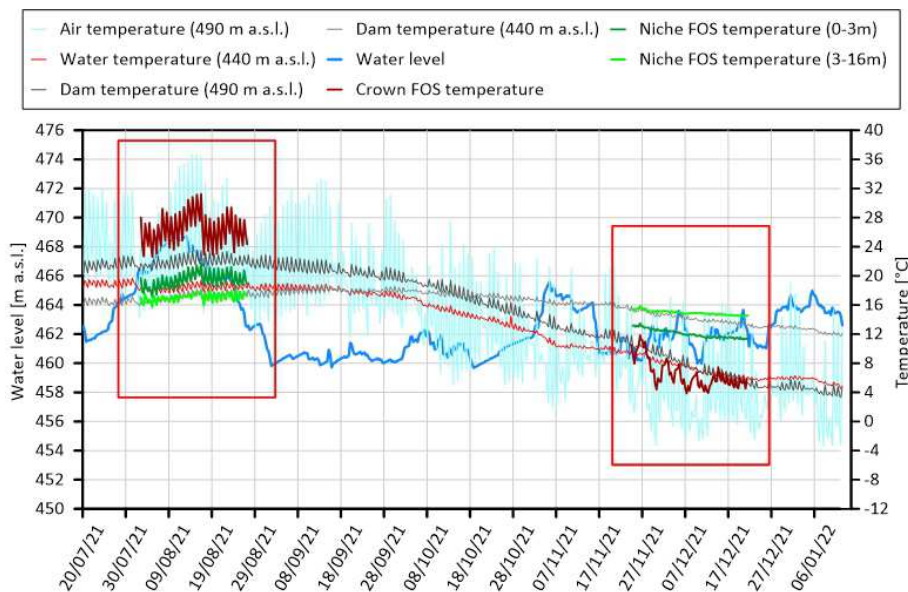
**Figure 7:** Measurements of temperature obtained by the FOS for the two period 7-8/2021 and 11-12/2021 compared with other sensors results.

Finally, Figure 7 shows a preliminary comparison among the temperature measured with the data of traditional sensors (those already commented in §2.1) and the data acquired by DFOS in the two campaigns. About the strain in the foundation, it is plotted the average value of the first 3 m of depth ( $L_1$ , 0-3 m, dark green) and the subsequent 13 m ( $L_2$ , 3-16 m, light green). The crowning measurements were instead averaged over the entire fiber length, as the homogeneity of the data was evident. The DFOS measure are translated from the temperature present in the dam on the reference day (27/5/2021), to make them comparable with the traditional sensor measurements. The temperatures acquired in section  $L_1$  show a translation of about 3°C with respect to those of the sensor immersed in the concrete at 440 m a.s.l., more in the summer and less in the

winter, testifying how the shallow portion of the fiber is more affected by the external temperature. The deeper part L<sub>2</sub>, on the other hand, shows results very similar both in trend and values to those detected by the traditional sensor. The trend of the crown DFOSs data is consistent with that of the traditional sensors. However, with exception of the last period of December, in which the measurements are very similar to those of the concrete sensor at 490 m a.s.l., in the remaining periods the amplitude of the oscillations, which is greater, and the temperature detected becomes intermediate between the data of the sensor in concrete and that in the air. This behaviour can be attributed to the fact that the fiber was installed at a shallower depth than the temperature sensor and is therefore more affected by the outside air temperature.
