The paper was published in the proceedings of the 11th International Symposium on Field Monitoring in Geomechanics and was edited by Dr. Andrew M. Ridley. The symposium was held in London, United Kingdom, 4-7 September 2022.

Long term monitoring of the foundation of a cable stayed bridge

Gianpiero RUSSO¹, Carlo VIGGIANI¹, Marco MOLADORI³

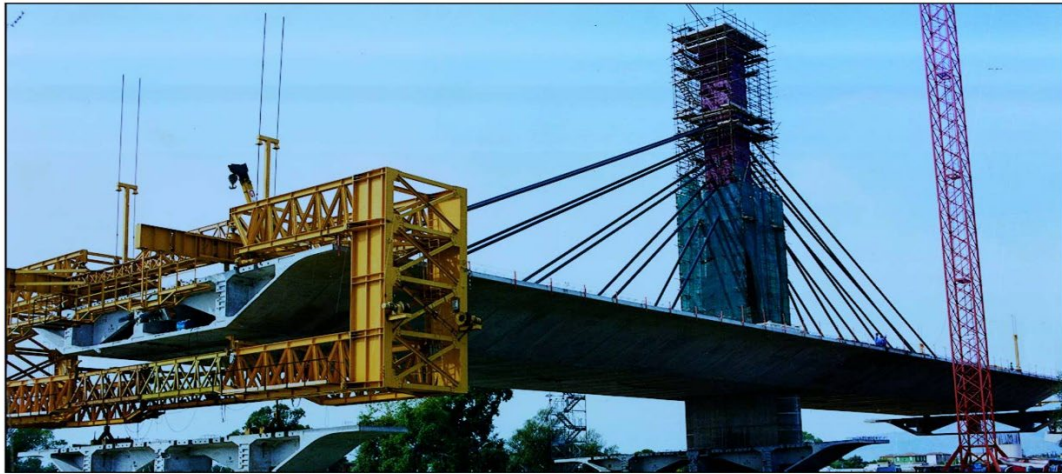
During construction the bridge deck with its cables and the main antenna were only supported by the central pier and its foundation due to the construction procedure prescribed by designers, as shown in fig. 2. Once the deck reached the side piers on the opposite side of the rivers, no significant change in the load measured on the head of the piles was recorded testifying that nearly 100 % of the load is kept by the central pier and its foundation.

Figure 2: Bridge deck construction

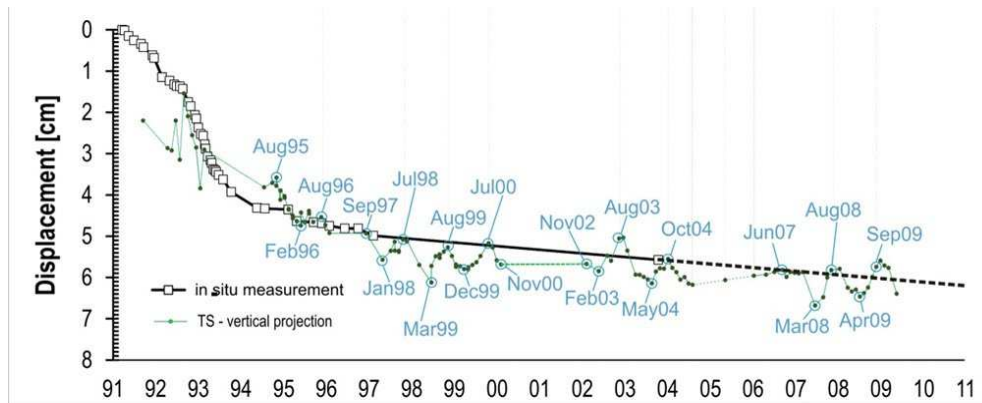
Figure 5: settlement of the pier 7, satellite and levelling data.

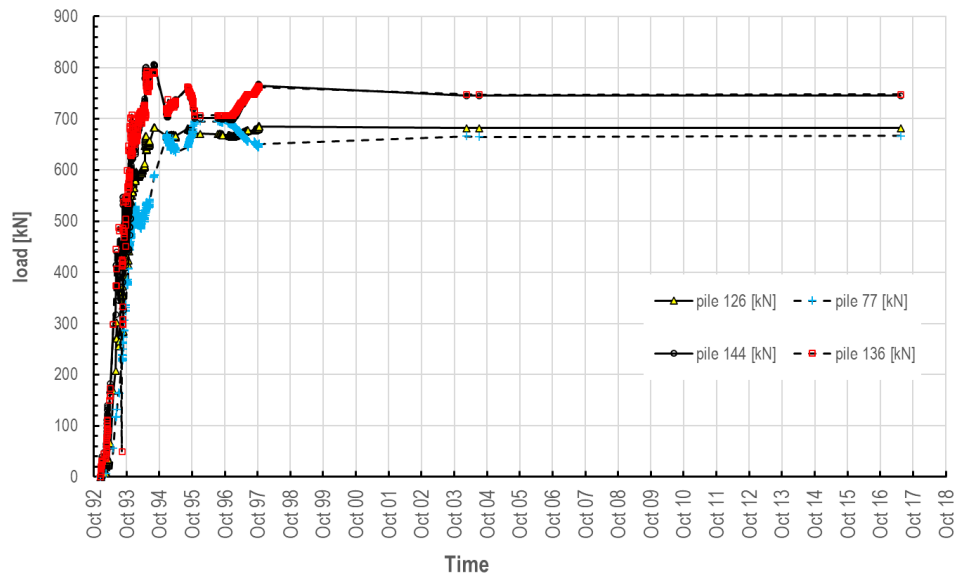
Three years later the load distribution was undergoing significant variations: the load on the peripheral piles was decreasing, while that on the piles below the pier was slightly increasing. Ten years later this trend is still confirmed. Finally twenty two years later the piles directly located below the pier have taken the largest load ratio well above the average followed by corner's pile. To the writers' knowledge, such a phenomenon had not been observed before; the observed trend of variation suggests that the main factor is creep of the reinforced concrete raft. Figure 7 reports the values of the load on some typical piles as a function of time, starting from the construction of the bridge deck in January 1993. While the total pile load keeps almost a constant value with only a slight increase for 25 years after the end of construction (figure 6) the loads on the single piles undergo a cyclic variation, with a period of 1 year. The values reported in table 1 have been taken always in the same month of the year, in order to minimize the influence of the observed cyclic behaviour.

Figure 7: Load on piles measured with vibrating wire load cells during more than 25 years. (144 and 136 corner piles – 126 edge pile – 77 central pile)

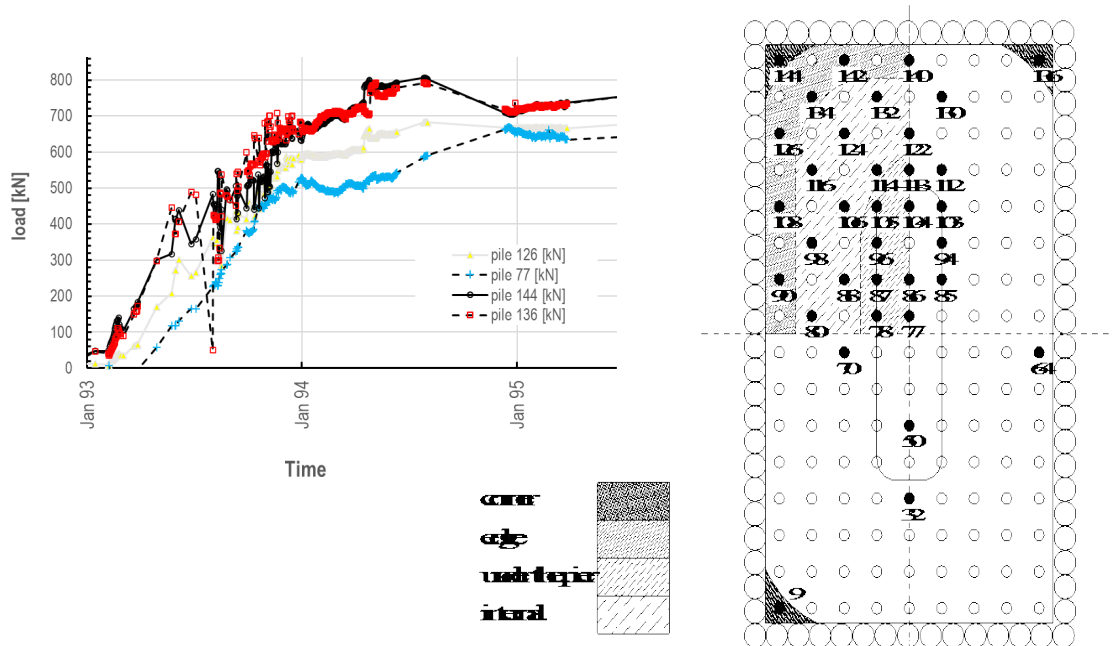
Figure 8: Zoom view on the construction period with the two corners piles (144-136) showing at the same time opposite peak loads and load corner effects disappearing with time after construction.

In figure 8 finally a zoom view of the load on some typical piles of the group during the period of the construction of the bridge deck and soon after the end of the construction is plotted. In this figure different details can be appreciated partially confirming the high quality of the monitoring data and also showing details of the performance that are indeed very interesting by a scientific point of view. First of all the pile 144 and 136 two corner piles on opposite sides of the central pier show very similar loads at the end of the construction period. The black dots and the red ones followed during the construction period on the other hand show the presence of contemporary opposite peaks in the context of an increasing average compression load. These opposite peaks are a clear consequence of the procedure adopted to build the bridge deck using cable suspended bridge deck segments alternatively installed on the two opposite sides of the central antenna.

Finally the higher loads on corner piles recorded at the end of the construction period and typically associated to the well known interaction effects among piles beneath a stiff raft as a matter of fact tend to vanish with the time after the end of the construction.
