The paper was published in the proceedings of the 11th International Symposium on Field Monitoring in Geomechanics and was edited by Dr. Andrew M. Ridley. The symposium was held in London, United Kingdom, 4-7 September 2022.

Wireless Monitoring Solutions as an early warning tool to manage growing risk of Alpine slope stability failures: a case study from a hotel construction project in Salzburg, Austria

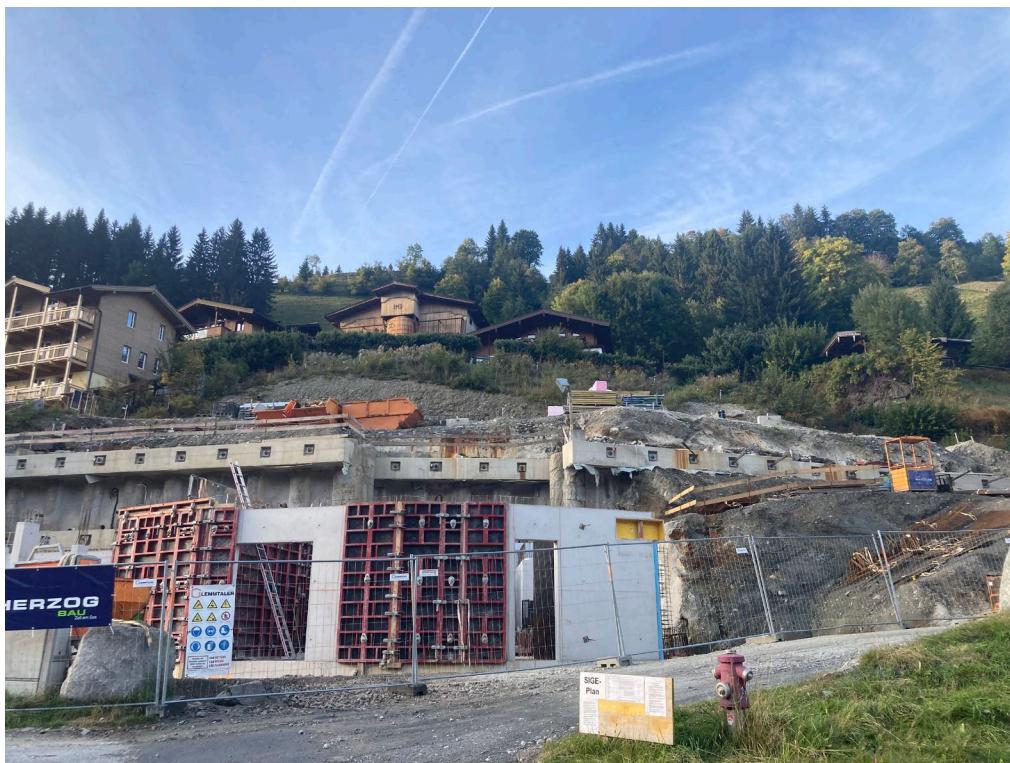
Figure 2: Construction site in September 2021

For the execution phase, the structural engineers of MJP-ZT carried out the structural analysis of the excavation support. This was essentially based on the results of the investigations carried out during the tendering phase, adapted to the final design. The construction is carried out in two phases. Phase one is the construction of buildings A & B (Fig. 2), currently under construction and phase two will be the construction of buildings C & D.

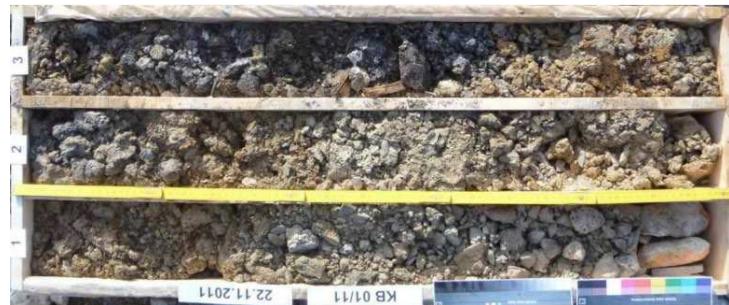
Figure 3: GA1 - Weathered material / slope rearrangement (KB 1/11, 0-3m); GA2 - Greywacke schist, predominantly deconsolidated (loose rock character) (KB 1/11, 8-11 m);

The genesis of the subsurface conditions is extremely complex and allows only a rough delimitation into geological layers. These are briefly described again below with photos from the drill cores.

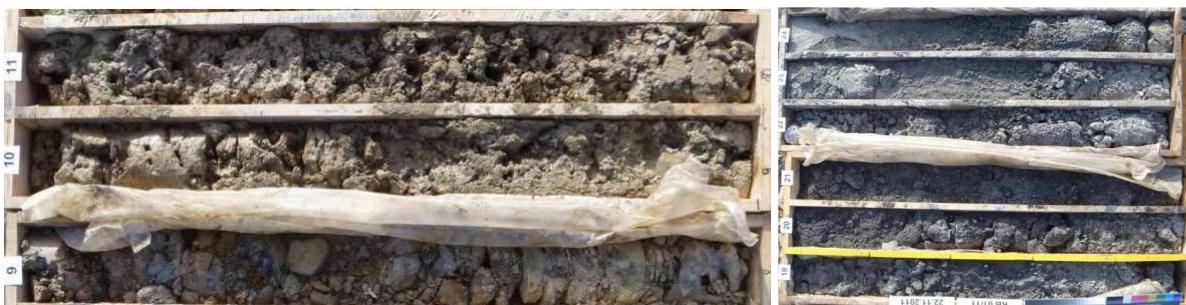
Figure 4: GA3 - Kakirite (KB 1/11, 18-24 m); GA4 - Greywacke schist, predominantly stratified, clearly deconsolidated (KB 2/11, 17-21m)

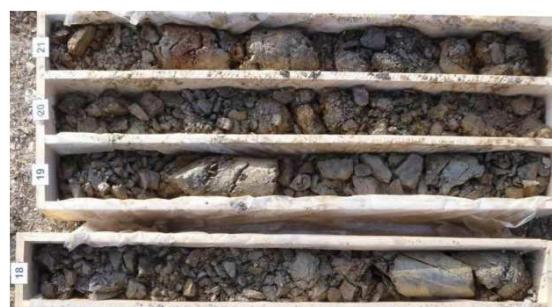
Figure 5: GA5 - Greywacke shale, in stratigraphy, dissected, weathered (KB 1/11, 29-. 30,8m);

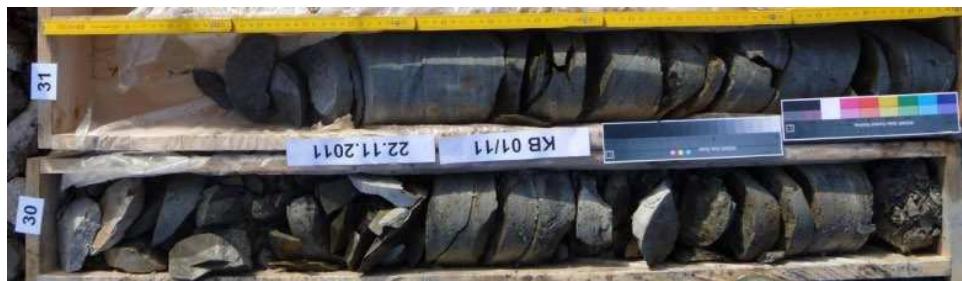
Figure 6: GA6 – Greywacke schist, stratified, un-weathered

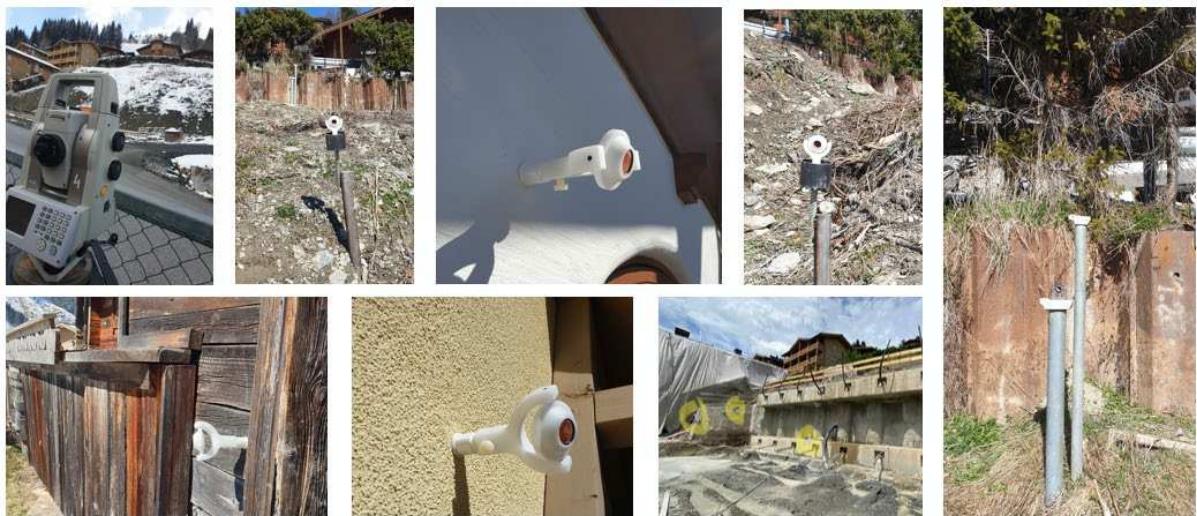
Figure 10: Monitoring installations on site

Weekly ground water monitoring was carried out at an open standpipe on site (Fig. 10).

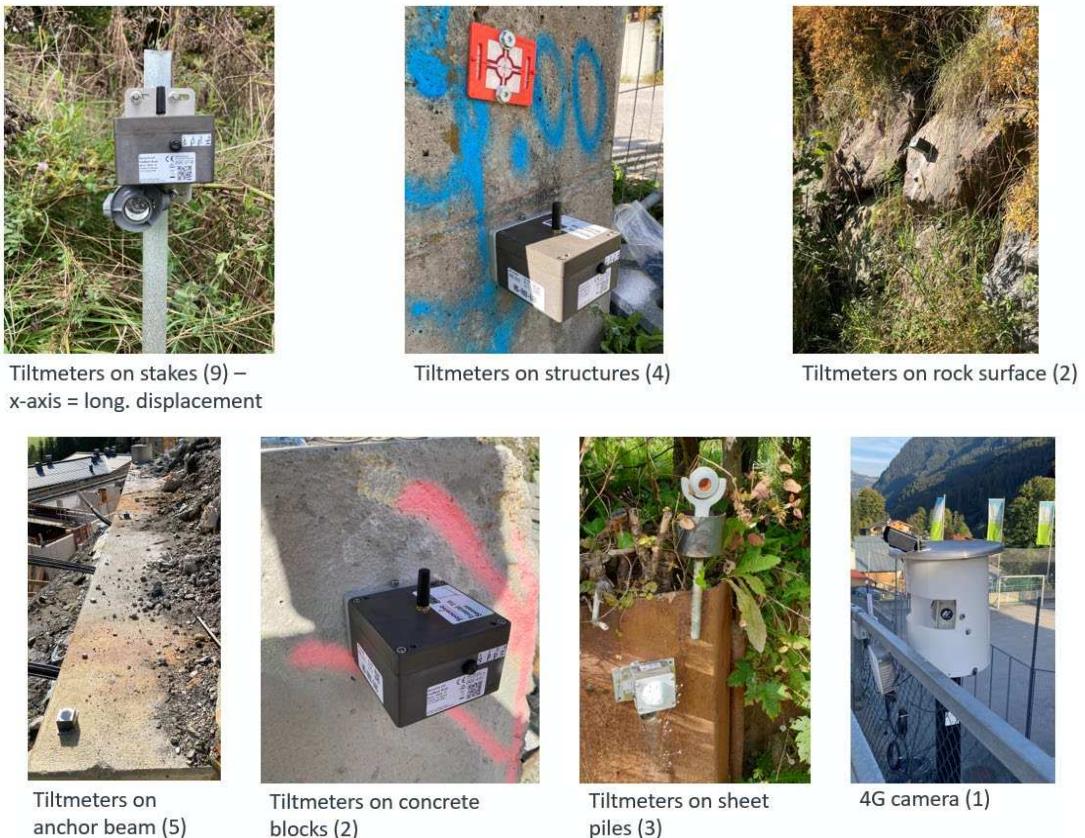
Figure 11: InfraGuard™ installations on site

In September 2021, a measurement system based on triaxial tilt sensors – Senceive InfraGuard™ - was installed, in addition to the geodetic measurement system. The triaxial tilt sensors were installed on structures, on the anchor beam and on stakes. Additional measuring points were installed on the stakes and included in the geodetic measuring program. The purpose of this system was to provide reliable information on slope movement and allow the direct comparison of the results from geodetic monitoring and results derived based on the data from the tilt sensors installed on stakes (Fig. 11).

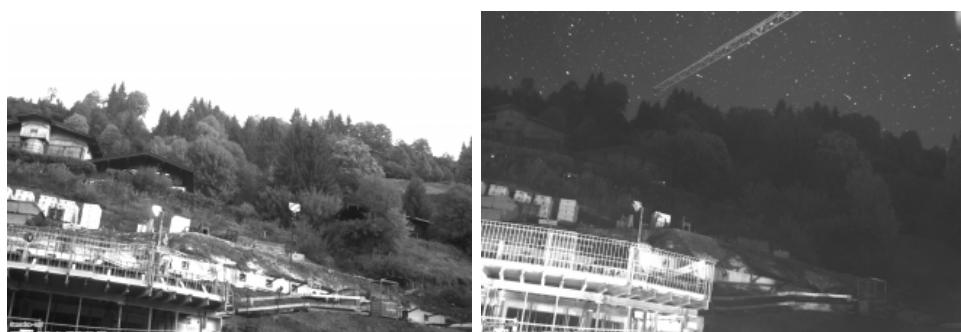
Fig. 13: Installation of camera at site (picture taken by 4G camera day and night).

This installation represents such an application (Fig. 13). The direct comparison between geodetic measurements and the measurements of the triaxial tilt sensors is interesting. The advantages of the tilt sensors compared to the geodetic measurements are a higher measuring frequency, the possibility of integrating the camera for visual inspection, and the fact that the measurements are not disturbed by construction activity. With the geodetic measuring system, a line of sight between the theodolite and the measuring point is necessary.

The location of the installed tilt sensors is shown in Fig. 13. Each stake was equipped with one sensor and one point of measurement. Nine sensors were installed in the area of the slope above the bored piles.

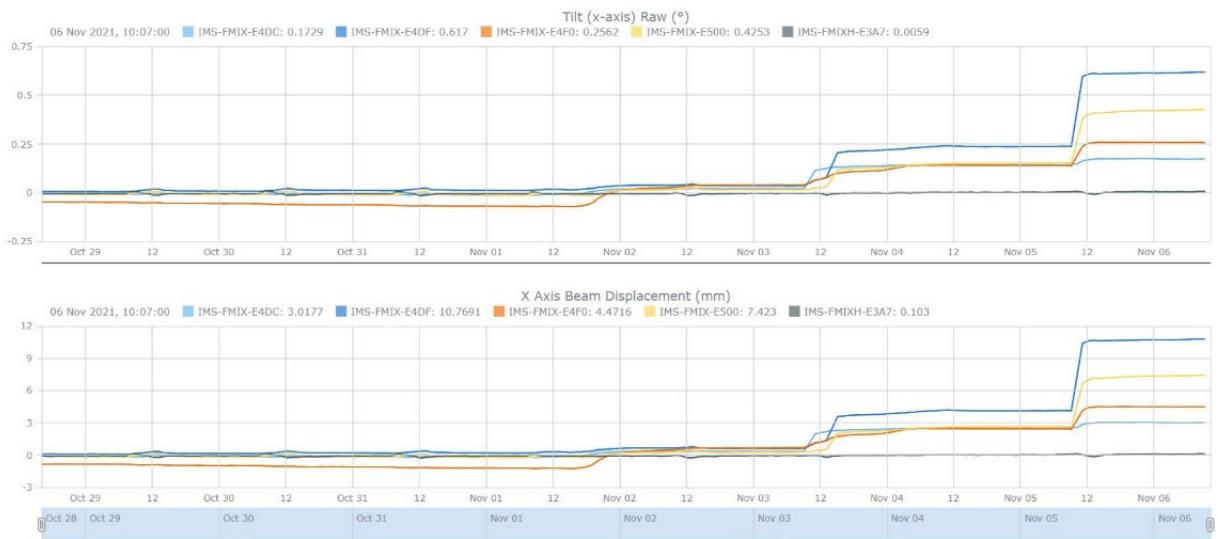
Fig. 18: Result of the tilt sensors and derived displacement in the longitudinal direction (x-axis sensor)

Comparing these results with the data from the tilt sensors (Fig. 18), the following picture emerges.

The tilt sensors on the stakes show an increase in inclination in the x-direction, which can be correlated in time with the measurements of the geodetic measuring system. Thereby, the inclination sensors E4DF, E4FO and E500 show the most extreme values, which corresponds to the geodetic measurement points MQIMS04, MQIMS-05 and MQIMS-03.

The longitudinal displacement calculated from the inclination values shows a lower value than the results of the geodetic measurement, because the base for the calculation was assumed to be 1 m, which, however, is only an approximate value and was not determined for the individual points on the site.

The calculated values of longitudinal displacement give a maximum value of 5 mm for the first event on November 3, and a maximum increase of 6 - 7 mm for the event on November 5, i.e. an absolute value of longitudinal displacement of 12 mm.
