The paper was published in the proceedings of the 11th International Symposium on Field Monitoring in Geomechanics and was edited by Dr. Andrew M. Ridley. The symposium was held in London, United Kingdom, 4-7 September 2022.

Failure of Fully-Grouted Method Grout Column

Keywords: Vibrating wire piezometer, tailings storage facility, fully-grouted method

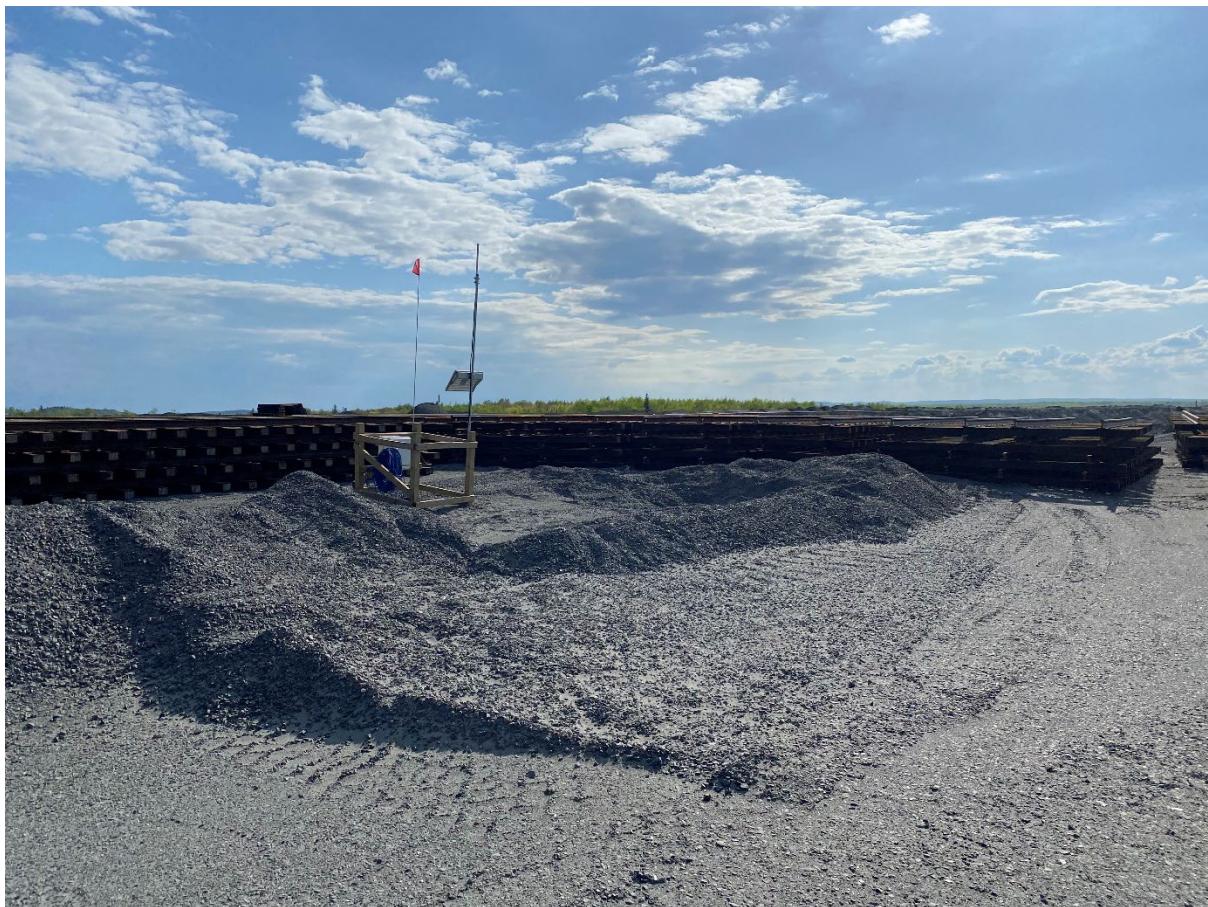
A site visit was conducted after the 18-day period of irregular piezometer behavior where it was observed that two potential loading mechanisms near the VWP installation were occurring. First, the VWP was very near a dump site that the TSF operator used for cycles of coarse tailings dumping, storage, and subsequent transportation around the site. This dump site was used frequently during the period where irregular VWP readings were being collected.

Furthermore, immediately adjacent to the VWP installation, new rail track panels were being constructed, moved, and stored using heavy machinery. Track panels were stacked and stored within 10 feet (3 meters) of the completed VWP installation. Figure 3 shows the VWP installation, and the rail track panels that were constructed and stored at the site.

Figure 3: Track panel storage adjacent to VWP installation.

as a coarse tailings dump site as well as a staging area for construction and storage of rail tack panels which caused excess, repetitive loading on the grout column and surrounding soils. Eventually, after several load cycles, the grout column cracked, pressures measured by the vibrating wire piezometer in the fine tailings no longer represented the actual pressures in the material unit, and readings corresponded to the approximate elevation of the upstream pond. Future plans for the site include blind drilling through the upper coarse tailings and installation of a drivepoint vibrating wire piezometer in the fine tailings for areas where high traffic and construction activity are anticipated.
