The paper was published in the proceedings of the 11th International Symposium on Field Monitoring in Geomechanics and was edited by Dr. Andrew M. Ridley. The symposium was held in London, United Kingdom, 4-7 September 2022.

Monitoring a full-scale backward erosion piping field test at Hedwigepolder

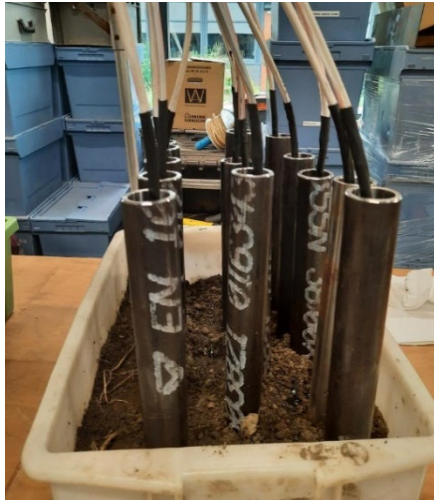
Figure 6: CPT cones with the attached DTS-cables. The cables were spliced together in order to make a loop. The heating cables were also looped.

In the northern test field temperature changes were measured using DTS. At 16 locations active DTS-cables were installed using CPT cones and rods (Fig. 6) by attaching the DTS cable to the cone of the CPT and by pushing the cone to the desired depth and then retracting the CPT-rods while at the same time filling the resulting hole with grout. The hypothesis was that the cooling curve of the heated cables will change (faster cooling) when an erosion pipe is active near a DTS-cable. At present, the analysis is not finished so it is yet unknown whether this hypothesis is true or false.

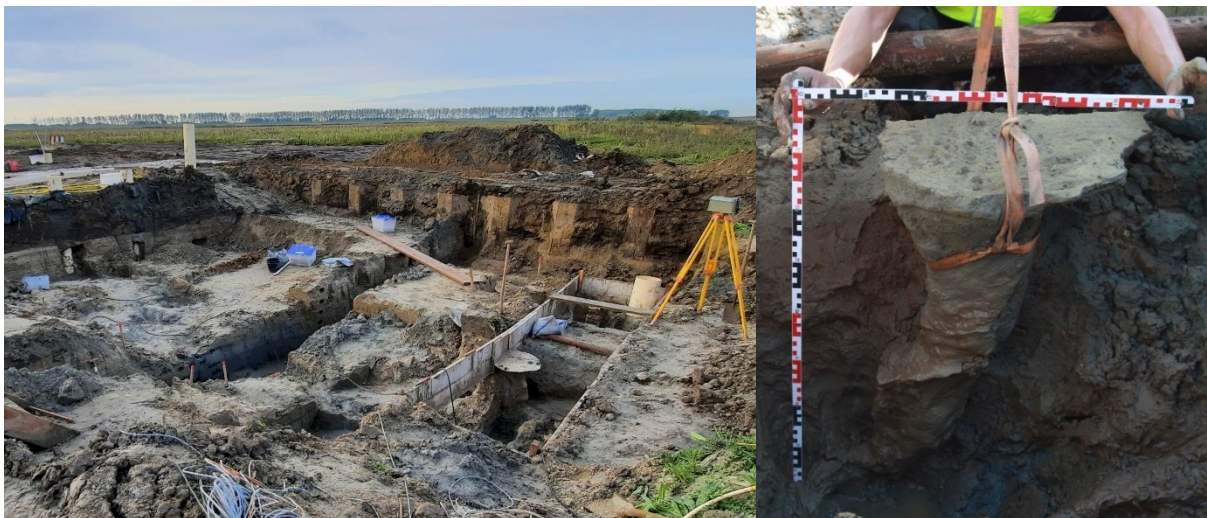
Figure 7: Left: Overview of the excavated northern test site during excavation phase of the experiment. Right: The hardened exit hole in the field.

After the experiments were finished the test field (Fig. 7) was excavated with the aim to find the pipe and measure its dimensions and route. Soil samples were taken and detailed geological descriptions of the subsurface were made. Before groundwater levels were levelled and excavation started, the exit hole was filled with levelling cement, a material that is used to level floors and hardens in water (Fig. 7).
