Multiscale analysis of gully erosion in Palmital stream watershed, Minas Gerais (Brazil)

Ádria Kanome Mori Soares

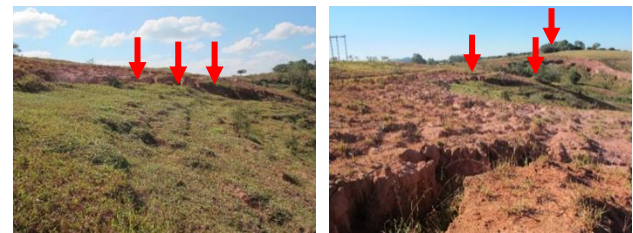
Figure 7. Part of the gully head: highlights for the “stair” formation on the ground.

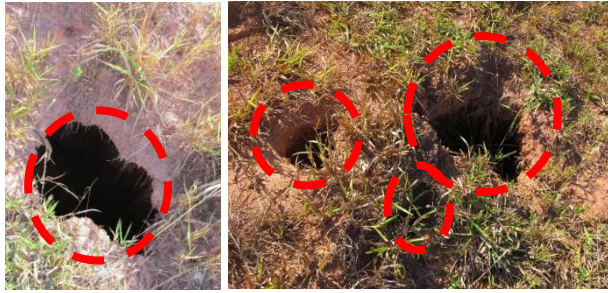
Figure 10. Examples of subsurface erosion over the gully head.

Subterranean flow played a major role in the evolution of the gully erosion process, since it removed Cambisol from underneath the more stable red-yellow Oxisol, creating empty subsurface spaces that collapsed, since Cambisols were exposed. An almost hollow “stair” formation (soil subsidence) is observed in the ground (Figure 7) and subsurface erosion is predominant in the gully head (Figure 10).

According to Figure 10, subterranean erosion occurs in the soil, i.e., the soil erosion mechanism begins inside the gully walls,

removing more fragile soil from the slope and letting more resistant soil be exposed to more weathering conditions (differently from the conditions experienced when the soil is exposed), thus increasing its fragility and causing slides.

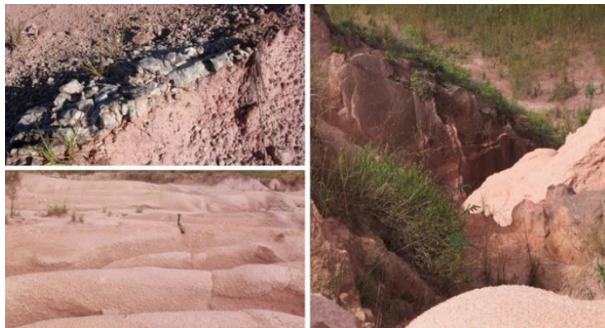
Fig. 11 Cambisol inside the gully erosion. Upper left: reminiscent rock structure; lower left: crack following fault direction on soil; right: possible rock structure among Cambisol.

The laboratory results (Table 2) and field study (Figure 11) showed reminiscent structures and minerals from the rock that formed the soil (orthogneiss and tonalite-trondjemite-granodiorite rocks) e.g., rare earth elements, and that the fault and shear zones also influence the erosion processes in the area. The layer can be considered a weak Cambisol and displays all conditions that worsen subterranean erosion.
