## Ensuring the safety of geotechnical works in the historical center of St. Petersburg in soft soils using interactive monitoring

**Rashid Mangushev, Anatoly Osokin & Ivan Dyakonov**

Saint Petersburg State University of Architecture and Civil Engineering (SPbGASU), Saint Petersburg, member of ISSMGE, Russia, [ramangushev@yandex.ru](mailto:ramangushev@yandex.ru)

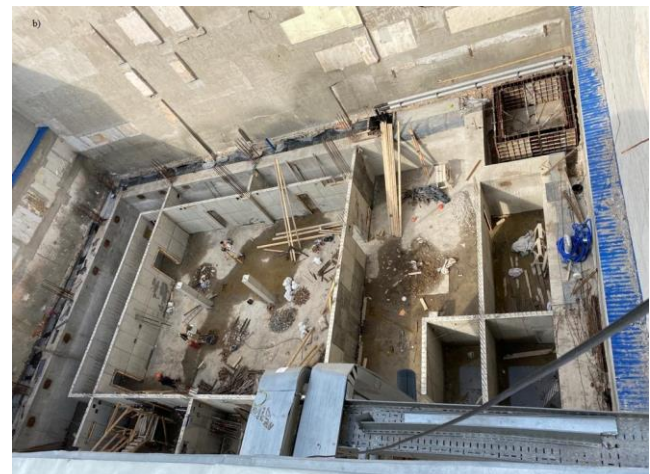
Fig.1. a- the constructive scheme of the "Palace of D.P. Naryshkin (S.L. Shuvalova)". The blue color indicates a building whose reconstruction has been completed; the pink color indicates the buildings of the surrounding development that fall into the zone of influence of the construction of the wing; the hatching indicates the construction site of a new wing with an underground space; b – the type of the completed underground space

The dimensions of the restored part of the building corresponded to historical measurements and amounted to 18.37 x 29.35 m. (Fig.1) The basement, necessary for the purpose of adapting the structure to modern use, had a design depth of 4.37 m from the surface of the courtyard.

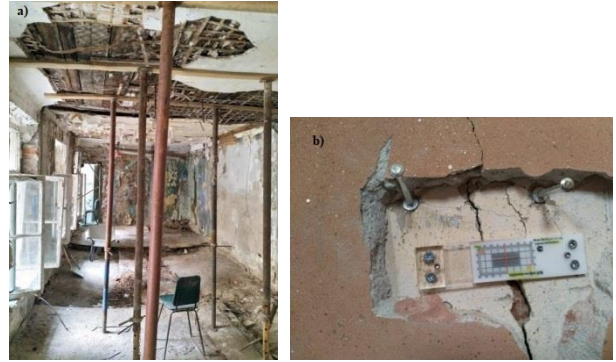
Fig.4. – View of a room with destroyed wooden floors (a) and a lighthouse installed on a crack for observation during geotechnical monitoring (b)

The building adjacent to the work site is a 2-5-storey building with two courtyards. The structural system of the building is a wall system with load-bearing longitudinal and transverse walls. According to the results of the technical inspection, cracks with an opening of 20 mm in the vaulted ceilings of the first floor, corrosion of beams, deflections of wooden beams with their sagging in the span along with filling were revealed (Fig.4). The floor structures are both in a limited working condition and in places in an emergency condition (Vasenin V.A. & Shashkin A.G 2022).

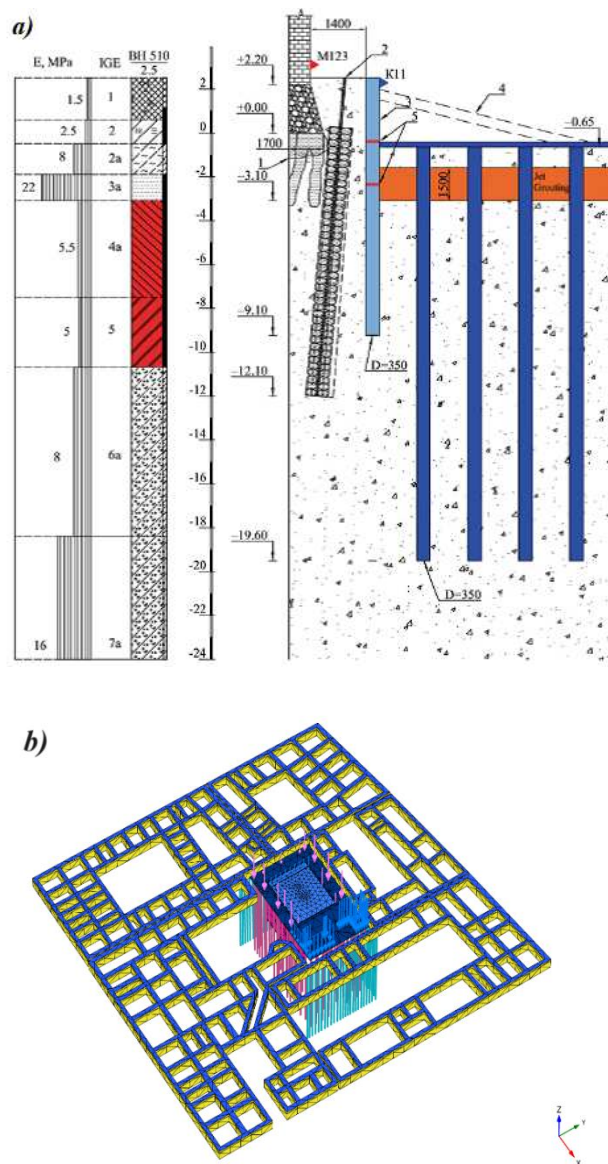
Fig. 7. The scheme of the underground part in the courtyard of the palace (a), the calculation scheme of the FEM for modeling the scheme of the underground part in the courtyard (b)

During the development of the excavation, work was additionally carried out on the construction of a fence made of bored piles with a length of 12 m and a cross section of 350 mm. Additionally, in order to reduce the impact of excavation on additional precipitation of adjacent buildings, which should be 1.5 m below the sole of existing foundations, a separation barrier (Jet key) was performed by jet cementation (Jet Grouting) with a width of 400 mm and a depth of 4.5 m, as well as a spacer deep diaphragm (Jet plate) with a thickness of 1.5 m, located 1 m deeper than the future bottom of the excavation. Drilling piles with a length of  $L = 14$  m and a diameter of  $D = 450$  mm were carried out under the slab of the projected underground structure, before the excavation began. The layout of the underground part in the courtyard of the palace is shown in Fig. 7a.

Variant calculations in the Hardening Soil Model of the Plaxis 3D software complex made it possible to justify the accepted design of the underground part of the reconstructed palace, as well as the technology of opening the pit, taking into account safety for the object itself and buildings of neighboring buildings (Fig.7b, 8) (Mangushev R.A., SPbGASU 2016).

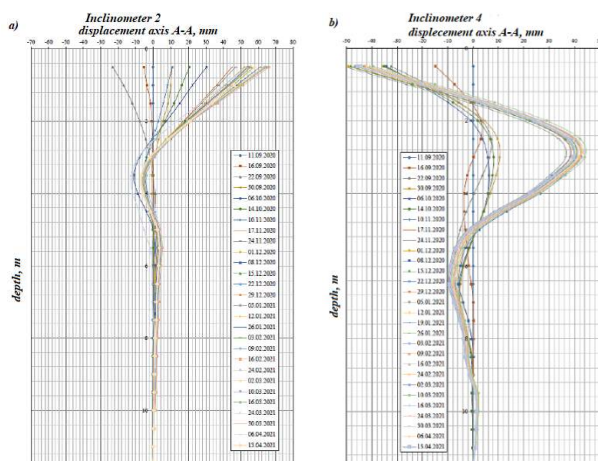
Fig. 10. Results of measurements of deformations of enclosing structures by inclinometric wells № 2 (a) and № 4 (b)

In order to control the deformations of enclosing structures during excavation of the pit, inclinometric wells were regularly monitored, which were located on all sides of the pit (Fig. 9). Typical results of measurements of deformations of enclosing structures using inclinometers are shown in Fig. 10.

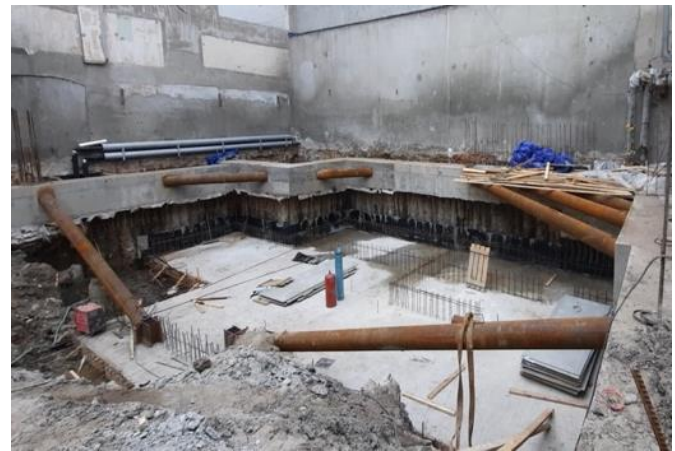
Fig. 11. View of a part of an arranged excavation with an angular spacer system
