Tensile tests on vertical and inclined anchors for high voltage electrical transmission towers in Uruguay

Javier Belsito, Daniel Hasard, Álvaro Gutiérrez, Valentina Cornelius Reyes, Pablo Chimenceji, Francisco Calvete
Universidad de la República, Geotechnical Engineering Department, Uruguay, jbelsito@fing.edu.uy

ABSTRACT: The Foundations Quality Control Laboratory (LCCF) of the Universidad de la República (UdelaR) conducted tensile tests on several vertical and inclined anchors to validate their individual load capacity. All the anchors evaluated are part of the foundation bases of the electrical power transmission towers built as part of the infrastructure works for the connection of the high-voltage lines between Uruguay, Brazil and Argentina. To perform these tests, procedures and protocols were previously established, considering the technical specifications required by the contractor and the reference standards. Drawings were also produced for the correct assembly of the reaction beams, instrumentation, and other components of the system. During the tests, load and unload cycles were staggered and the displacements obtained were recorded at the top of the grout and at two po

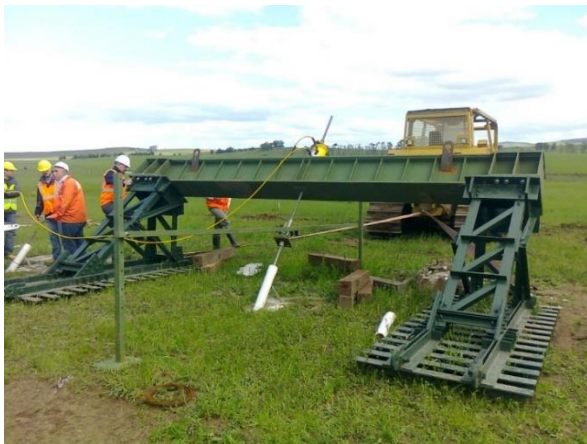
The reaction system (Figure 1) consisted of a 6 m long steel beam, supported on inclined metal supports to take the 49° inclination of the brace anchors.

Figure 1. Reaction system for brace testing – Site 1.

The horizontal forces were taken by anchors in the ground and by pulling two slings towards a bulldozer located behind the device. An Enerpac hydraulic cylinder with a 1,000 kN capacity was used to apply axial loads.

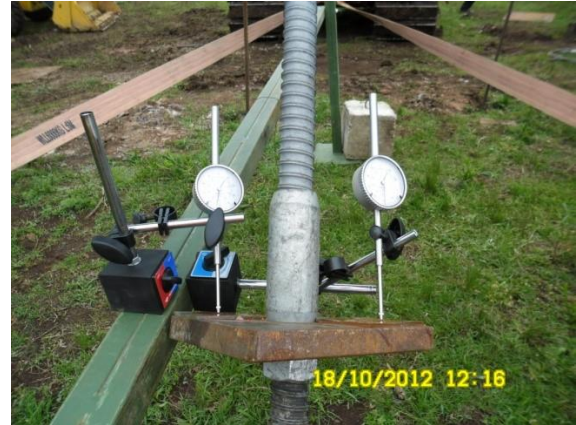
The graduation of the dial test indicators (Figure 2) to measure the displacements was 0.01 mm, mounted on a 5 m long structure, independent of the load application system. The dial test indicators were placed on a plate fixed to the bar, approximately 0.20 m from the head of the anchor.

Figure 2. Strain measurement system for brace testing – Site 1.

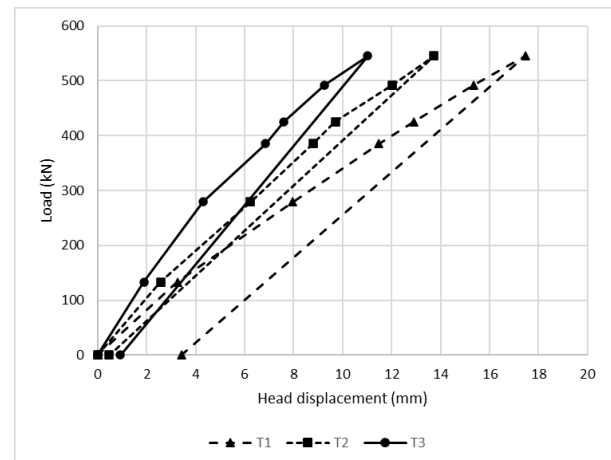
Figure 3 presents the load displacement behavior for three different anchors. One has 8.2 m long in a cohesive soil and the other two are the solid bar cases: one has 4.6 m long in a granite massif rock and the other has 5.0 m long in a sandstone massif rock. The degree of weathering of the rock massifs varies in depth, being classified between highly and moderately weathered, corresponding to grade IV to grade II according to the classification proposed by International Society of Rock Mechanics (ISRM 1981).

Figure 3. Load-displacement behavior of inclined anchors. T1: 8.2 m long, 40 mm diameter anchor in cohesive soil; T2: 4.6 m long, 29.6 mm diameter bar in granite rock; T3: 5.0 m long, 29.6 mm diameter bar in sandstone.

All anchors have been conservatively designed for the project loads and the resulting displacements were admissible, according to the adopted criteria. Failure occurs due to creep of the anchor bar and not due to bar-grout or grout-rock bond.

The residual displacements are quite small and show that, although the elastic behavior is exceeded, the anchor barely enters the plastic phase of the load-displacement diagram.

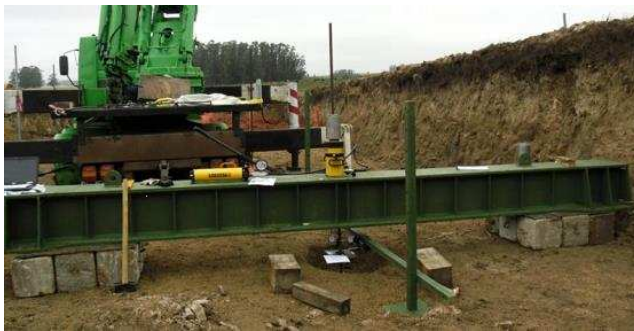
The tests had to reach loads between 270 kN and 500 kN, corresponding to the design load increased 30 %. The testing procedure was similar to that implemented for brace anchors. The reaction system (Figure 4) consisted of a 6 m long steel beam, supported on concrete blocks and a ½" steel plate. The comparators (Figure 5) were mounted on a structure independent of the load application system, 5 m long. The dial test indicators rested on a plate fixed to the bar, approximately 0.20 m from the head of the anchor.

Figure 4. Reaction system for vertical anchor testing – Site 1.

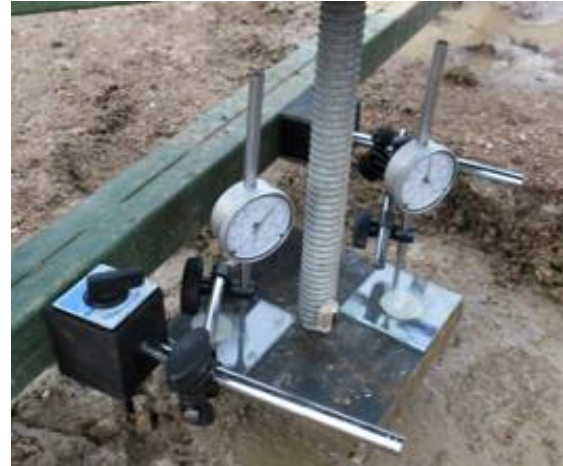
Figure 5. Strain measurement system for vertical anchors - Site 1.

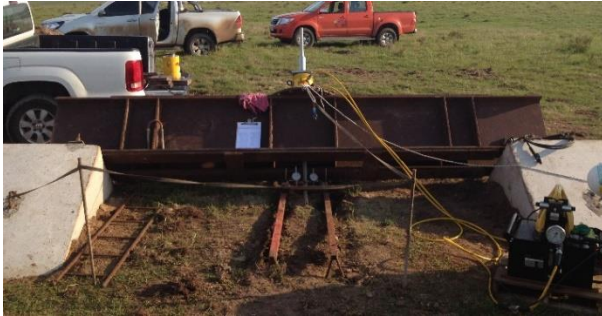
The reaction system (Figure 6) consisted of a steel beam supported on two concrete blocks of sufficient size and capacity to transmit the load to the ground without considerable displacements. The distance between internal edges of the supports was 3.50 m. The comparators (Figure 7) were mounted on a 4 m long structure independent of the loading system. They rested on a plate attached to the bar, situated about 0.10 m from the head of the anchor.

Figure 6. Reaction system for inclined anchor testing - Site 2.

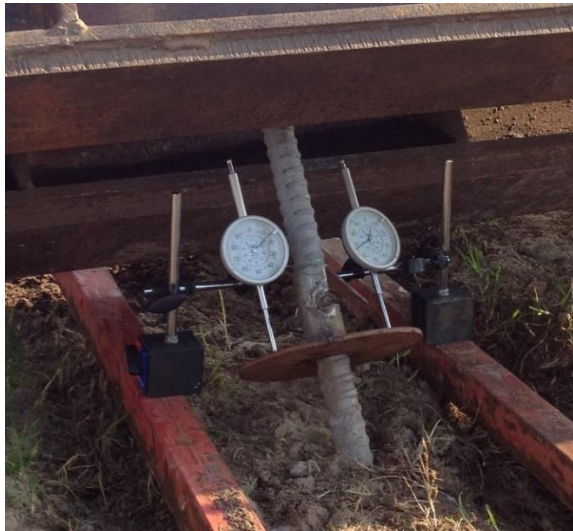
Figure 7. Strain measurement system for inclined anchor testing - Site 2.

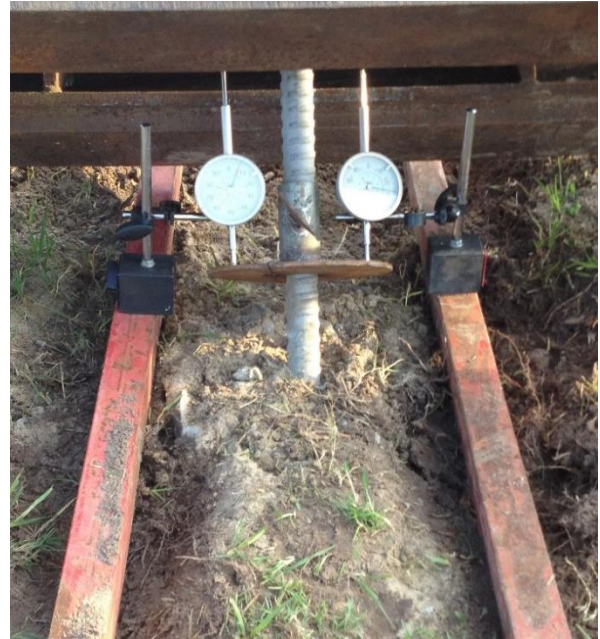
On the test of the 10.5 m long anchor of the same location, the maximum test load was not achieved. Having reached a load of 600 kN, the failure of the soil surrounding the grout was observed (Figure 8), noting that the anchor was pulled out of the soil without failure of the steel-grout bond. Localized cracking of the cement slurry at the surface was not observed at any time.

Figure 8. Breakage of soil surrounding the grout. Location 283 - Site 2.

Since the maximum test load was not reached (nor the design load) due to the failure of the surrounding soil in the form of a failure cylinder and the results obtained, the anchor design had to be modified.

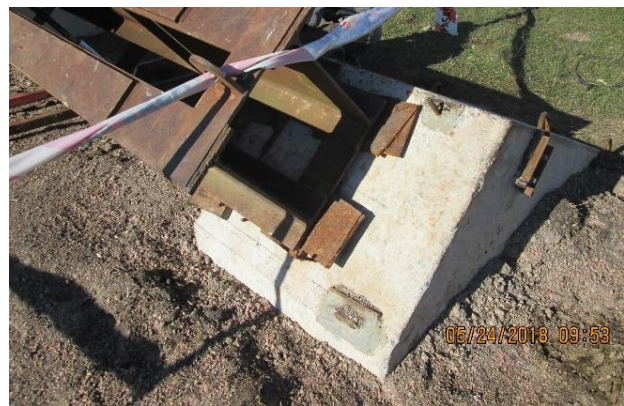
Finally, it was decided to proceed to a third loading cycle in order to reach 100 % (900 kN) of the maximum planned load or failure of the anchor. However, the maximum load reached was 840 kN due to the failure of the reaction system (compression supports), see Figure 9. Therefore, the test was interrupted for safety reasons. Figure 10 presents the load-displacement behavior obtained for this test. It is possible to observe some plastic displacements attaining the design load.

Figure 9. Failure of the reaction system support - Site 2.

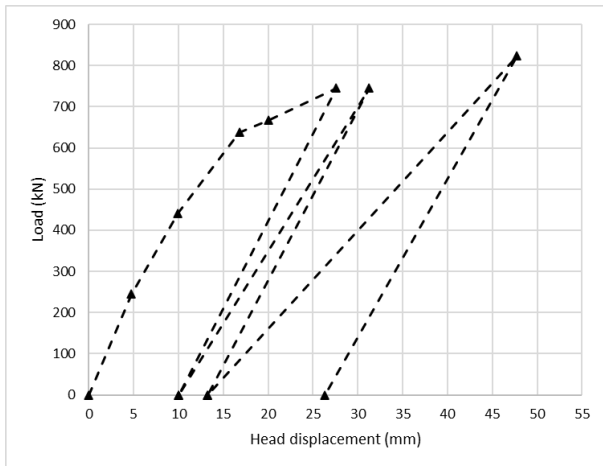
Figure 10. Load-displacement behavior for the test on location 54 – Site 2.

At the end of the cycle, it was found that the cracking in the head of the anchor, between the soil and the grout, was stabilized. The failure load was estimated in the order of 850 kN, with an associated displacement of 35 mm.

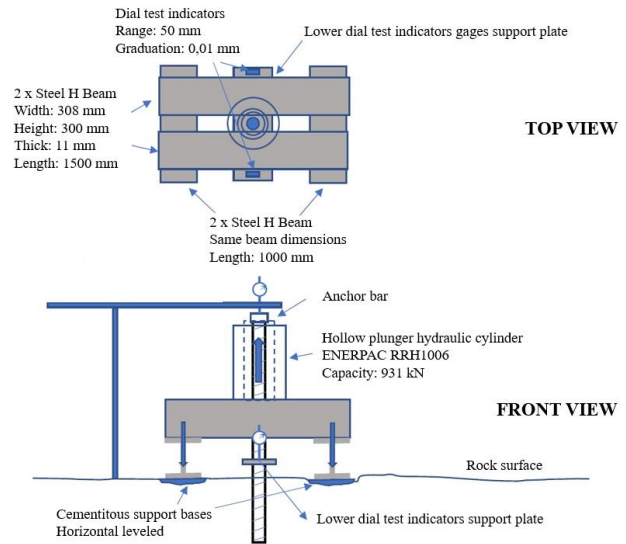
To verify that, a specific test device was prepared to test loads of up to 300 kN in tension according to the diagram in Figure 11, which allowed the measurement of displacements with a dial test indicator at the free upper end of the anchor (upper stop) and another dial test indicator on the rock support base.

Figure 11. Test device scheme for vertical anchor testing - Site 3.

On the four tests conducted (in the location 92, 518, 561 and 622) it was observed that displacement of the free steel bar, above the anchors, presented a linear elastic behavior, which was in accordance with the theoretical modulus of elasticity for steel.

The anchor tests had a linear behavior with insignificant displacements, varying between 0.33 mm and 1.70 mm for the maximum loads achieved.

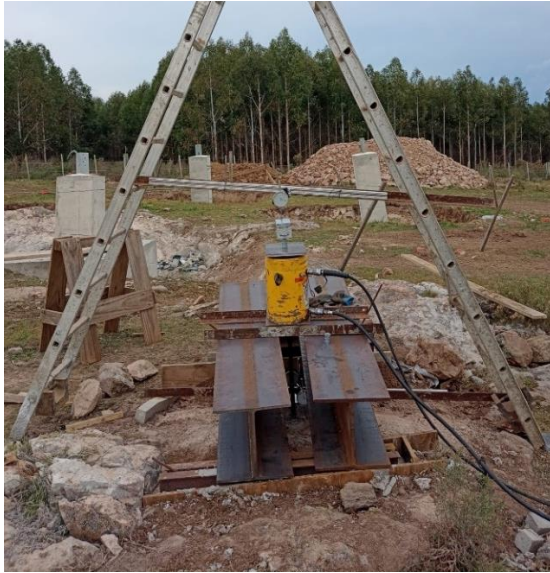
To verify the four possible failure modes, a test device was prepared (see Figure 12) that allowed the measurement of displacements with a dial test indicator at the free upper end of the anchor (anchor head) and another dial test indicator near the rock surface, δ_A and δ_B , respectively.

Figure 12. Anchor testing device for vertical anchors – Site 4.

An Enerpac hydraulic cylinder with a capacity of 1,000 kN and a stroke of 150 mm was employed for loads application. Load measurement was conducted using a manometer gauge with a maximum pressure of 70 MPa.

The graduation of the dial test indicators to measure the displacements was 0.01 mm, with a maximum extension of 50 mm. The dial test indicators used for displacement measurement had a graduation of 0.01 mm, with a maximum range of 50 mm.

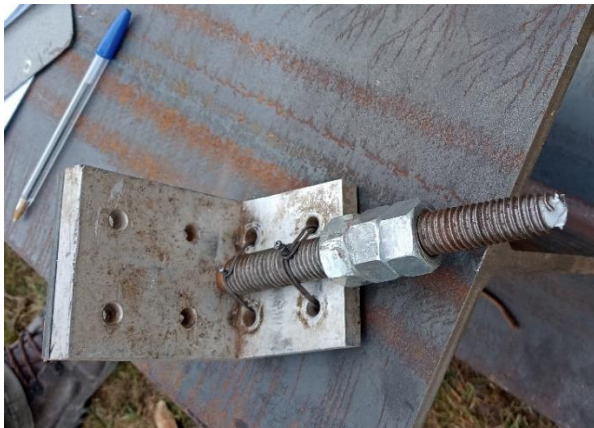
In anchor test 1, during the maximum load of the initial loading cycle, the free bar steel reached its yield strength limit, resulting in its fracture at one of its ends (refer to Figure 13). The test results are summarized in Table 1. Figure 14 presents the load displacement behavior at the anchor head; it is possible to note the decrement on stiffness before the failure detected in the bar due to yield stress.

Figure 13. Anchor breakage due to steel creep – Site 4.

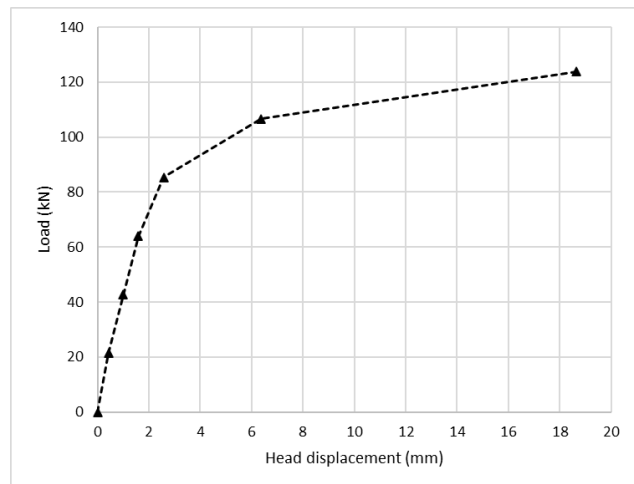
Figure 14. Load-displacement behavior of a bar exhibiting a yield failure - Test 1 - Site 4.
