# Mitigation and prevention plan for debris flows-induced disasters in El Melocotón and San Alfonso, upper Maipo River Basin, Chile

**Carlos Andrade & Patricio Muñoz & Vanessa Rugiero**  
*Natural Hazards Department, AFRY, Chile, carlos.andrade@afry.com*

**ABSTRACT:** At the end of January 2021, a climatological event triggered numerous flows in the villages of El Melocotón and San Alfonso (Chile), causing floods, and damaging houses and public facilities. Eight months later, AFRY was commissioned by the Government to develop a mitigation and prevention plan for debris flows-induced disasters. In this paper, the main results of the project are summarized. The hazardous processes were classified as debris and hyperconcentrated flows, and its sediment volume and water flow were estimated for a 100-yr scenario. Regarding structural mitigation, at El Melocotón was recognized designed adequations of bridges to prevent the overflow and to facilitate the water discharge in Maipo River, while for San Alfonso, were not recognized protection measures for the protection of the locality. With respect to non-structural measures, the Emergency Plan is under review, as a part of the future Disa

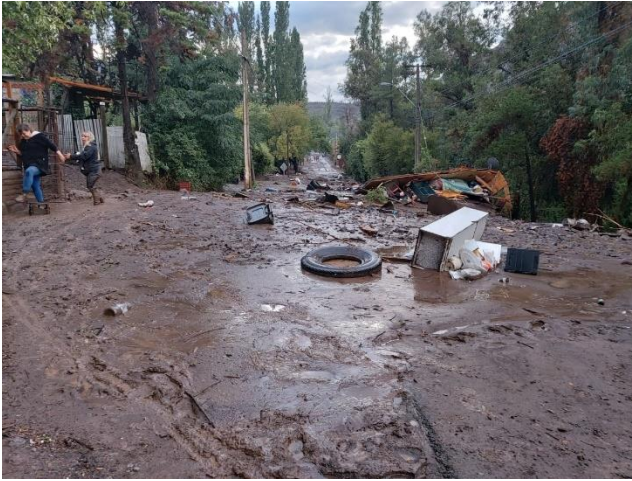
Figure 2. Deposits from the flow that occurred in the January 2021 event, San Alfonso. Photo facilitated by Andres Trincado, resident of El Melocotón.

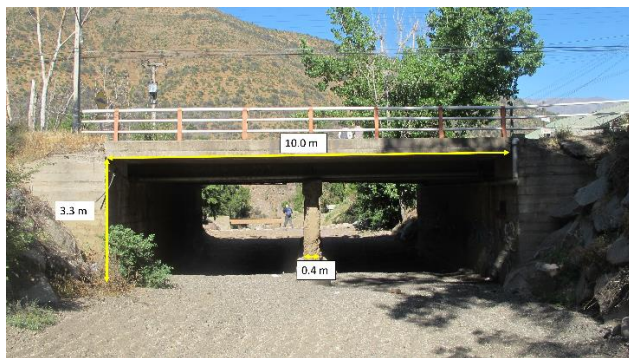
b) El Melocotón Bridge (Figure 3): It's located at Las Cucas ravine. It is a bridge with concrete abutments, steel beams, and a concrete central pier. Riprap bank protection upstream and downstream of the bridge was recognized.

Figure 3. Downstream view of El Melocotón Bridge.

Respect structural mitigation measures, in El Melocotón the strategy aims to ensure that flows pass safely under the bridges without causing overflow. For this purpose, we proposed mainly bridge design adjustments and, in some cases, a riprap installation upstream of the bridges, on the ravine's edge to prevent erosion. In San Alfonso, the structural mitigation strategy was more complex, there is a limitation on the available space on which to build mitigation works without causing harm to the community. The focus of structural mitigation works in San Alfonso should be a mix of active and passive structural mitigation, aimed to reduce the possibility of flow generation, or once these occur, to reduce the volume flow and/or redirecting them safely through the locality to discharge into the Maipo River. For this purpose, slope reinforcement to prevent sediment contributions, diverting and containing walls that allow flow discharge to established sectors are proposed. The option of retention systems like flexible barriers or sediment traps was included only at an idea level, as preliminary estimates indicate a low performance compared to the cost these measures entail. The volumes of water and sediment delivered in this study can help to size the first sketches of these protection systems.

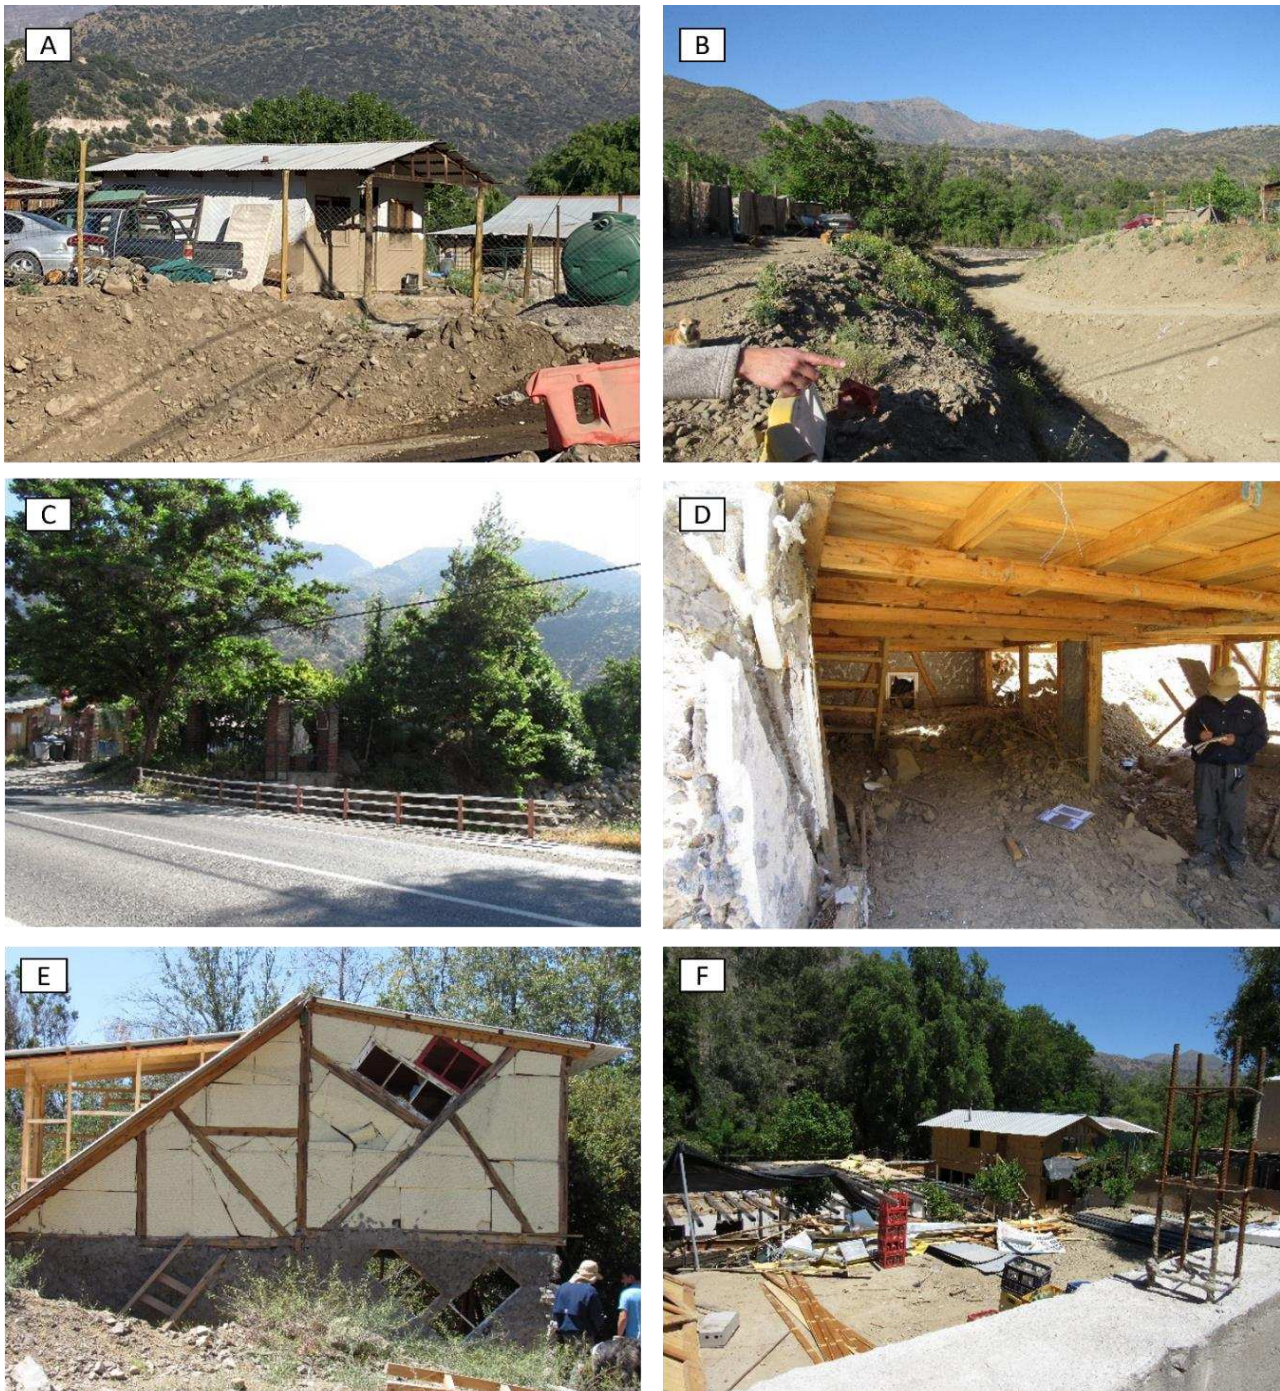
For San Alfonso, evidence of at least three flows were recognized, where the paths followed the course of streets and avenues such as Carmen Grossi and Bernardo O'Higgins streets (Figure 8-D and Figure 8-E), covering a large part of the populated area, affecting housing, equipment, and infrastructure. Sports and

social equipment, such as San Alfonso Development Corporation, were also exposed to this event. The soccer field was affected, as well as part of San Alfonso square. Parallel to the G-25 route, there are also sewer pipes that do not have sufficient capacity to allow optimal flow and water passage, causing obstructions. Damage was widespread throughout the locality (Figure 8-F).

Figure 8. A) Mud marks on house in El Arenal sector. B) On the side of La Solana ravine, there are precarious houses of light material in an informal settlement. C) Elderly home foundation Las Rosas situated outside the urban limit to the North, next to Las Cucas ravine. D) Mud marks and deposits inside a house, upstream Bernardo O'Higgins avenue. Deposits exceeding 1.5 m in height. E) Damage observed on house due debris/hyperconcentrated flow impact. F) Reconstruction of houses devastated by flows of January 2021.

Respect to non-structural measures, it was recommended to close as soon as possible the development of a municipal territorial planning instrument that allows the identification and the regulation of the risk zones. In this sense, it is urgent to develop a tool that allows the recognition of the regional risk zones of the PRMS and to detail them at a local level, the use of planning criteria, the postponement of building permits, and the protection of vital lines and essential buildings. It was also emphasized that both structural and non-structural measures must be accompanied by an educational and awareness campaign that allows the understanding the risk to which society is exposed, as well as acting preventively (e.g., an emergency evacuation plan) and being prepared for an emergency (e.g., coordination between the community and institutions).
