# Stability and movements of an anchored wall in phyllite

The paper discusses the stability and movement of a 24m deep anchored retaining wall. The retained material is a schistose phyllite which discontinuities layers are inclined towards the excavation. Stability calculations of the anchored retaining wall were carried out by limit equilibrium method adopting planar and circular failure surfaces as well as by the finite element method. These analyses were based on strength parameters obtained from the direct shear tests in which the residual strength parameters were estimated with the failure plane coincident with the schistose phyllite discontinuities. The analyses showed a safety factor value of the retaining system close to one for the current situation at the time of the analyses (24m excavation). This study shows that the designer adopted peak parameters without considering the schistose discontinuities. The numerical analyses also confirmed that an entire mass of soil underwent a considerable horizontal displacement. This result was in accordance to what was registered using the inclinometer installed on the site.

This paper presents a study to evaluate the behaviour of a

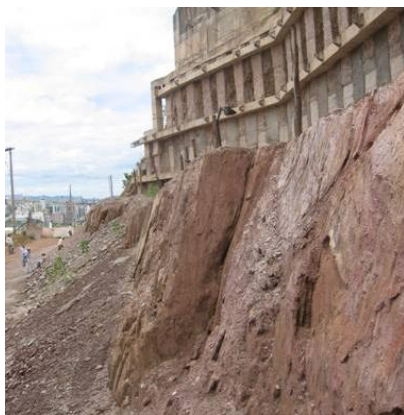
Figure 2. Bottom of the anchored wall where  $70^\circ$  discontinuities can be seen.

The discontinuities in the site are represented by both weathered and unweathered intrinsic schistosity planes. These planes have an inclination at an angle of about  $70^\circ$  (from the horizontal plane) towards the excavation side as shown in Figure 2. The profile also features some tectonic joints and fractures with discretely defined directions.

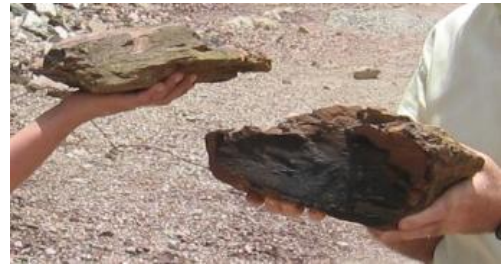
Figure 3. Phyllite schist samples collected for direct shear tests

In order to determine the geotechnical parameters of the retained material, undisturbed samples, shown in Figure 3, were taken from the soil surrounding the bottom of wall and drained direct shear tests were carried out. The measured unit weight of the phyllite

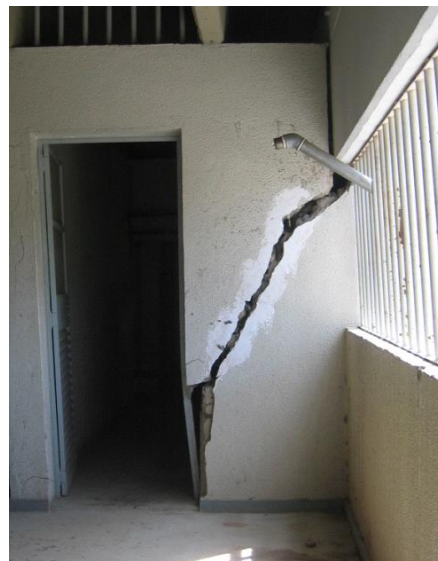
Figure 7 Cracks and movements in the building

The building located behind the wall has five storeys two of which are below the street level. The building is founded on 110 piers of about 8 m long. Settlements measured in some of the building columns are presented in Figure 6. Most of the structural elements of the building are precast elements thus forming an isostatic system that is sensitive to movements. Damages which occurred in the building are exemplified by cracks and movements shown in Figure 7.

The structural problems including development of cracks in the adjacent building were due to the inadequate retaining wall that did not provide a reliable retaining system and hence caused significant displacement during the excavation works.

It was recommended to install a greater number of anchors to improve the stability of the system and increase the safety factor from about 1.0 to 1.5 as specified by the standards. The additional anchors should provide a force of about 1050 kN/m. The anchorage length should be determined in order to ensure that the anchor end is positioned beyond the failure slip surface; i.e. the anchor should intercept the failure slip surface.
