# The effects of deep excavations in soils and rock on adjacent structures

## The 2011 R.M. Hardy Address

K.Y. Lo  
GRC Director and Professor Emeritus  
*The University of Western Ontario, London, ON, Canada*

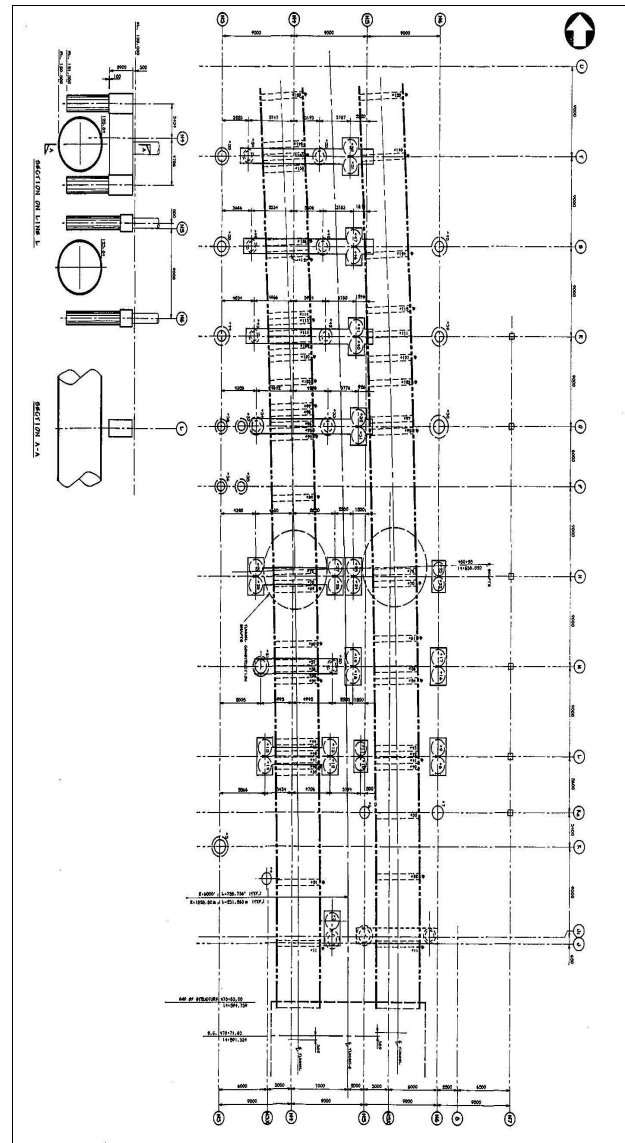
Figure 1. Plan of excavation and foundation layout- York Mills Centre

Figure 1 shows the foundation layout over the TTC subway tunnels. To eliminate the net structural loading onto the tunnels the loads were transferred to the subsoil below the invert by caissons of 1.1 to 2.4 m diameters, straddling the tunnels. The design and construction issues were therefore to minimize the effect of excavation for the substructure so as to satisfy the structural and operational requirements of the subway tunnels.

Complications in analyses and interpretation also arise because excavation was continuing at the south portion (south of column line M in Figure 1) with permission of the engineers, so as not to delay construction. In principle, therefore, for any given profile of final excavation, the predicted displacements (and other relevant quantities) should be considered in the following manner:

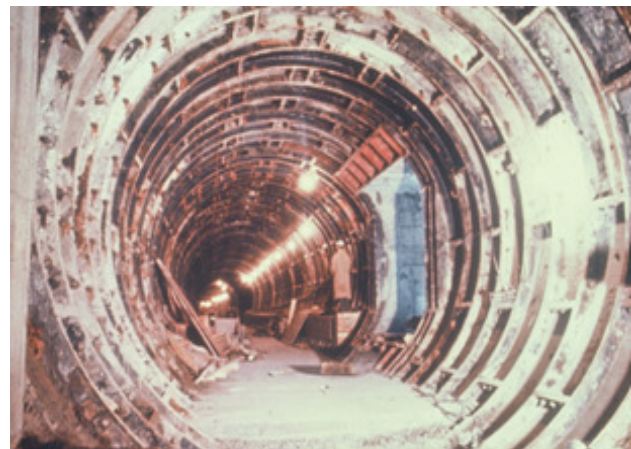
Figure 2. TTC Subway tunnel

The excavation for the substructure was approximately 90 m by 40 m, with depth of excavation generally 7 m to 9 m. The proximity of the general excavation to the tunnel crown was about 2 m. However, local excavation for the load transfer girders was within 0.5 m from the extrados of the lining. A photo of the tunnel is shown in Figure 2. Details of the cast-iron segmental lining are shown in Figure 3. This section of the Yonge Line was constructed in the late 1960s, with cast-iron segmental lining.

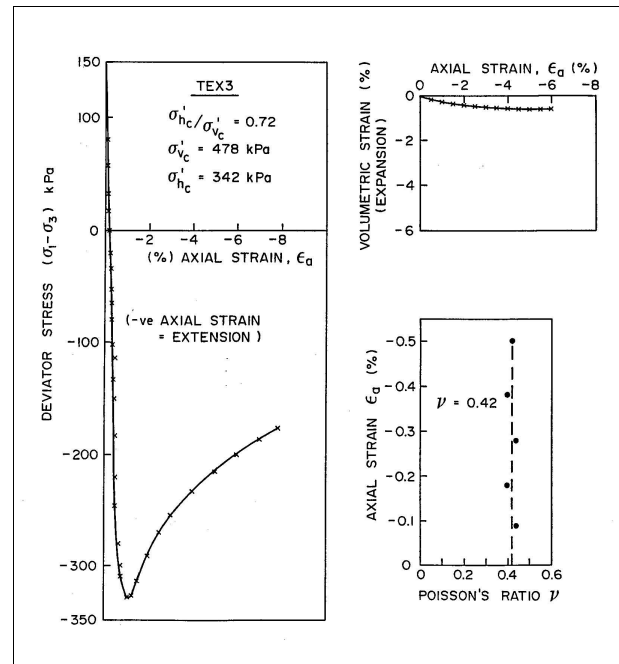
Figure 4. Typical results of anisotropically consolidated drained triaxial extension test

Typical results of a triaxial extension test are shown in Figure 4. It may be seen that the initial portion of the stress-strain curve is linear up to at least 0.4% axial strain. The strain at failure is approximately 1%. The sample dilates during shear but the volumetric strain is small. The Poisson's ratio is 0.42 in this test.

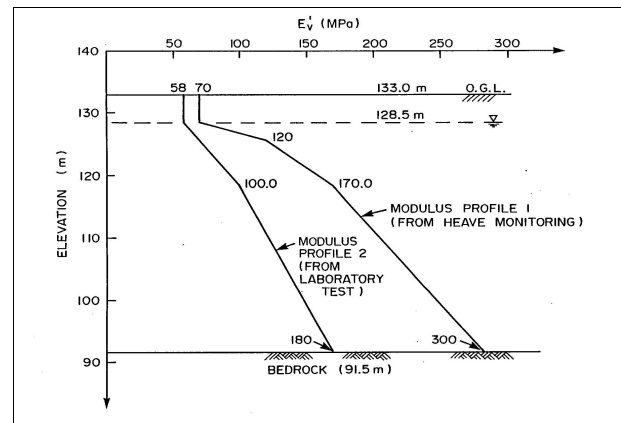
Figure 7. Distribution of unloading modulus with depth

In the second stage, block samples were recovered at the location of the south-east portion of the excavation already completed. Typical results of drained extension tests, shown in Figure 4 were employed to obtain the distribution of modulus with depth. Finally, advantage was taken of the on-going excavation west of the Don Mills subway station (see Figure 6) to install instruments for heave monitoring. At locations P1 and P2, magnetic extensometers were installed and the heaves at six different depths were measured as local excavations were carried out in this area. No de-watering is allowed within the zone of influence of the heave monitoring area, to ensure that the heave measurements were not affected. The results of these measurements are shown in Figure 7.

The soil parameters, based on laboratory test results are shown in Table 1. The two soil deformation modulus profiles in Figure 7 were employed, but design decisions

were based on the profile evaluated from heave measurement.

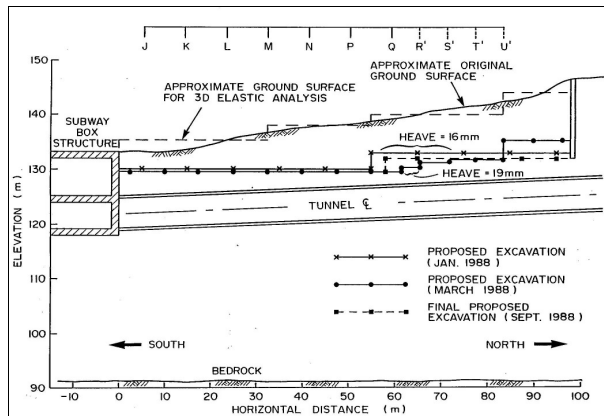
Figure 8. Longitudinal section of proposed excavations along tunnel

During the course of design, however, the geometry and depths of excavation were changed several times. The final longitudinal section adopted, together with two other proposals analyzed, is shown in Figure 8.

The results of analyses indicated that the proposed excavation with the final profile shown in Figure 8 was technically feasible without causing undue distress to the lining and it was decided that the construction would go ahead with a monitoring program to verify the design assumptions and construction control.

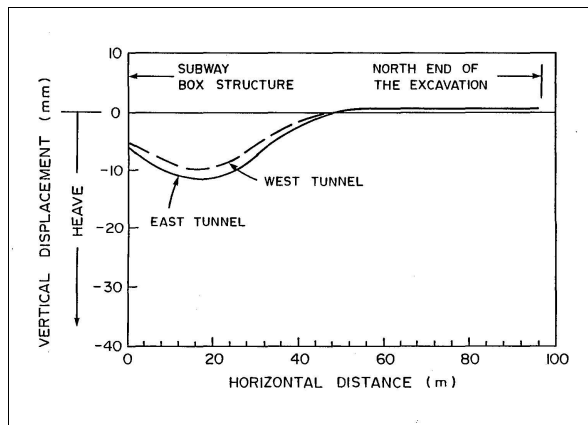
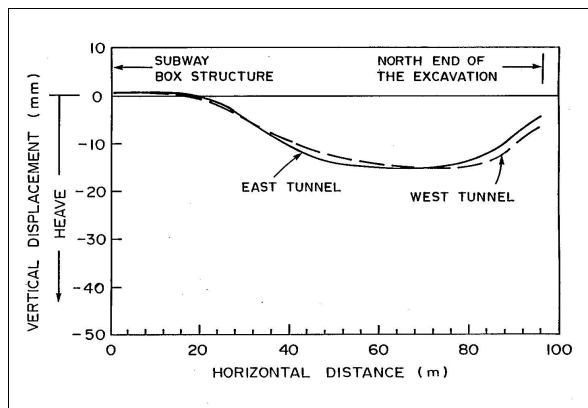
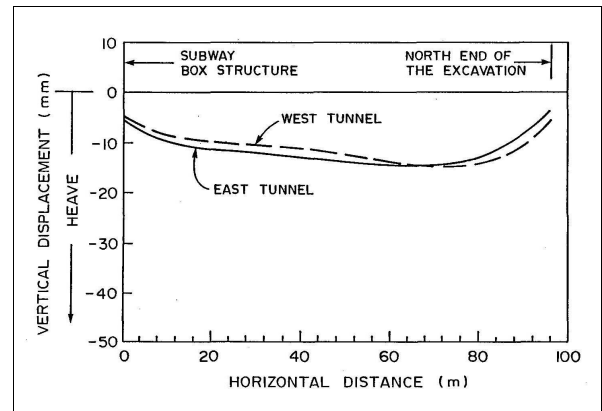
The predicted longitudinal deflection of the east and west tunnels at different stages are shown in Figure 10 to Figure 12. Further details of analysis and interpretation of analysis results may be found in Lo and Ramsay (1991).

Figure 10. Predicted displacement profiles of the east and west tunnel for the area excavated prior to December 1, 1987 – prior to monitoring

Figure 11. Predicted additional displacements along the east and west tunnels due to proposed additional excavation

Figure 12. Predicted displacement profile of east and west tunnels after general excavation

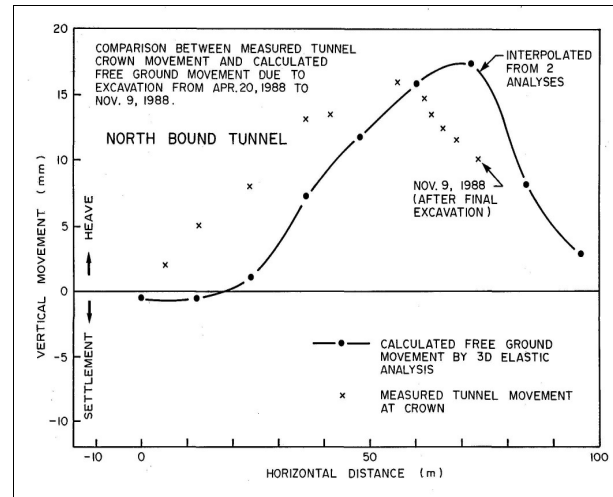
In the longitudinal direction, the deflections predicted for the northbound and southbound tunnels are compared with results of monitoring in Figure 13 and Figure 14 respectively. It can be seen that the maximum heaves measured were slightly below those predicted for both tunnels. It may be observed that the design criterion for heave was satisfied.

Figure 13. Comparison between predicted and measured heaves – northbound tunnel

Figure 14. Comparison between predicted and measured heaves – southbound tunnel

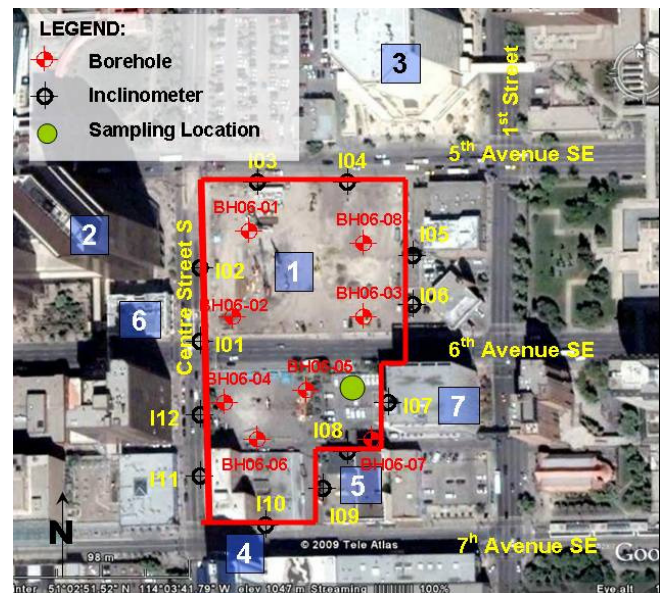
Figure 15. The Bow site: (1) The Bow; (2) Petro-Canada Centre; (3) Telus; (4) Calgary's Light Rail Transit; (5) The Royal Canadian Legion No. 1; (6) Chamber of Commerce and (7) Andrew Davidson Building (modified from Lo et al. 2009)

The excavation for the construction of the Bow office tower involved two city blocks. It covers a footprint of  $17,000 \text{ m}^2$ , 190 m long, 100 m wide and 21 m deep. It covers a footprint of  $17,000 \text{ m}^2$ , 190 m long, 100 m wide and 21 m deep. As shown in Figure 15, a number of structures exist at close proximity to the excavation. These structures include the Telus building in the north, the Calgary Light Rail Transit in the south, the Petro-

To obtain the required strength and deformation parameters, block samples were recovered from the bottom of the excavation at the location shown in Figure 15. The highly fissile nature of the mudstone rendered both sampling and preparation of specimen for triaxial and shear box tests very difficult. Nonetheless, adequate test results were obtained for the on-going analysis and excavation process.

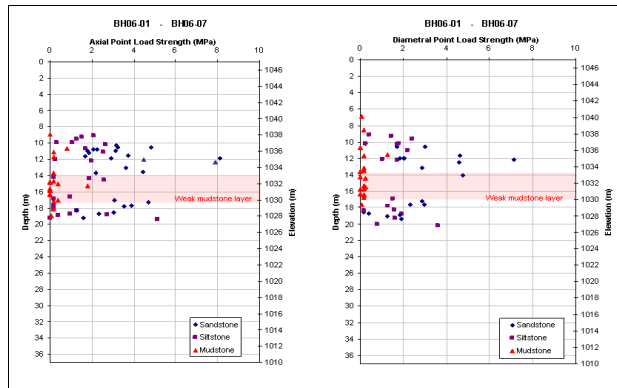
Figure 18. Point load strength profile

A detailed review of geotechnical site investigation report was performed. A summary plot of all the point load test results from BH06-01 to BH06-07 in both the axial and diametral directions are shown in Figure 18. It can be seen from the results of diametral point load test that there is a clear demarcation of a weak zone of mudstone exist within the depths of 13.5 m to 17 m across the area of the excavation. The results of axial tests did not give a distinct trend. The difference in behaviour is due to the layered nature of the rock. Failure in the axial direction tends to involve more than one layer while failure in the diametral direction tends to be tensile fractures in the weak mudstone. It will be shown that this weak zone correlates well with results of inclinometer monitoring. It also played a major role in contributing to some significant movements to the surrounding structures.

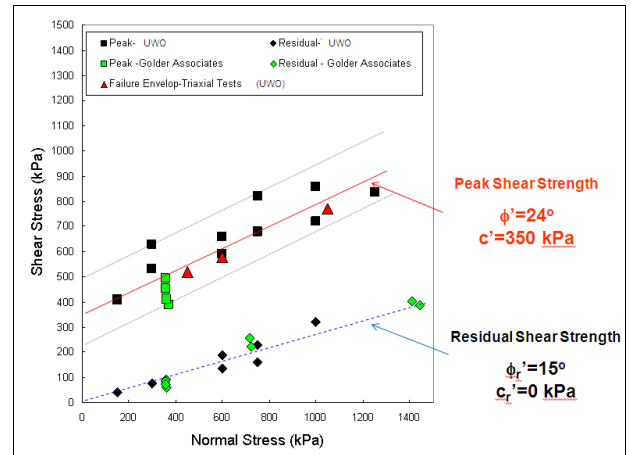
Figure 19. Multistage direct shear test results

The results of shear box and triaxial tests are shown in Figure 19. To verify the reliability of test results, tests were performed at two laboratories. It can be seen that the results were quite consistent, yielding peak strength parameters of  $c' = 0.35 \text{ MPa}$  and  $\phi = 24^\circ$  and residual parameters  $c'_r = 0 \text{ MPa}$  and  $\phi'_r = 15^\circ$ . Further details of test results and deformation parameters obtained therefrom may be found in Lo et al (2009). The engineering parameters employed in numerical analysis for each rock unit are summarized in Figure 20.

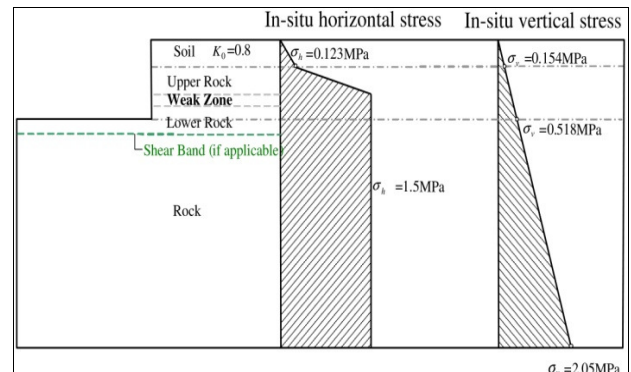
Figure 21. Assumed vertical and lateral *in-situ* stresses

It appears that no in situ rock stress measurements have been carried out in the near surface rock formations in the Calgary area. Therefore, the magnitudes and directions of the in situ horizontal stresses which provide the driving force in rock deformation are not known. Based on experience of stress measurements in weak rock formation elsewhere, it was assumed that the magnitude of the horizontal stress may lie between 1 to 2 MPa. The distribution of assumed horizontal stress is shown in Figure 21, together with the vertical stress distribution based on overburden weight.

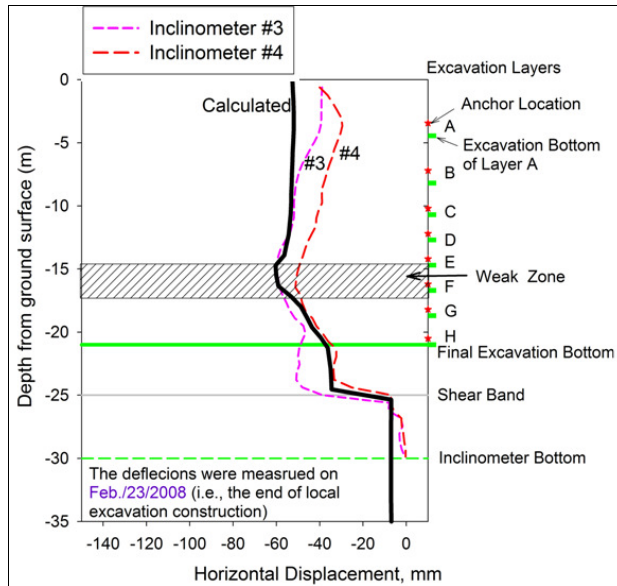
Figure 22. Calculated and measured deflections- North wall

The results of analysis at the north wall are compared with the results of monitoring from inclinometers No. 3 and No. 4 as shown in Figure 22.

The measured displacements from the two inclinometers are quite comparable and exhibit the same characteristics in the distribution of movements with depth. The calculated displacements show the same features. In particular, the following characteristics of movements may be observed.

- (i) The shear band induced an abrupt displacement of about 30 mm at a depth of 4 m below the bottom of the excavation.
- (ii) The weak zone between 14.5 m to 17.5 m depth caused a bulging effect at its corresponding elevations consistent with the results of diametral point load tests shown in Figure 18.
- (iii) The magnitude and depth of maximum lateral movement (60 mm) from monitoring and computations are consistent. The pattern of deformation behind the excavation is shown in Figure 23.

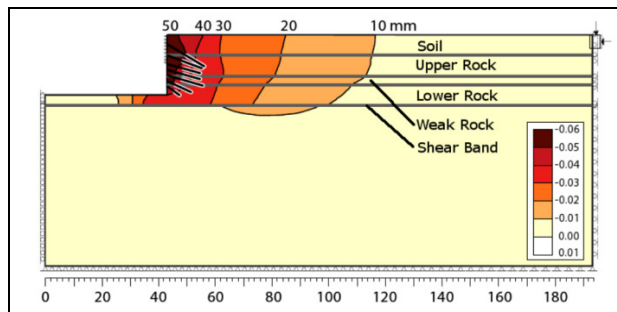
Figure 23. Computed horizontal displacements- North wall

It is significant to note that the displacement contours show a clear discontinuity at the shear band, indicating interface slip. This interface slip resulted in substantial lateral displacements far away from the excavation face as shown in the figure. Thus, at a distance approximately 4 times the depth of the excavation, the horizontal displacement is still as much as 10 mm.

The maximum calculated settlement is 13.3 mm at a distance of about 10 m from the north wall. The maximum base heave is 28 mm at a distance of about 12 m from the excavation face. While no precise measurements were made with regard to these quantities, general observations at the site are quantitatively consistent with the estimates.

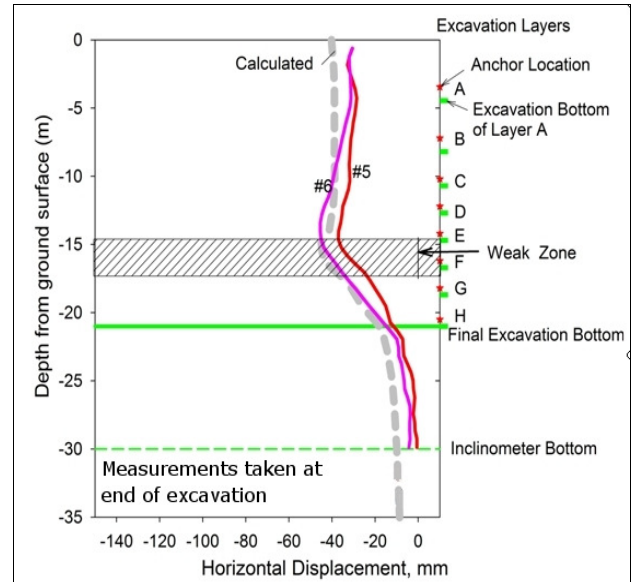
Figure 24. Calculated and measured deflections – East wall

The calculated and measured deflections at the East Wall at locations of inclinometer 5 and 6 are shown in Figure 24. At these locations the shear band did not exist but the effect of the weak zone was apparent. No abrupt discontinuity of the displacement distribution with depth occurred. As can be seen in Figure 24, the results of numerical analysis represent the measured deflections of

two inclinometers quite satisfactorily both in magnitude and distribution.

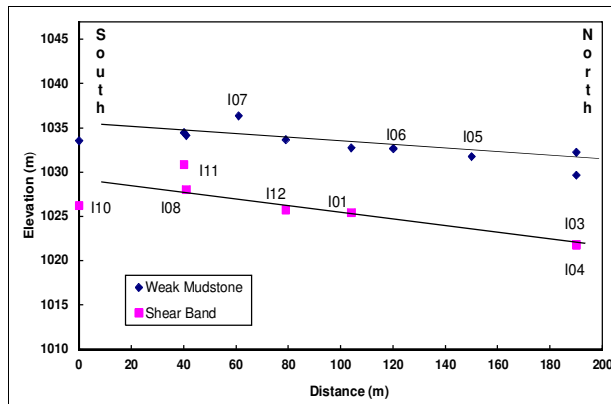
Figure 26. Inclination of the weak zone and shear band across the site

From results of inclinometer monitoring, it is possible to identify the occurrence and location of the weak zone and shear band across the site. The results are shown in Figure 26. It is noted that the weak zone was present at all locations monitored by the inclinometers.

The shear band, however, was not exhibited at locations of I05, I06 and I09. It is also interesting to note that both the shear band and weak zone have apparent movement towards the Bow River in the north.
