# A Case History on the use of High Strength Woven Geotextiles to Reinforce a Oil Sands Tailings Pond Closure

Andrew Mills, C.E.T.  
*Layfield Environmental Systems, Edmonton, Alberta, Canada*

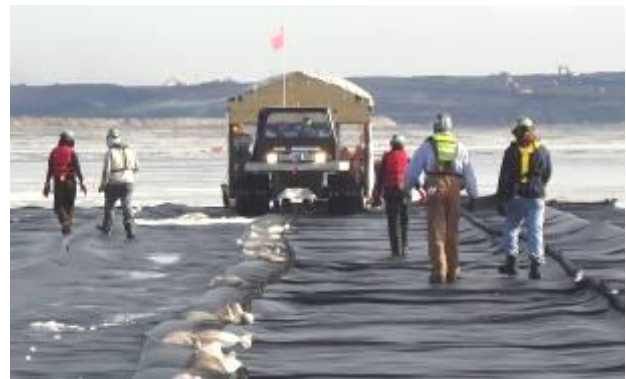
Figure 1. Preparing to sew a seam on the ice. Note stockpile of coke in the background.

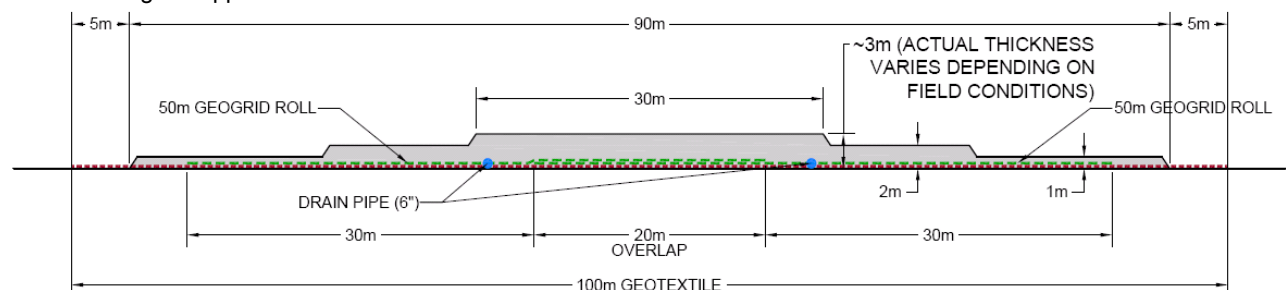
Figure 2. Cross section of proposed coke road on tailings pond (Suncor tender drawing, used with permission).

The 2009/2010 road project involved 13 kilometres of road 90 m wide (Figure 3). The cross section of the road began with a 100 m wide layer of sewn high strength biaxial woven geotextile with a finished strength of 82.5 kN/m (Figure 2). On top of that was an 80 m wide layer of a biaxial geogrid (30 kN/m) overlapped 20 m in the centre. Then drainage pipes were added in the direction of the road. Coke fill was then placed on top of these geosynthetics. The first lift was 1 m thick and 90 m wide. The second lift increased the centre 60 m of road to a 2 m thickness. Then the centre 30 m wide portion of the road was increased to a 3 m thickness. The initial 1 m

thickness was to be placed with snow-cats while the other lifts were to be placed with small dozers. The centre road was for truck access with 40 ton articulated mine trucks. A more detailed review of the road design is contained in the paper Suncor Pond 5 Coke Cap – The Story of Its Conception, Testing, and Advance to Full Scale Construction (Wells, Caldwell, and Fournier 2010).

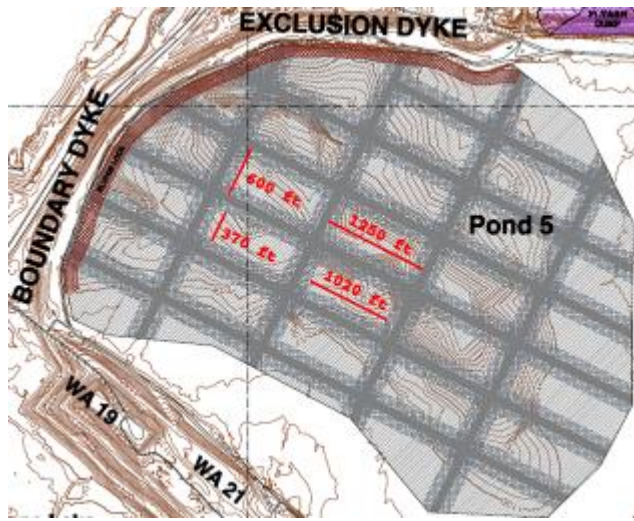
Figure 3. Proposed road layout on pond 5. (Suncor Tender drawing, used with permission).

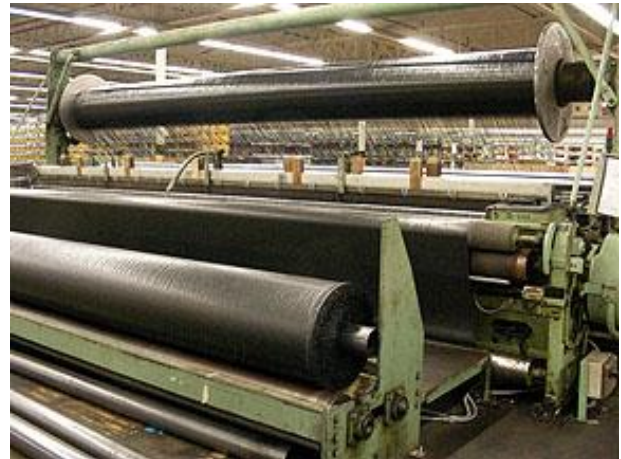
Figure 4. High strength woven geotextile loom that can make geotextiles with stacked tapes.

A custom fabric design for this project was discussed. The two main specification requirements were strength and a specific opening size (to retain tailings but promote drainage). The starting point was an existing material design that had a strength of 105 by 105 kN/m (HP 770). At the time the factory was just completing a production run of the 105 by 105 kN/m material so a loom was all set up and ready (Figure 4). Higher cross direction fibres were woven into the fabric but the strengths were still not high enough. The final solution involved stacking the tapes two high and changing the weave pattern so that more high strength tapes could be packed into a denser weave pattern.

The resulting fabric had a strength of 105 kN/m in the machine direction and 155 kN/m in the cross machine

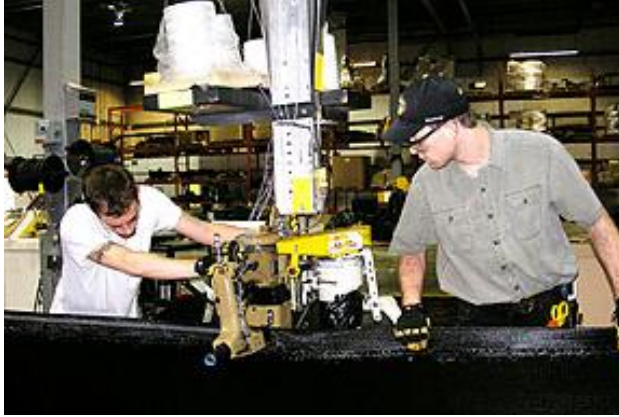
Figure 5. Shop fabrication sewing

that a heated structure would be needed for sewing. The sewing machine used by our crews is the Union Special 80200Z high strength sewing machine (Figure 5). This sewing machine sews two stitch lines at a time and is designed to sew the heaviest geotextile materials. This machine is usually mounted to an overhead support that is attached to the back of a truck or trailer. If a heated structure was needed then it needed to be built with a strong enough roof structure to support this sewing machine.

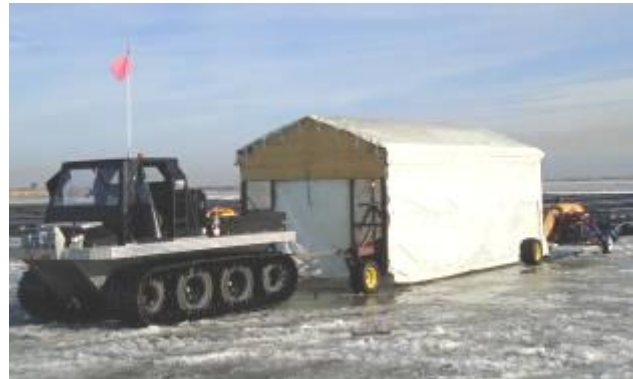
Figure 6. Completed sewing trailer.

A number of sewing structure designs were put forward and evaluated. The final design was a trailer structure with an overhead rail to hold the sewing machine. The trailer was pulled by an amphibious vehicle and had another small trailer set up behind the main trailer to hold the generator and heater. A small video camera and monitor were rigged so that the driver of the towing vehicle could match speed with the sewing.

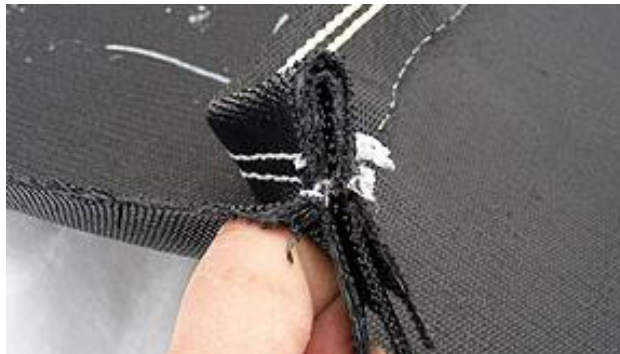
Figure 7. J-Seam stitch type

As with any new type of material there can be unexpected issues. In the initial sewing of the geotextile the shop was using the J-seam type as this is the easiest to produce (Figure 7). In the J-seam both layers of material are folded in one direction and then sewn. This hides the bottom layer and there were instances where the bottom layer was not captured by the sewing thread. These areas were re-sewn in the field. After this incident the fabrication technique moved to the "butterfly" seam type (Figure 8). In the butterfly stitch type each layer of material is folded away from the other. When sewn the butterfly seam lets the inspector see both sides of the stitching and the inspector can easily see if all layers of material have been captured in the seam.

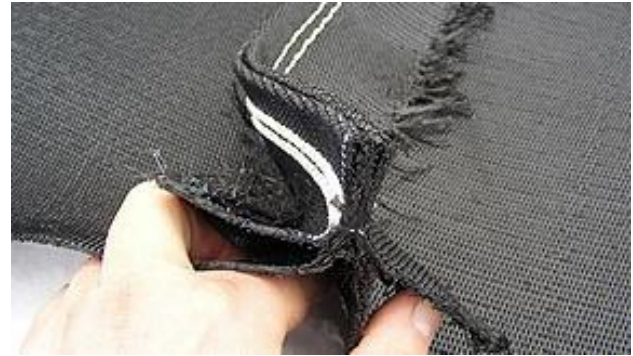
Figure 8. Butterfly stitch type

with a J-Seam, 69.4 kN/m with a butterfly seam, and 64.0 kN/m with a prayer seam (a flat seam with no folds). Obviously more work was needed to get reliable seams in this unique new material.

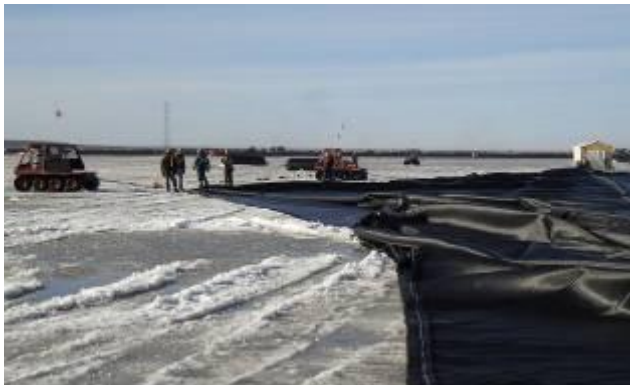
Figure 9. Deployment of a fabricated panel on the ice

Field construction began on January 12<sup>th</sup> 2010. Initial construction was intended as an experimental phase where deployment (Figure 9) and seaming techniques (Figure 10) would be evaluated. Two field seaming companies were employed on this part of the project each associated with a separate earth moving contractor who was installing the other materials and backfilling the geotextile with coke.

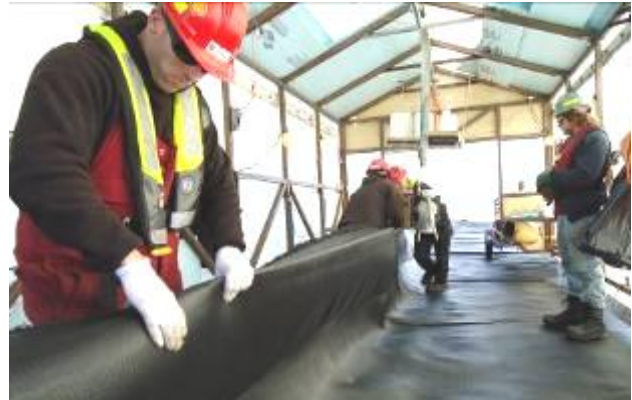
Figure 10. Field seams being sewn in the heated sewing trailer

Sewing of the panels on the ice was easier than originally thought. The use of heated trailers protected the crews doing the sewing and the sewing machines worked well. Samples taken from the sewn seams were tested on site with the field tensile tester and all field seams produced passed their associated tensile test.

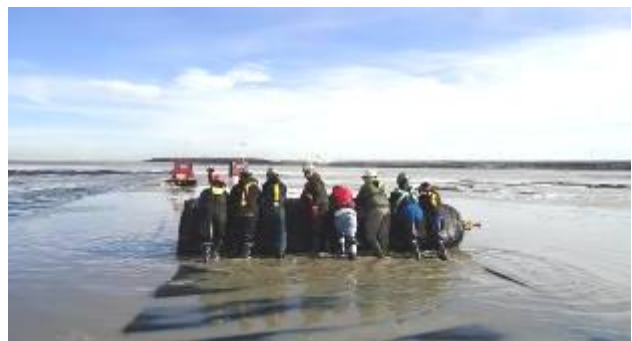
Figure 11. Last few panels placed before spring melting stopped on-ice activities

The second impact on production was due to an early spring. An early and sustained warm spell early in March meant that by the middle of March the ice had thinned to a

point where construction had to stop (Figure 11). At the end of 2010 winter construction, 4.5 km of the planned 13 km of roads had been placed.

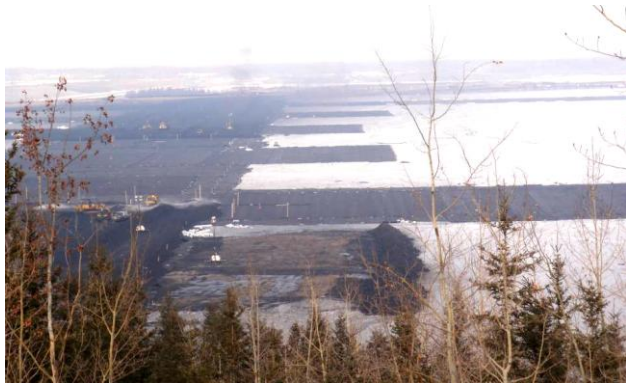
Figure 12. Extent of roads at end of construction in winter of 2010
