# A large scale laboratory swell test to establish the susceptibility to expansion of crushed rock containing pyrite

Michael L J Maher  
*Golder Associates Ltd., Ontario, Canada*  
Bernadette Azzie & Cróna Gray  
*Golder Associates Ireland Limited, Co. Kildare, Ireland*  
Jon Hunt  
*Golder Associates Pty Ltd., Sydney, Australia*

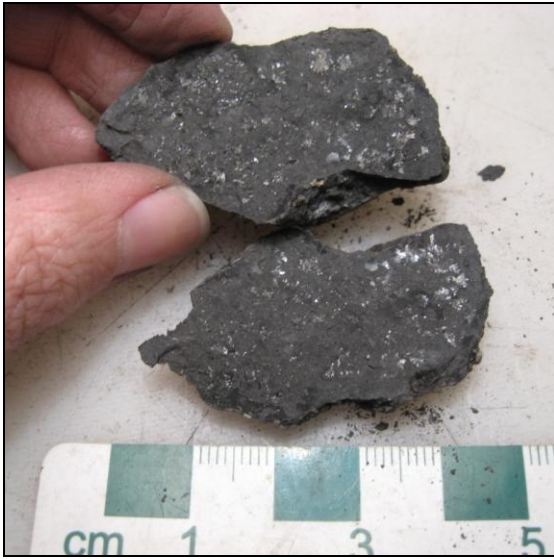
The recovered aggregate samples were geologically examined and were found to be elongated and platy. Two lithologies were identified – a calcareous mudstone/siltstone and a medium to fine grained limestone. The calcareous mudstone/siltstone made up approximately 95% of the sample with the remaining 5% consisting of the limestone. Secondary mineralisation had occurred on the outer surfaces of some particles. This was identified as gypsum and calcite crystals (subsequently confirmed by SEM analysis). Some particles showed extensive partings along lamination boundaries. Gypsum was also seen to have formed within the laminations (Figure 2).

Figure 2. Visible gypsum crystal clusters on faces of freshly opened lamination

The widespread presence of gypsum crystal growth within laminations and on particle surfaces provided visible evidence within the aggregate of heave. The natural laminations within the mudstone, in combination with the high absorptive properties of the rock fabric, readily allow ingress of sulphate saturated solution into the aggregate particles and the precipitation of gypsum. As the gypsum grows, these laminations are prised open and results in an overall degradation of the aggregate. We believe this chemical weathering process explains the

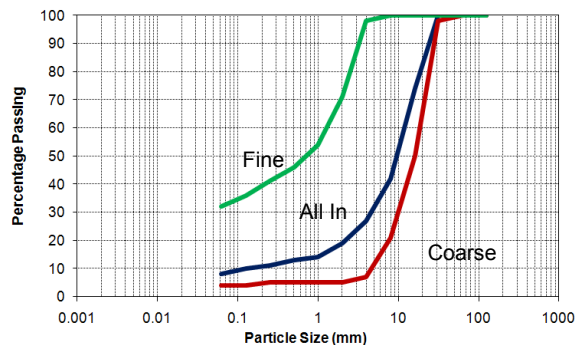
An extensive program of physical testing was undertaken on the aggregate for characterization purposes. Figure 3 presents particle size distribution curves for the test materials. The 'All in' material was well graded with 31% and 8%, respectively, passing the 5 mm and 63  $\mu$ m sieves. In addition, a wide range of physical testing was undertaken using both European and North American standards. These results are summarized in Table 2.

Figure 3. Particle size grading curves for test samples

The grading curves for the material used in Tests BY-D (Fine) and BY-E (Coarse) are shown along with the original as-sampled fill material (All-In) in Figure 3. The fill was compacted into each test cylinder in three equal lifts

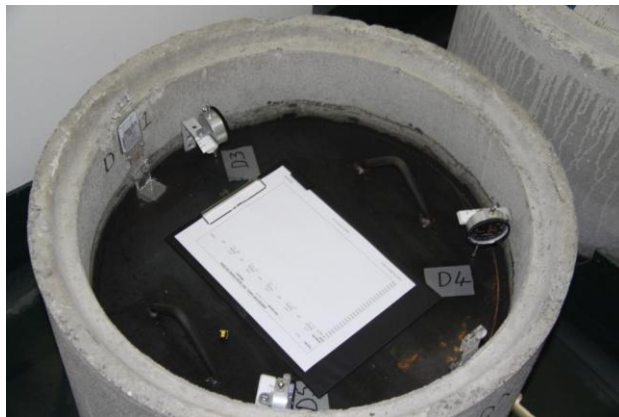
to achieve a final sample thickness of 300 mm using a pneumatic drill with plate tamper attachment. The surface was levelled and a heavy steel top plate installed. Two sets of measuring gauges were used to monitor any movement of the top plate. Initially two Avongard® corner tell-tale gauges were installed between the inside wall of the concrete pipe and the steel top plate. As these gauges can only be read to an accuracy of about 0.5 mm, they were used as back-up to the more accurate dial gauges. Three dial gauges, reading to an accuracy of 0.005 mm, were rigidly mounted on the concrete test cylinder wall with the point resting on the top plate. Table 4 summarizes the condition of the test materials at the start of the test. A photograph of the gauges in place at the start of test is shown in Figure 4.

Figure 4. Monitoring gauges in place at start of test

The three dial gauges were not installed until two weeks after the start of the test to allow sufficient time for hydration affects to take place.

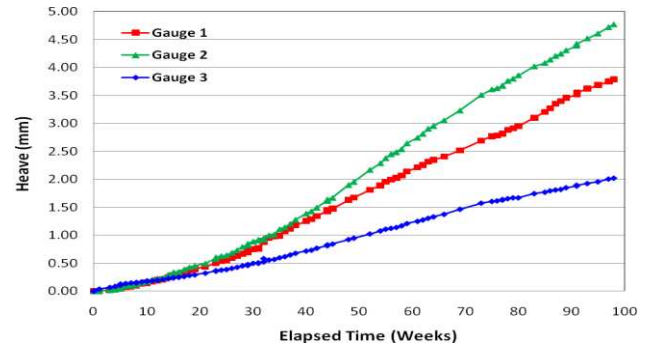
The plots for the measured dial gauge movement for Test BY-C are shown in Figure 5. The results show some

minor tilting of the top plate and suggest some non-uniformity in heave over the area of the sample. The plot also confirms some changes in rate of heave between the three gauges. It is not surprising that the heave is non-uniform and this explains the extensive cracking patterns observed in ground-supported floor slabs due to pyrite-induced heave.

Figure 5. Heave plots for Test BY-C

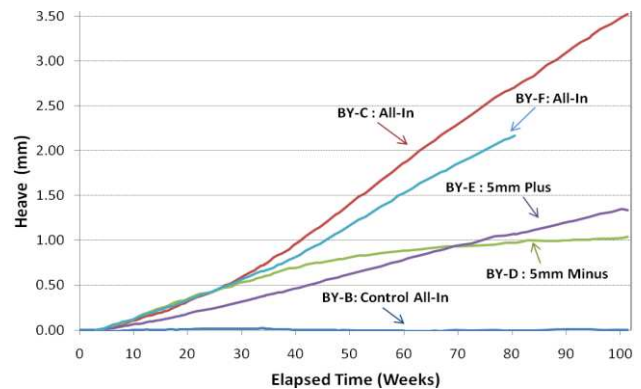
The results of the monitoring of the upward movement of the top plate in all five tests are shown in Figure 6. The line plotted for each test is the average movement for the three dial gauges on that test.

Figure 6. Average heave for all five tests

The heave plots in Figure 6 demonstrate that the changes in average rate of heave are quite smooth. The two-week cycling of the water in the trough had no noticeable impact on the shape of the trendlines.

Table 5 summarizes the total cumulative upward movement after 52 and 100 weeks for the tests. Test BY-F was terminated after 80 weeks. No measurable

movement was detected for the limestone control test sample. The two duplicate tests on the all-in mudstone material show generally similar heave results. The higher magnitude of heave in BY-C compared to BY-F may be as a result of the higher bulk density in the fill in that test. Both the fines and coarse fractions show significantly lower total heave when compared to the all-in samples. In the case of the fines (Test BY-D) the initial rate of heave was quite fast but by about Week 50 the rate of heave decreased and by Week 100 heave had almost ceased. This is also consistent with the expectation that pyrite contained in fine-grained aggregate is more readily accessible and so oxidizes faster. Thus the fines component is the fast reactor in terms of the time for initial damage to occur. By contrast the coarse component (BY-E) had a slower initial rate of heave. By about Week 70 it had surpassed the heave of the fines. This is also consistent with the expectation that more time is needed for the pyrite to oxidize within the coarse fraction. In addition, the coarse fraction would have a higher voids content which would accommodate some of the gypsum that forms on exterior particle surfaces. In considering the magnitude of heave summarized in Table 5, it should be borne in mind that when the tests were initiated, the aggregate was already five years old and had already caused significant structural damage to a building prior to removal. In other words, a considerable amount of the original pyrite had already oxidized.

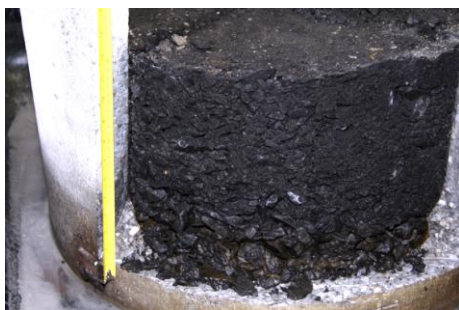
At Week 80 the BY-F test was discontinued and the test dismantled. Initially, a segment of the concrete pipe wall was cut out to reveal the profile of the compacted fill. A clear change in the appearance of the fill was noted in the form of a higher fines content and visible reduction in the middle sized particles, as shown in Figure 7. Gypsum was observed on freshly opened laminations of the coarser particles. Much of the samples comprised wet fine material, which crumbled easily between the fingers and left a sticky black clayey residue. Some minor amounts of coarser more competent calcite-rich particles were present.

Figure 7. Exposed condition of aggregate after removal of section of test cylinder

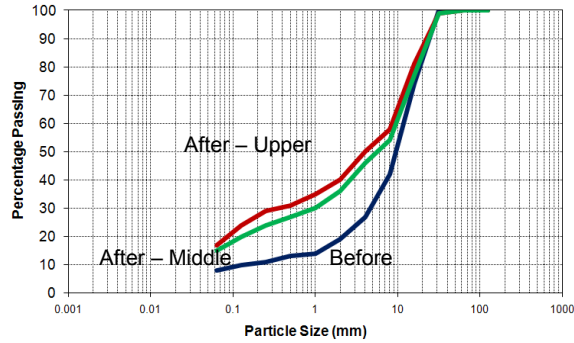
The results of limited physical testing on the two bulk samples recovered from the test after 80 weeks are summarized in Table 7. They are compared to the average test results for the testing on the material at the start of the test given in Table 2. The grading curves for the two recovered bulk samples are shown in Figure 8 along with the grading curve for the material at the start of the test.

Figure 8. Comparison of All-in grading curves before and after swell test

Given the limited amount of testing it is difficult to confirm any definitive trends. However, there appears to be a dramatic increase in the liquid limit for the lower sample which would be consistent with the degradation of the clay components in the mudstone. The grading analyses also suggest some differences before and after with a significant increase in the particles finer than about 10 mm. The extent of the change in grading was similar for both the upper and lower samples despite the variation in the extent of pyrite oxidation with depth.
