Assessing the integrity of subsurface drainage system using Deflectograph residual life data

Morteza Zohrabi

2 CASE STUDIES

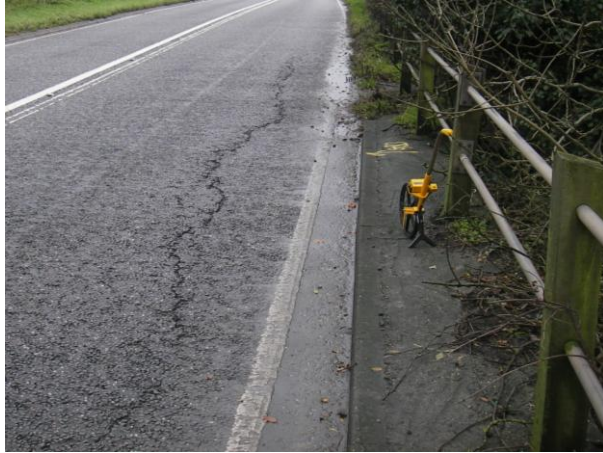
Figure 1. Wheeltrack cracking through a section of the scheme

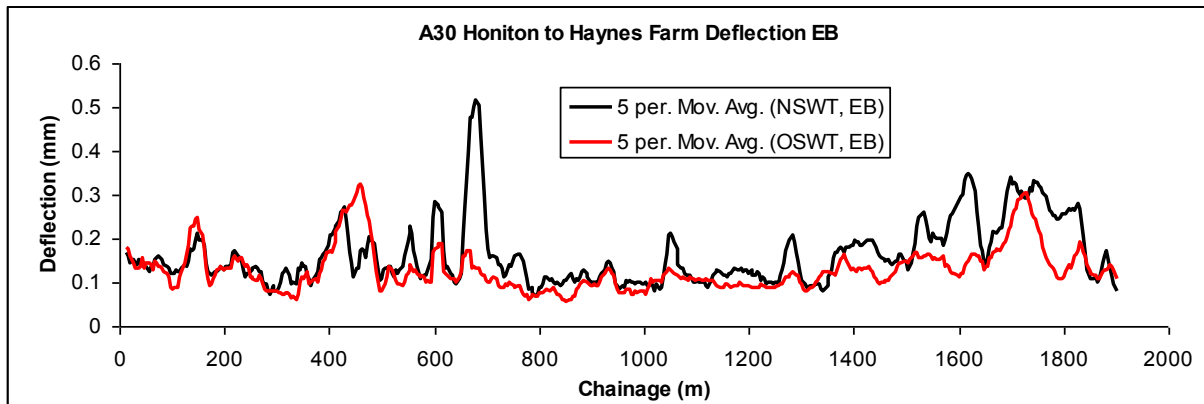
Chainage 600 to 800 and 1400 to 1800 EB: There is a marked increase in the NSWT deflections compared to OSWT ones. Drainage investigation shows that no drains are present in the same precise locations. This can mean that water is somehow flowing over the carriageway which has gradually reached the foundation, thus weakening the pavement along the haunches, possibly by soaking into the edge, where it is un-kerbed and possibly damaged.

Figure 2. Deflection profiles for NSWT and OSWT in the EB direction

The Deflectograph profiles show that in a number of locations the NSWT deflections are higher than the OSWT deflections.

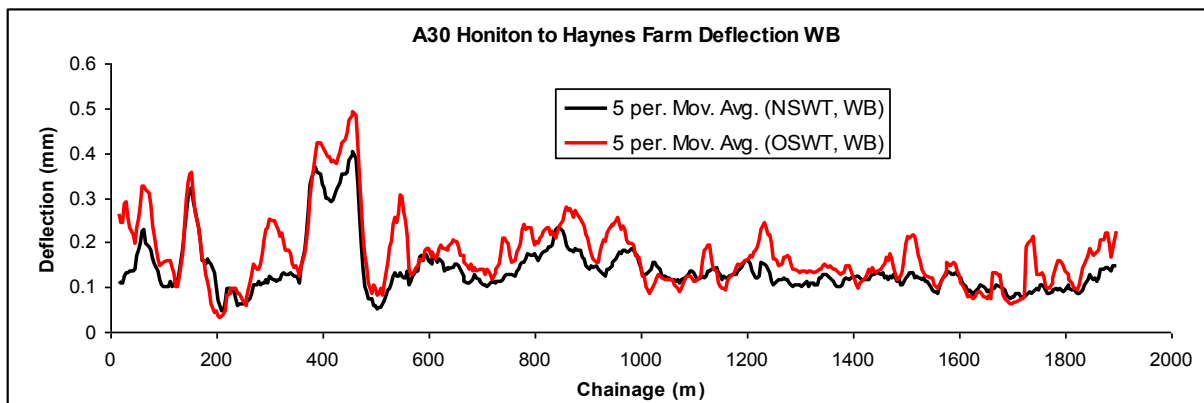
On the other hand, the WB carriageway shows strong NS foundation, meaning that drains are not leaking.

Figure 3. Deflection profiles for NSWT and OSWT in the WB direction

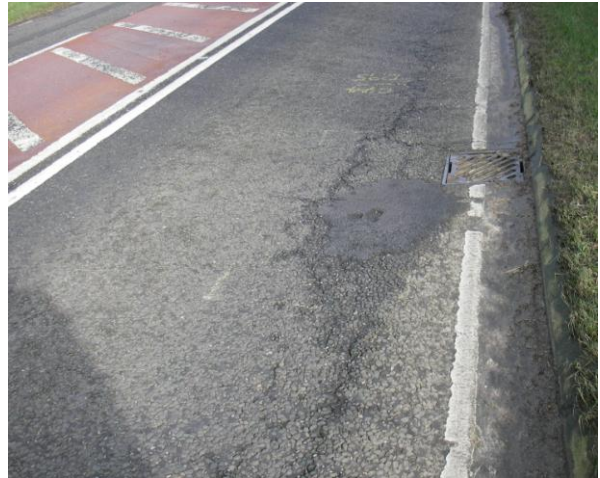
This 1.6km pavement scheme is situated along the same road as the case study 1, which is a rural single carriageway with a 50mph limit. The road width is standard (7.3m). The main driver for this scheme is the extensive longitudinal (alligator) cracking along the nearside wheeltrack, as illustrated in the following visual plans. The secondary driver for this scheme includes poor drainage with water ponding on the carriageway during prolonged periods of rain.

Figure 4. Wheeltrack cracking through a section of the scheme

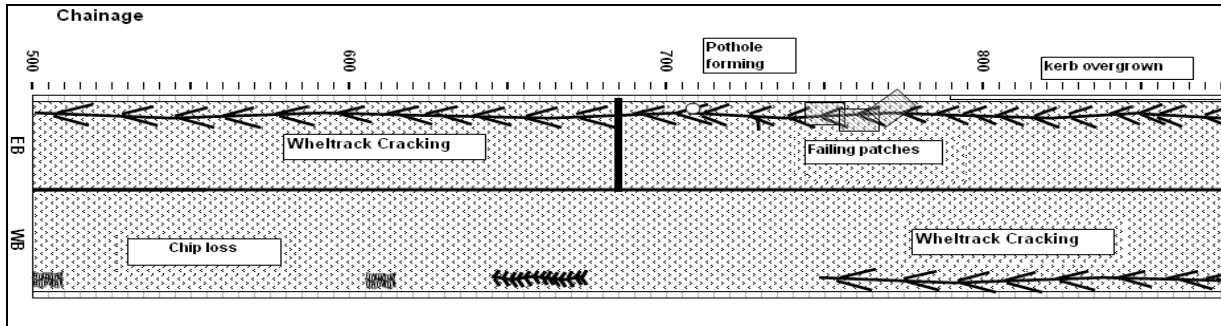
Figure 5. Schematics of the surface defects on A30 Rawridge Hill to Devonshire House (ch. 500 – 850m)

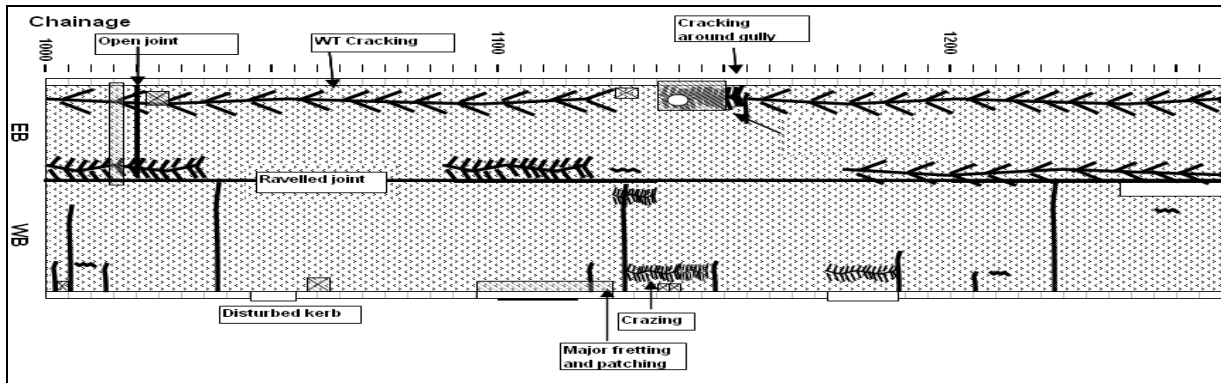
Figure 6. Schematics of the surface defects on A30 Rawridge Hill to Devonshire House (ch. 1000 – 1250M)

In comparison, the WB carriageway shows higher deflection on the OSWT in comparison to the NSWT. This can be seen by the joint cracking on the centreline of the road (see the visual survey illustration given previously for chainage 1000 to 1200m). This trend is similar to that found in the first case study where water entering through the centreline cracks has weakened the foundation of the OSWT in the WB carriageway.

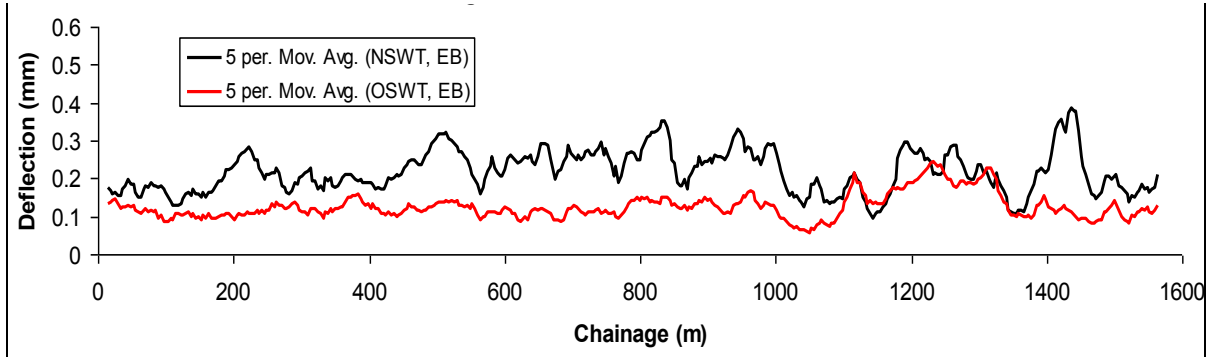
The deflection profile on the NSWT shows a similar response in the pavement foundation between areas where there is no drainage system but there is surface cracking and areas where there is drainage but the drain pipes have collapsed/broken. Both cases allow water to enter the foundation, resulting in higher deflections on the NSWT in comparison to OSWT. This appears to be the case in both EB and WB directions.

It is worth noting that where the wheeltrack cracking has occurred in both the NSWT and OSWT of the EB (i.e. chainage 1100 to 1350m of the EB carriageway), the deflection profiles converge to a value similar to that in the rest of the NSWT where there foundation has softened.

Figure 7. Deflection profiles for NSW and OSWT on A30 Rawridge Hill to Devonshire House in the EB direction

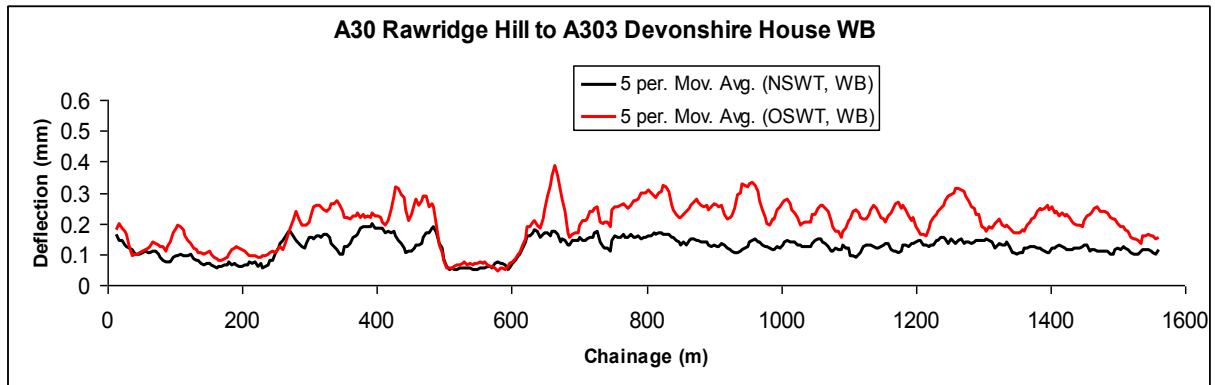
Figure 8. Deflection profiles for NSW and OSWT on A30 Rawridge Hill to A303 Devonshire House WB

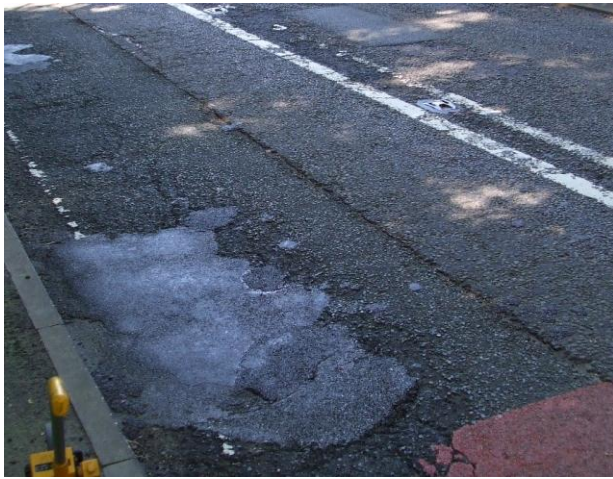
Figure 9. Localised failure and cracking through a section of the scheme

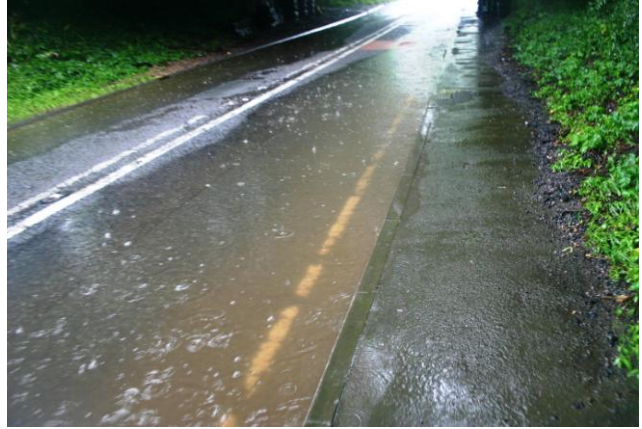
Figure 10. Flooding of the road through the defective area within the scheme

Visual survey has shown that during heavy rain, water tends to flow on the nswt for a great deal of the scheme length. However, wheeltrack cracking defects are only localised to certain locations.

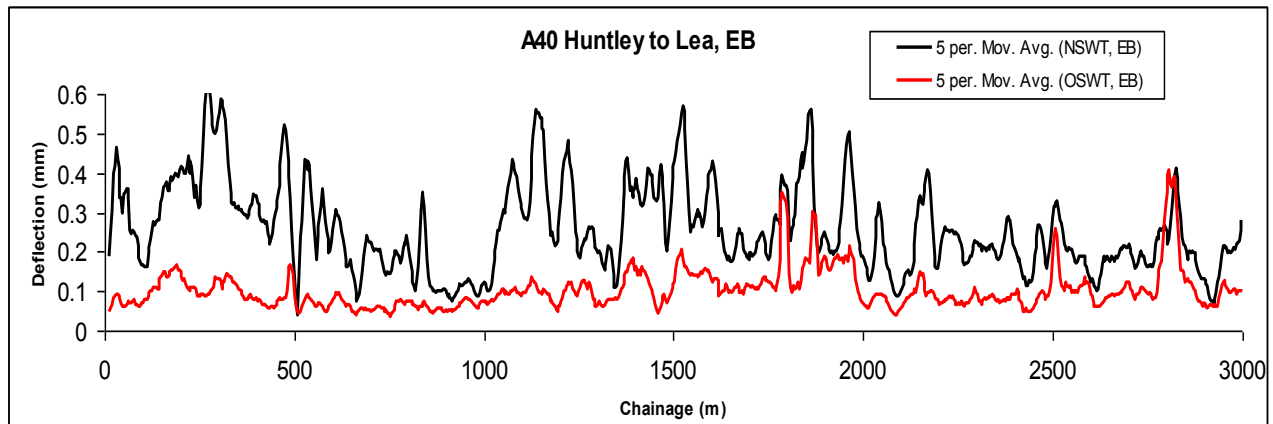
Profiles of the deflection values indicate a very weak foundation for the NSWT for the majority of the scheme length in both directions. This can be expected given the amount of ponding on the pavement, wheeltrack cracking and softened verges as a result of water runoff. There was a known drainage scheme at Boxbush (located between chainage 1712 and 1900m) which caused major flooding of the carriageway. The carrier drain had reduced capacity due to excessive silting, causing the water to flow over the carriageway. Hence, the NSWT deflection is at its peak value at chainage 1900m on the WB direction. The same trend is also evident on the EB direction.

Figure 11. Deflection profiles for NSWT and OSWT on A40 Huntley to Lea in the EB direction

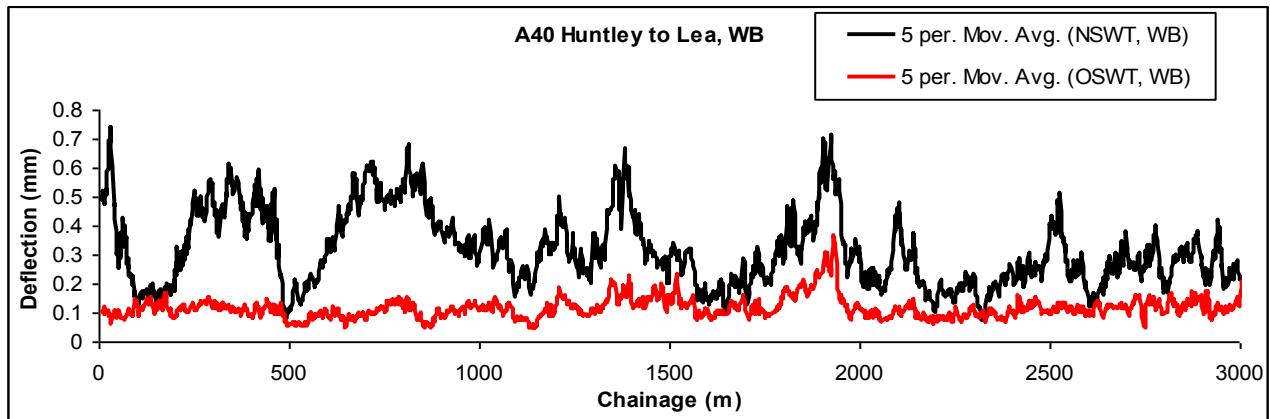
Figure 12. Deflection profiles for NSW and OSWT on A40 Huntley to Lea in the WB direction
