Fulton street transit center – foundation design and construction in a dense urban environment

Joseph Appleby & Craig Covil
Arup, New York, NY, USA
Uday Durg & Hsin Wu
Metropolitan Transportation Authority Capital Construction, NY, USA
Michael Deutscher
Formerly Arup, New York, NY, USA

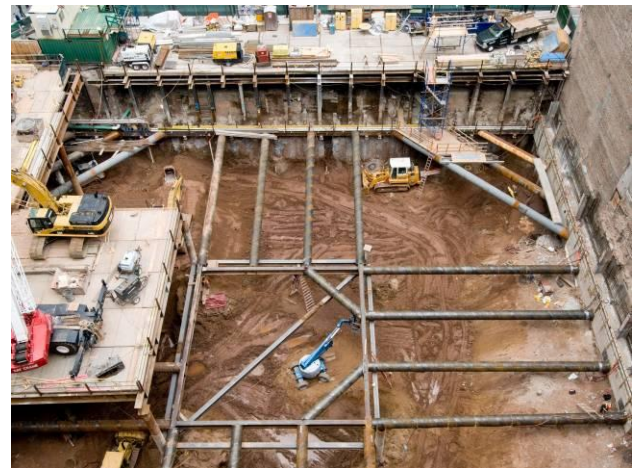
Figure 6. Aerial view of the Transit Center site, October 2009 (facing north from the Corbin Building).

Once the secant piles had been completed, the capping beam was constructed and the temporary bracing system installed. Skanska decided to install a single layer of bracing, supported on four pipe piles drilled to rock in the center of the site, and relying on the additional stiffness provided by the capping beam to ensure that the movements were kept within tolerance. The bracing system is shown in Figure 6.

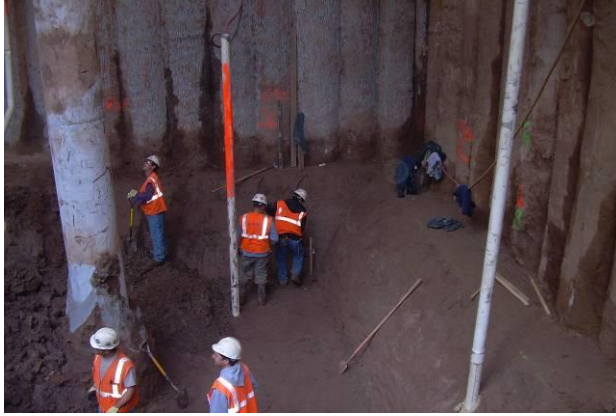
Figure 7. Excavation at full depth.

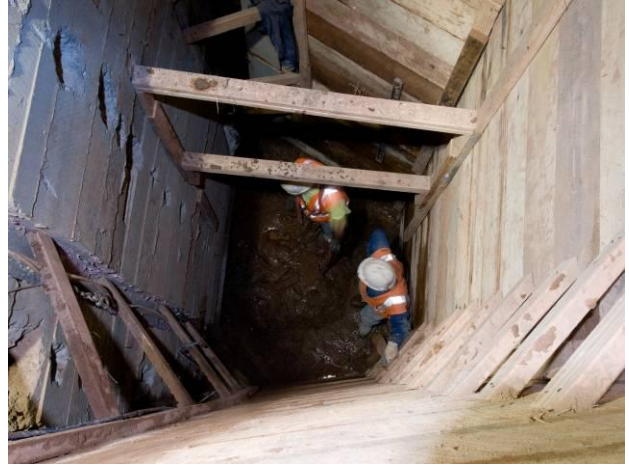
Figure 9. Hand excavated pit.

Once water tightness had been achieved, hand excavated pits were constructed and concrete underpinning piers were formed beneath the existing foundations. Thirty four pits were excavated, these were 5ft by 5ft and ranged from 10 to over 30ft deep, as shown in Figure 9. To reduce the likelihood of settlement, the
