# Stabilization of Alberta Highway Landslides using Pile Walls

Tarek S. Abdelaziz, Donald W. Proudfoot  
*Thurber Engineering Ltd., Edmonton, Alberta, Canada*  
Roger Skirrow  
*Alberta Transportation, Edmonton, Alberta, Canada*

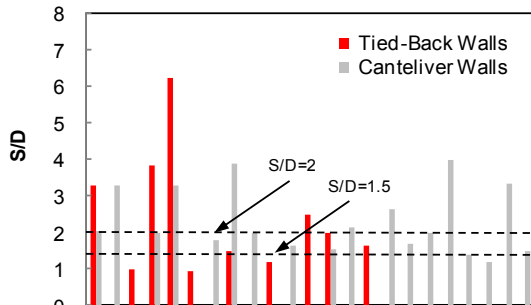
Figure 2. Distribution of S/D for pile walls

Figure 2 shows the distribution of S/D for all of the pile wall sites. The ratio typically varied between 1 for tangent piles and 4 for spaced piles, with average values of 1.5 and 2 for cantilever and tied-back walls, respectively. Figure 3 shows the distribution of  $L_b/H_u$  for all of the pile wall sites. The ratio varied from 0.7 to 4, with average values of 1 and 1.5 for cantilever and tied-back walls, respectively.

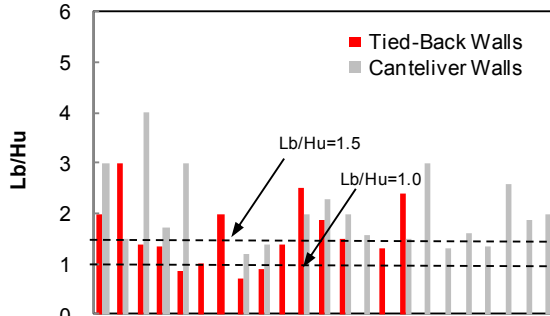
Figure 3. Distribution of  $L_b/H_u$  for pile walls

Table 1 lists pertinent information regarding twenty-eight pile walls used to stabilize active landslides in *Alberta*. Some of these sites were constructed a long time ago and complete records could not be located in the archived documents. However, available information was collected and summarized in the table for completeness. For each of the sites, the table presents the slide depth at the pile wall location, type of piles and anchors, number and diameter of piles, total length of pile wall, center-to-center pile spacing, and construction costs. The construction costs are for the entire project and have not been normalized to 2010 rates. The table also includes spacing (S) to pile diameter (D) ratio (i.e. S/D) and embedment depth below slide ( $L_b$ ) to slide depth ( $H_u$ ) ratio (i.e.  $L_b/H_u$ ).

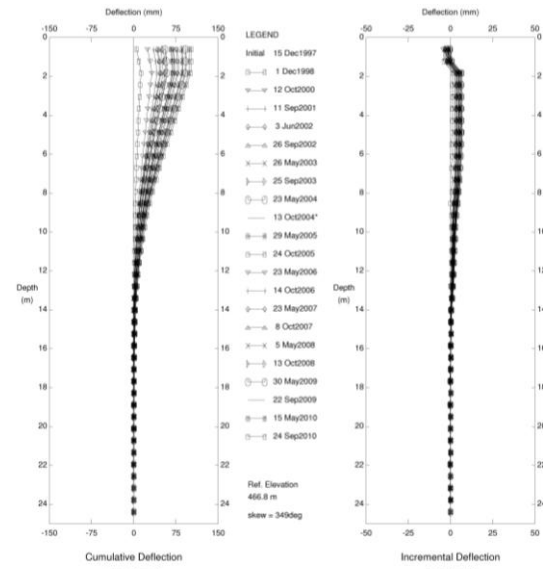
Figure 4. Incremental and cumulative deflection versus depth plots for the Meikle River upper wall.

Figure 4 presents an example of slope inclinometer plots for a cantilever pile wall. Plots of incremental and cumulative deflections from one of the slope inclinometers installed at Site 10, Meikle River upper wall, are shown in this figure. It should be noted that positive and negative deflections indicate downslope and upslope movements, respectively. The incremental deflection plot shows no distinct kink in the plot at the slip surface (10-12 m depth). This indicates that the pile wall successfully retained the slide mass without sacrificing the integrity of the wall. The cumulative plot indicated that the pile head has deflected downslope of the highway by about 100

mm between December 1997 (installation date) and September 2010 (i.e. wall moved at a rate of 6.6 mm/year) and that the lateral deflection occurred primarily between the top of the wall and 14 m depth (2-4 m below the location of the slip surface). The plots basically pointed out that the pile wall was embedded sufficiently into the stable stratum below the slip surface to develop the required resistance and stabilize the slide movement, and deflected by about 0.4 % of its height.

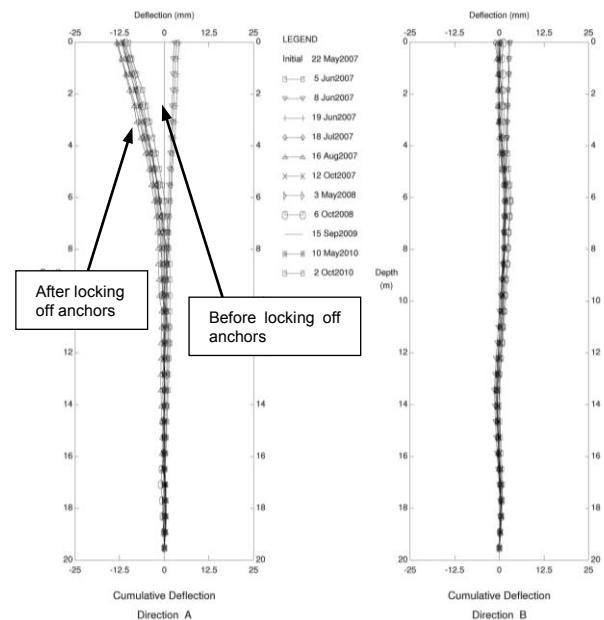
Figure 5. Incremental and cumulative deflection versus depth plots for the Lindbergh Hill wall

Figure 5 presents an example of the slope inclinometer plots for a tied-back pile wall. Plots of incremental and cumulative deflections from one of the slope inclinometers installed at Site 20, Lindbergh Hill

wall, are shown in this figure. At this site, the grouted anchors were locked-off one month after the installation of piles was completed. It can be seen from the cumulative deflection plot that the wall deflected a bit in the downslope direction prior to locking off the anchors (i.e. cantilever type pile wall behaviour). Immediately after locking-off the anchors, the pre-stress forces in the anchors pulled the wall into the upslope direction (towards the highway) by about 12.5 mm. Minimal movements were noted in the slope inclinometer after applying the pre-stress forces in the anchors. In this case, the slope inclinometers were very helpful during and after construction to capture slide movements prior to the locking off the anchors and monitor the effect of locking-off anchors on the overall behaviour of the wall.

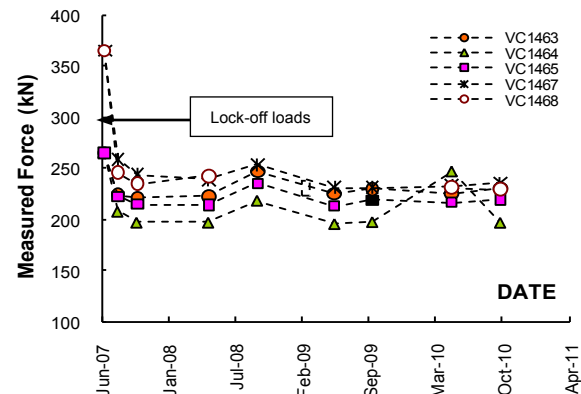
Figure 6. Variation of anchor loads with time for the Lindbergh Hill wall

Figure 6 shows the variation of anchor loads with time for the Lindbergh Hill pile wall. Although the anchor design loads dropped by 15 to 30 % one month after locking off the loads in 2007, the variation in loads afterwards remained negligible in the majority of monitored anchors and varied by 6 to 9%. The reduction in the anchor loads was probably due to the non-simultaneous locking of anchors and re-distribution of loads along the wall. No evidence of cracking other than reflective cracks was noted on highway surface and the site continued to perform satisfactorily.
