# Shallow slump stabilization using percussion soil nails at Hamelin creek site on Highway 725:02, Peace Region, AB

Renato Clementino, Robin Tweedie, & Harjeet Panesar  
*Thurber Engineering Ltd., Edmonton, Alberta, Canada*  
Roger Skirrow  
*Alberta Transportation, Edmonton, Alberta, Canada*

A precast concrete arch culvert was constructed to pass Hamelin Creek under the 24 m high embankment of Highway 725:02 in Northern Alberta. During construction in 2003, several slides occurred on the marginally stable valley slopes. Extensive mitigation works were constructed to stabilize the site, however deep seated slope creep movements continue on the northwest quadrant of the highway embankment subjecting the culvert structure to distress. Rapid downcutting of the streambed upstream of the culvert following construction has also resulted in shallow slumps along the toe of the northwest slope. There was concern that these slumps could retrogress and further destabilize the large deep seated slide. It was therefore necessary to improve the stability of these shallow slumps along the toe of the slope. The method chosen consisted of using "soil nails" to reinforce of the slide mass. The soi

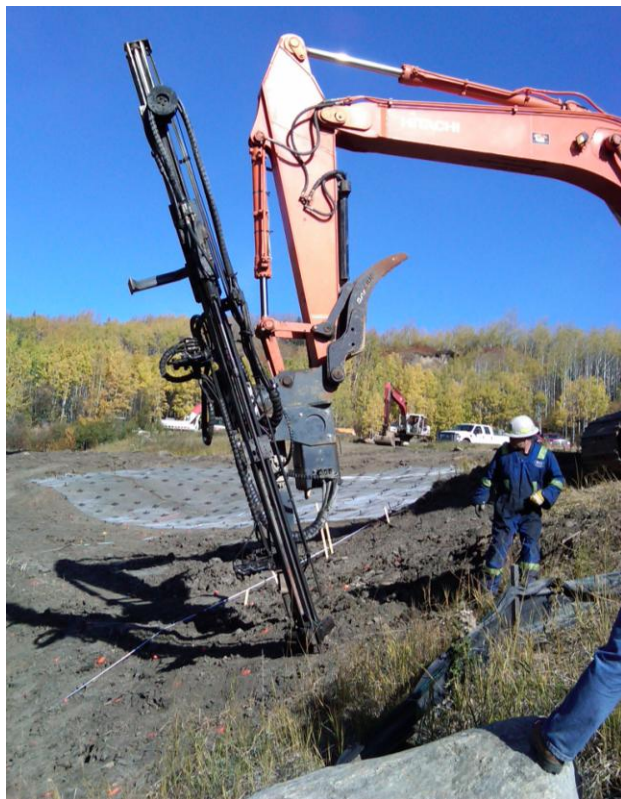
The percussion soil nails were installed by Beck Drilling Environmental Services Ltd. of Calgary, Alberta. The nails were installed using a track mounted excavation equipped with a rotary percussion drill that installed the nails by simultaneously rotating and hammering the nails into the ground as shown in Figure 5.

Figure 5. Percussion soil nail installation equipment.

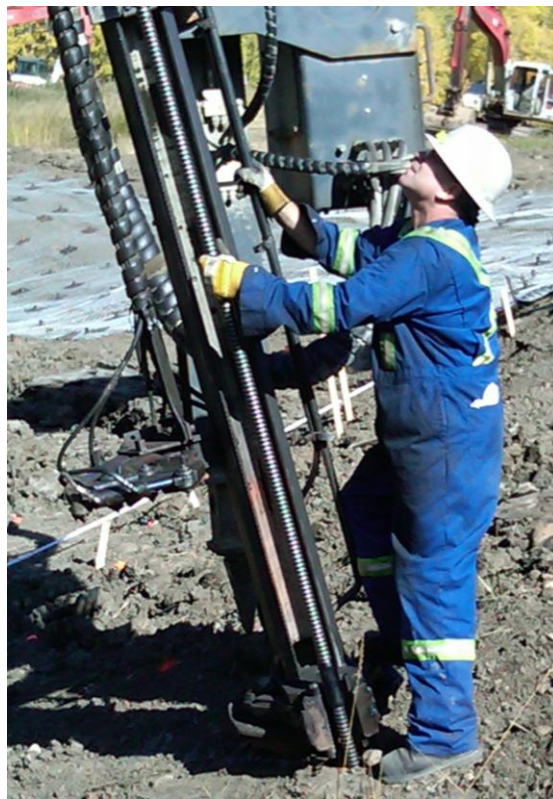
The soil nails consisted of threaded hollow steel bars (R38N) 38 mm outside diameter and 22 mm inside diameter with 250 MPa yield strength and axial capacity of approximately 500 kN. The bars came in 3 m lengths which were spliced with a 52 mm outside diameter threaded coupler to form the 6 m long nail as shown in Figure 6.

Figure 6. Splicing the second 3 m segment of the nail.

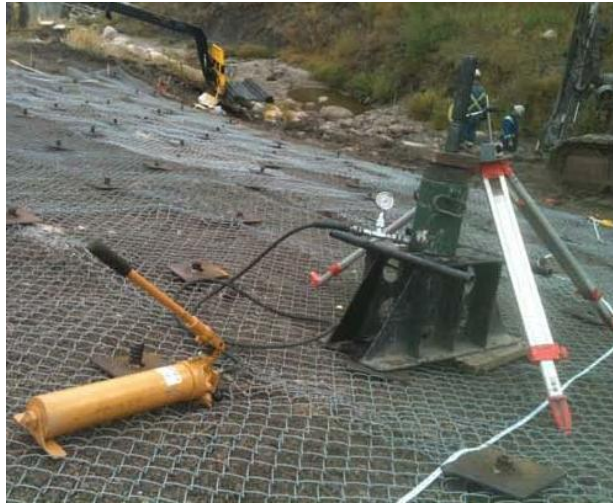
A hollow centre hydraulic jack (530 kN) was placed on a steel reaction beam as shown in Figure 7. The soil nail displacement was measured using a dial gauge (0.01 mm per division) placed on a 25 mm thick steel plate installed at the end of the jack.

An alignment load of 3.5 kN was applied to remove any slack from the loading frame and then the dial gauge was set to zero. The load was applied in stages of approximately 2.5 kN until failure.

Figure 7. Soil nail pullout test setup
