# Evaluation of sensitivity of the geotechnical parameters in the analysis of slope stability

Prof. Abraham Benarroch B. MSc., Eng. María Alejandra Hernández, Eng. Rafael Manzanilla  
*Universidad Metropolitana, Caracas, Distrito Capital, Venezuela*

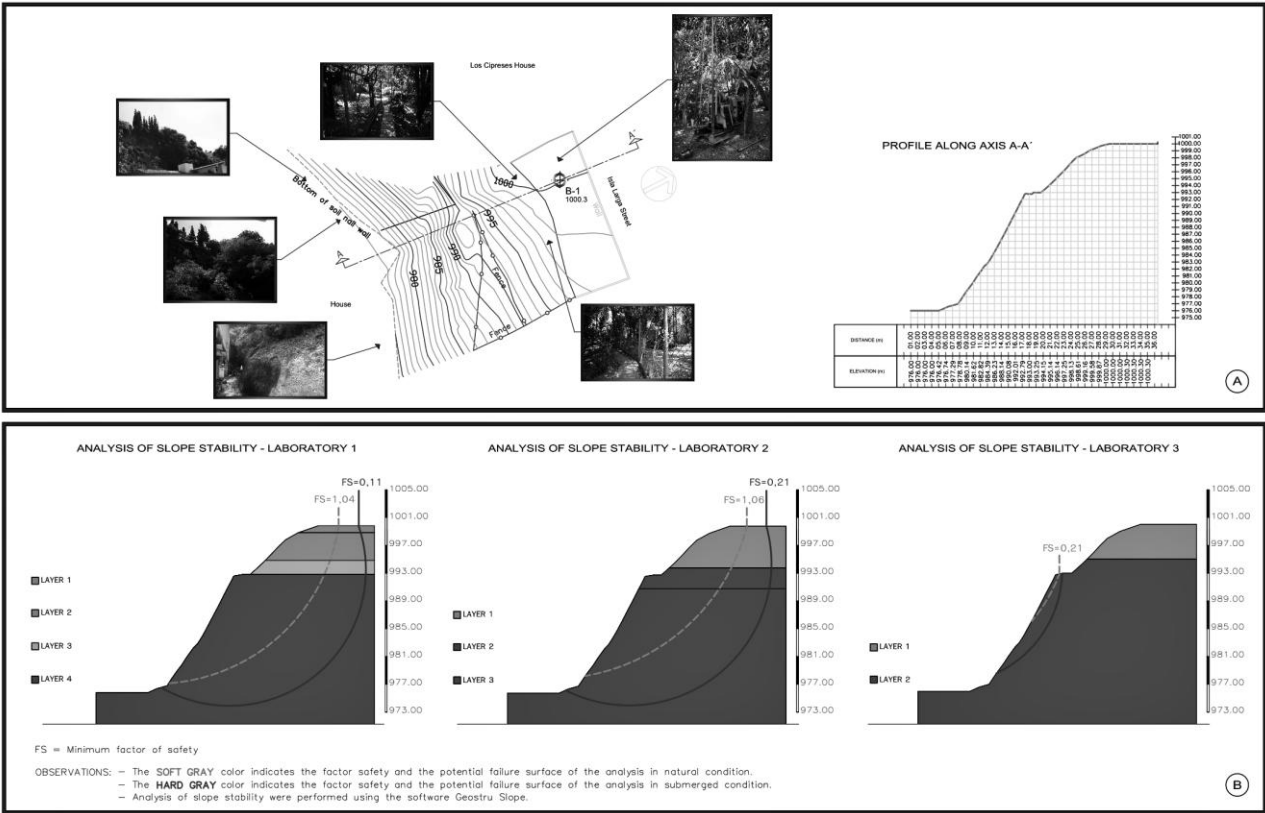
Figure 3. (A) Topographical survey, Profile along axis A-A' (B) Results of slope stability analysis

The stability analyses are reflected in Figure 3, as the topography and the profile along the axis A-A' of the area of study.

In the figure of the results of stability analysis, obtained with the software Geostru Slope, is the differentiation of the layers for each model to study that corresponds to reports of direct shear testing by each laboratory.

The layers were separated into 3 groups which are represented by the following colors: medium gray for the fill, light gray for sandy clay and dark gray for the weathered mica schist. The slip surfaces were placed in light gray with dotted line for analyses in natural condition and dark gray with continuous line for submerged condition.

With all the information of soil parameters of the study area, we proceed to use the obtained topography to create a soil profile along the axis A-A' (shown in Figure 3-A). It was selected the most unfavourable slope profile to obtain information on the profile of the worst.

First, in submerged condition resulted that all raised models were unstable, but the safety factors obtained do not have a significant difference between them, even though the cost to stabilize the slope with the results of Laboratory 1 and Laboratory 2 can be a considerable difference.

These results showed how the factor of safety obtained by the software's help Geostru Slope by the Modified Bishop method, according to data supplied by the Laboratory 2 was resulting in the higher safety factor 0.21, while with the Laboratory 1 report gives a factor of only 0.11. Moreover, note that the software for the results of laboratory 3 provided an error resulting in a safety factor out of range, so it could be assumed as a limitation of the software for the parameters used. Thus, it was decided to use another software of slope stability analysis to verify the values that would have the safety factor, with the results of Laboratory 3 in submerged condition.

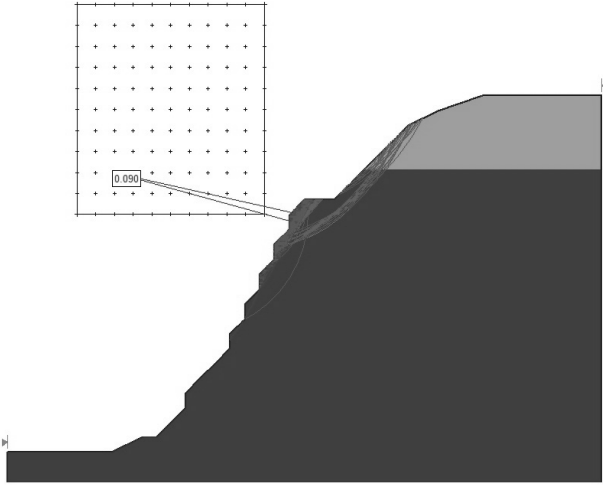
Figure 4. Result of slope stability analysis in submerged condition - Laboratory 3 (Using Rocscience Slide Software)

Using the software Rocscience Slide to check what safety factor would associate the software with the terms, we obtained the results as reflected in Figure 4, with a safety factor of 0.09, being this value the lowest of all.

It should be emphasized that the stability calculations were performed with the Software GeoStru Slope, which presented an error or deficiency analyzing the slope in submerged condition for the results of Laboratory 3; it showed a factor of safety out of range. This error could be visualized analyzing the slope, with the same data, but with RocScience Slide Software and obtaining a safety factor of 0.09, which is much more consistent for the data provided.

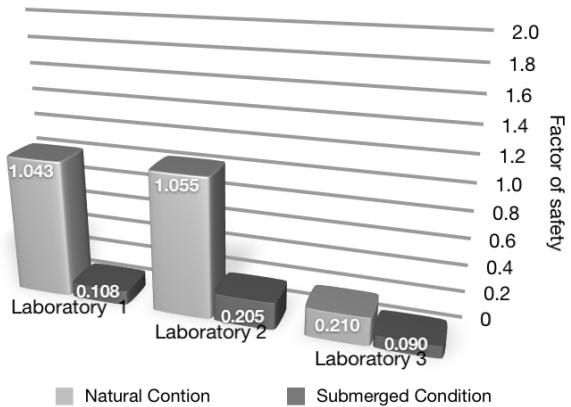
Figure 5. Comparison of the safety factors of each laboratory in both conditions.

If the results now are analyze in both conditions, arise graphs as shown below in Figure 5, and clearly indicates the significant difference between the assessment of slope stability of the natural condition and under the parameters established by the ASTM - 3080 in submerged condition.

The figure 5, presented above, shows how the factors of safety for laboratory vary with submerged and natural conditions in which the ordinate (y) represents the safety factor as the abscissa (x) represents each laboratory.

It is worth mentioning that the safety factor obtained from the geotechnical parameters provided by the Laboratory 2, even in submerged condition, this value is equal to that obtained under natural conditions for the Laboratory 3.

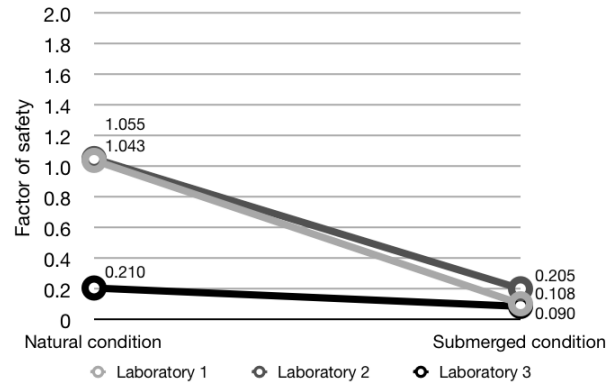
Figure 6. Trend of the safety factors of each laboratory in both conditions.

Also Figure 6 shows how with the results of each laboratory arise factors of safety so diverse.

In natural condition, all laboratories have angles of internal friction similar to each other in layers considered, but values of cohesion variables, being very similar for Laboratories 1 and 2, and radically different for the Laboratory 3. This discrepancy in the cohesion is directly reflected in the stability of the slope because the factors of safety associated with each laboratory report are easily influenced by this parameter. Then emphasizes the closeness between the factors of safety obtained by the results of Laboratories 1 and 2, and the vast distance between them and the factors obtained by the laboratory 3.

In submerged condition, obtained values converge a bit more than in natural condition, results in the stability analysis with the reports of the Laboratories 1 and 2 are quite similar. On the other hand, with the Laboratory 3 could not be established comparison because the Software GeoStru Slope did not show a value in this case. It may be mentioned that the Software has limitations in this regard. Presumably the factor of safety could be so small that the software can not report it. It can be stated because under natural conditions, this value was 0.21, and in submerged condition must be substantially lower.
