# Grouting Treatment Design in Foundation and Abutments of La Yesca Hydroelectric Project

López-Molina, J.A., Valencia-Quintanar, J.A. & Espinosa-Guillén, J.A.  
*Comisión Federal de Electricidad, México*  
*Department of Rock Mechanics and Grouting*

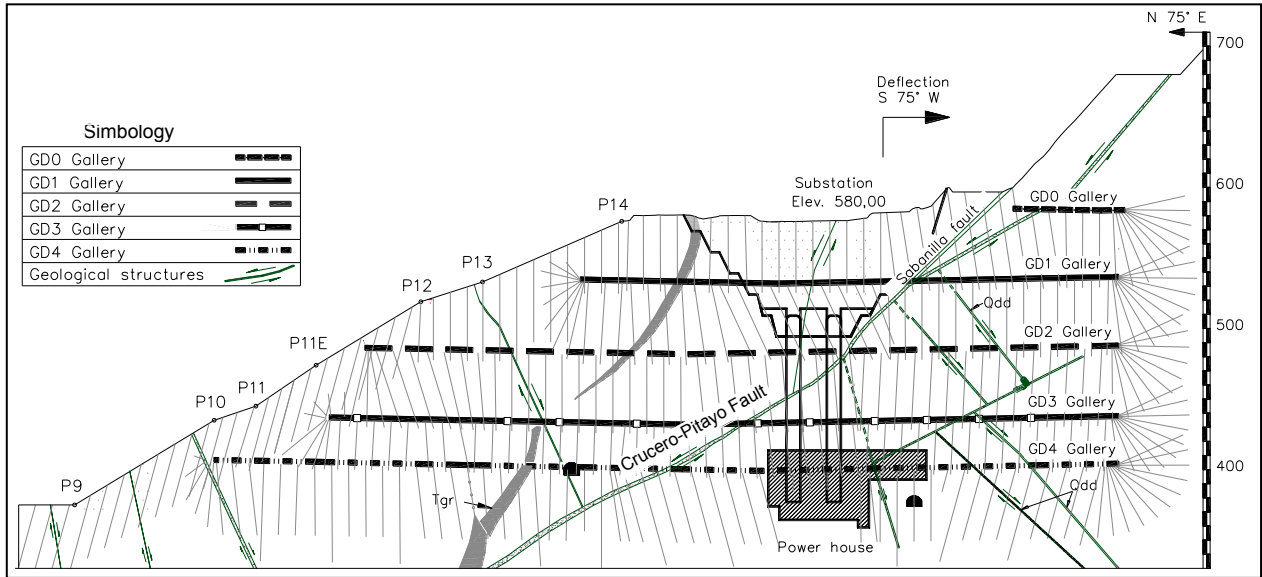
Figure 1. La Yesca right bank section through Plinth and galleries axis.

Rock near major geological structures is usually highly fractured and packed with clay, affectation thicknesses ranging from 1 to 10 meters. Many of these structures are oriented so that during the operation stage may represent seepage paths to underground structures or to embankment downstream (Figures 1 to 4).

Treatment from galleries includes a deep grout line and three lines of connection holes, which aim to give continuity to the grout curtain between galleries. Vertical separation between galleries is about 50 m; their length at right abutment was defined to protect the powerhouse from seepage; and for the left abutment grout curtain was extended to intersect main geological structures that could represent seepage pathways (Figures 1 to 4).

Remaining tests will be located on interest areas where seepage paths may arise or where erodible fractures during operation stage may involve fine migration and seepage increments (e.g. Vertedor Fault in left abutment and Crucero-Pitayo Fault in right abutment, see Figures 1 to 4).

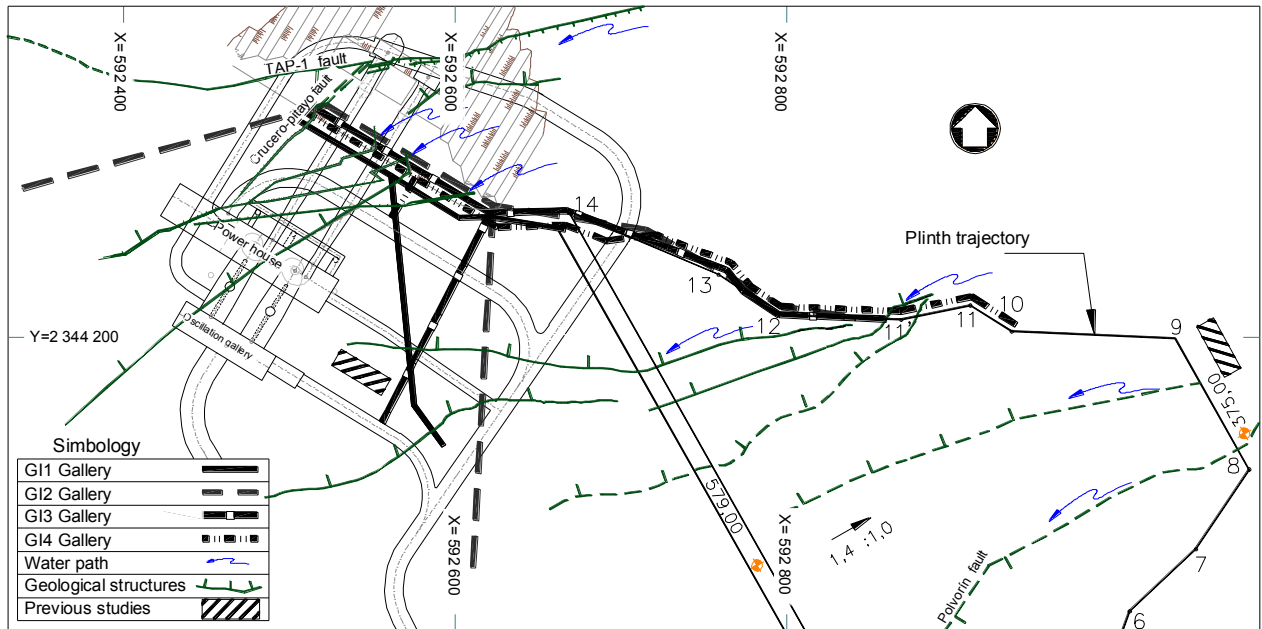
Figure 2. La Yesca right bank, Plinth and galleries trajectory, main geological structures and preferential seepage paths.

In order to determine the grout curtain characteristics, grouting parameters and implementation criteria, three test sites were studied to determine the rock mass hydraulic conductivity, critical pressure and groutability. The location of these sites is shown in Figures 2 and 4.

**Right abutment.** Tests were performed within an exploratory adit excavated in fair to poor quality rock with clay-filled fractures at elevation 412 (Figure 2). 40 m length boreholes were carried out to evaluate the groutability and permeability behaviour during split-spacing sequence with hole separations from 12 m to 1.5 m. Hydraulic conductivities under 3 Lugeon Units (LU) and 18 l/m average grout consumption were obtained.

**Central section.** Two test boreholes were performed at elevation 396. (Figure 2). Average grout consumption of 13 l/m was obtained and a zone affected by NW-SE fracture system resulted in consumptions over 200 l/m, however, due to its orientation and upstream dip, results were not considered adverse to ensure the section watertightness.

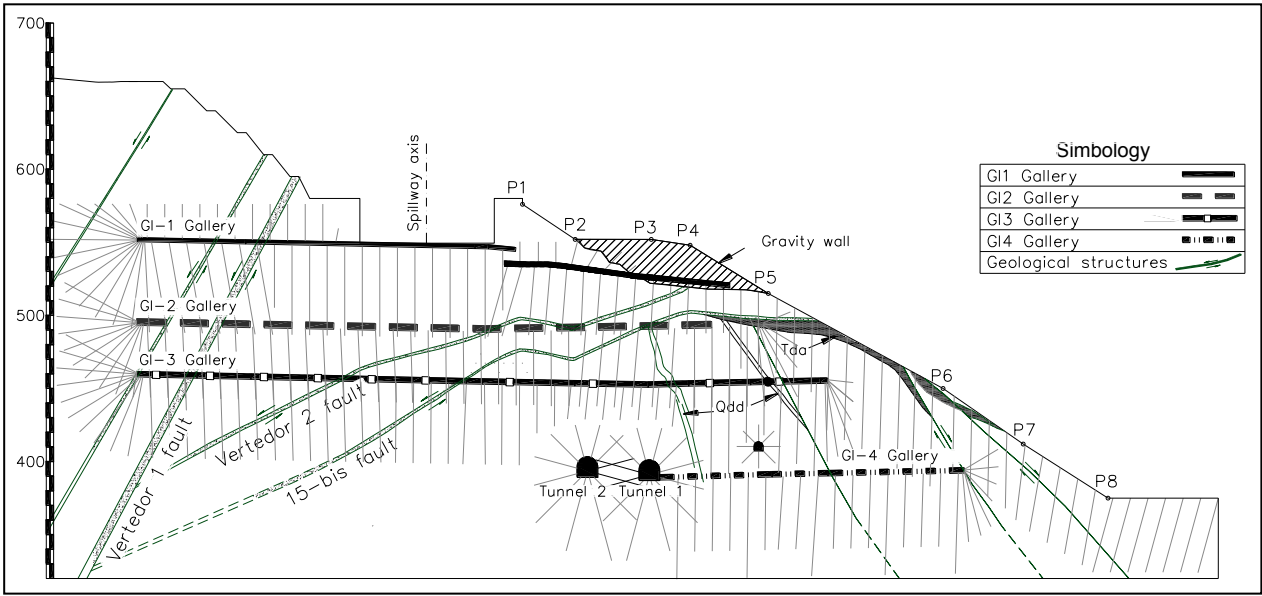
Figure 3. La Yesca left bank section through Plinth and galleries axis

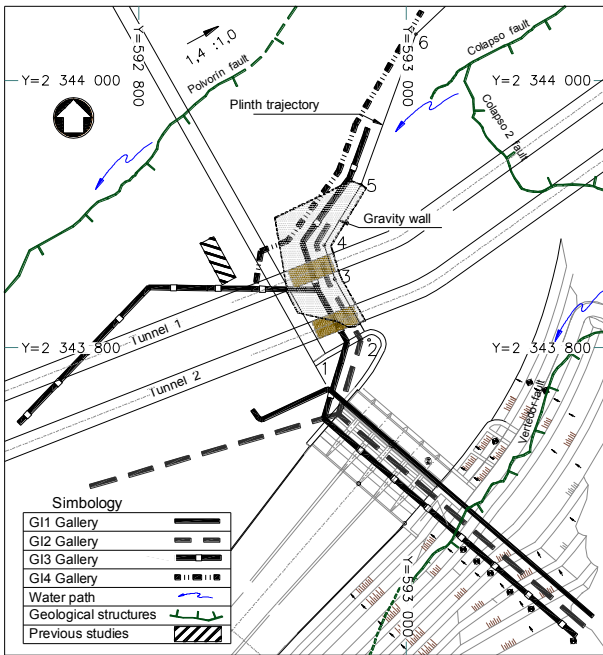
Figure 4. La Yesca left bank, Plinth and galleries trajectory, main geological structures and preferential seepage paths.

**Left abutment.** 50 m length boreholes were performed from an exploratory adit at elevation 455 (Figure 4) applying the same test methodology of right abutment. Average hydraulic conductivities about 10 LU, and maximum of 40 LU in intrusive rock contacts were obtained; average grout consumption was around 35 l/m. Applied pressures between 1.0 and 2.5 MPa during WPT and groutability tests, produced high conductivities and grout takes related to hydrofracturing, especially in rock-dyke contacts.

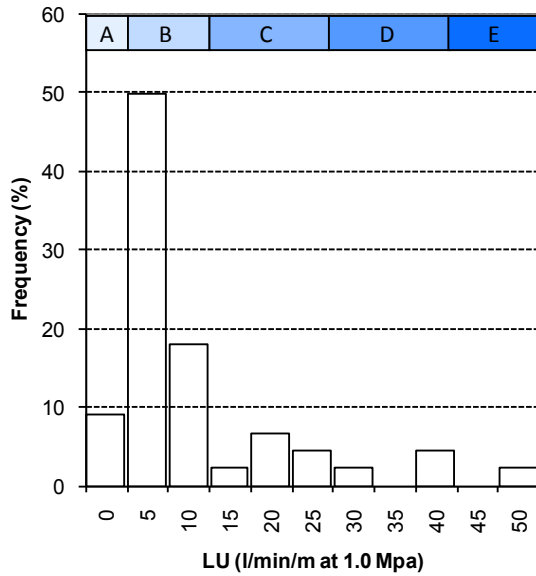
**Figure 5.** Hydraulic conductivity frequency in Lugeon units for three sites evaluated during studies. (A) Impermeable, (B) Slightly permeable, (C) Permeable, (D) Very permeable, (H) Highly permeable.

According to permeability results (Figure 5), was possible to define that grouting curtain extension should be governed by the presence of main faults and dykes, whose contacts were susceptible to erosion at lower pressures than those generated during dam operation. On the other hand, according to trial results, was established that rock mass general permeability not represent a risk for ensure the project watertightness, but due to rock heterogeneity, systematic exploration boreholes were adequate during construction stage.

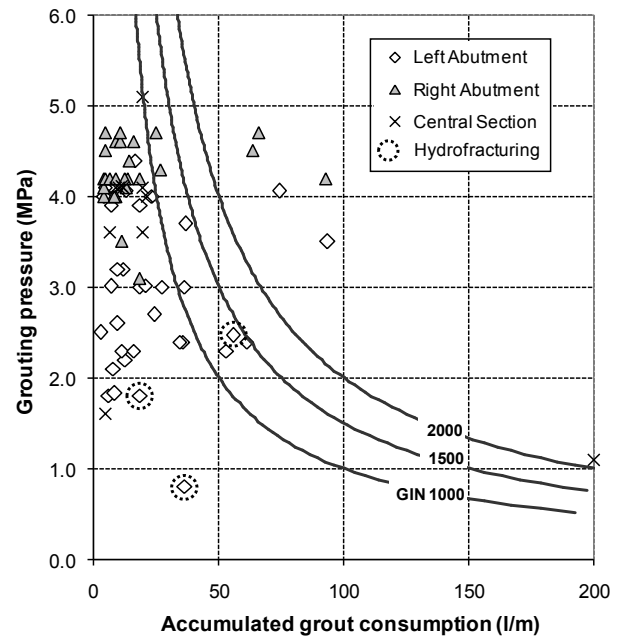
**Figure 6.** Previous studies groutability test data.

Groutability studies evidence the use of moderate grout intensity (GIN between 1000 and 1500 bar-l/m) to increase penetrability, considering the rock mass average competence to hold pressures about 4.0 MPa with grout consumption around 30 L/m (Figure 6).

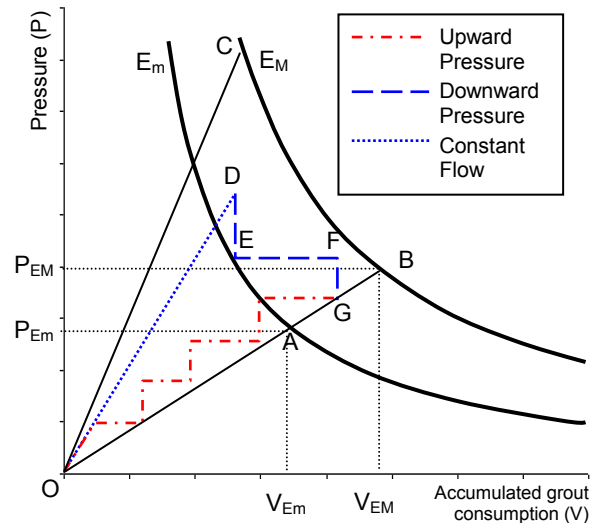
volume. Figure 7 illustrates a GIN diagram with diverse grout paths. This diagram shows a target point G where nil flow and acceptable energy value between  $E_m$  and  $E_M$  ( $\pm 10\%$  specified GIN for this project) are reached.

**Figure 7.** Grouting paths in GIN diagram (adapted from El Tani, 2009).

OG line represents a grouting path with nil flow and, therefore, infinite grouting time, on the other hand, OC path represents a grouting with the maximum possible flow.

GIN methodology in Mexico has antecedents in Aguamilpa (1994) and El Cajón (2007) projects, both located in Santiago River and built in igneous geology. In these projects the grouting process was carried out applied pressure increments up to reach a target flow and pressure (stepped path OG in Figure 7).

Currently the process was modified through automated grouting equipment, which allowed constant flow grouting (OD) and then a pressure-controlled second stage (DEFG) until reach target GIN with practically nil flow.

First procedure, stepped controlled pressure, provides adequate results to define precisely the rock critical pressure which generate unnecessary grout travels; however, grouting times required may be impractical during construction phase.

Constant flow procedure offers advantages related to grouting time, however, critical pressure and GIN value must be properly pre-defined, because during process is complicated to identify precisely the path position where hydrofracturing is generated.

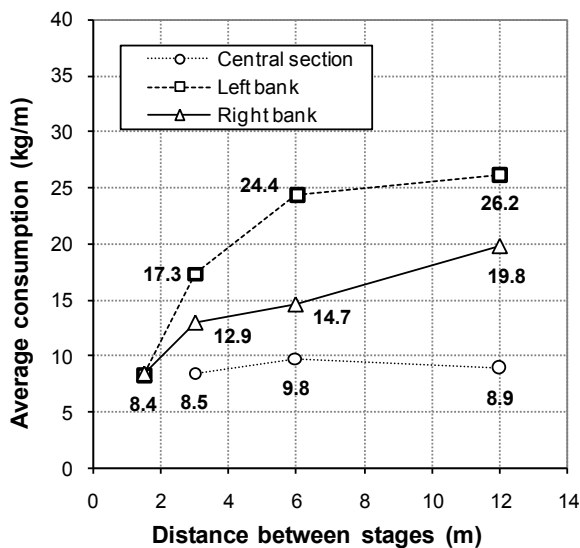
Figure 8. Average cement consumption from first to fourth stage holes (January 2011).

Successful progressive reduction ratios between grouting stages have been registered in whole project (Figure 8); grout take reductions between 6 and 50% have been obtained in left abutment; between 12 and 35% in right abutment; and around 10% in central section.

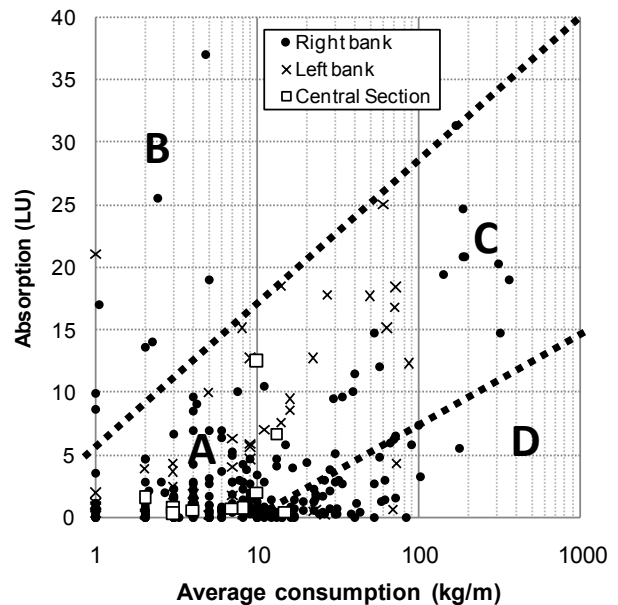
Figure 9 shows grout consumption against LU obtained during treatments execution in central section and abutments.

Figure 9. Grout consumption against absorption (adapted from Ewert, 1997).

“A” zone represents a low absorption and low consumption region, where the treatment efficiency is limited. The central section of the project presents this behaviour in great proportion, except for shallow areas (from surface to 10 m). To date 69% of grouted stages in whole project exhibits this behaviour.

“B” zone indicates the presence of tight fractures with high permeability and limited grout consumption due to the grout mix low penetrability; these cases were limited and are considered not representative of the rock mass general behaviour (3% of analyzed cases).

“C” zone of permeable and groutable rock features was mainly identified in project abutments below 400 m elevation. Grouting treatment in these areas was an effective measure to improve the rock conditions; which was confirmed through verification holes direct toward areas that showed average consumption over 100 l/m,

these verification holes showed grout takes, after quaternary holes, lesser than 20 l/m; nevertheless, sites with this behaviour represents only 8% of executed treatments.

“D” zone is represented by impermeable rock susceptible to hydrofracturing during grouting progress. Around 20% of treatment associated to hydrojacking phenomena have been identified, mainly in inferior galleries of left abutment, which did not cause excessive grout takes, however, reduction ratios between stages showed local anomalous results that have been solved with additional holes.

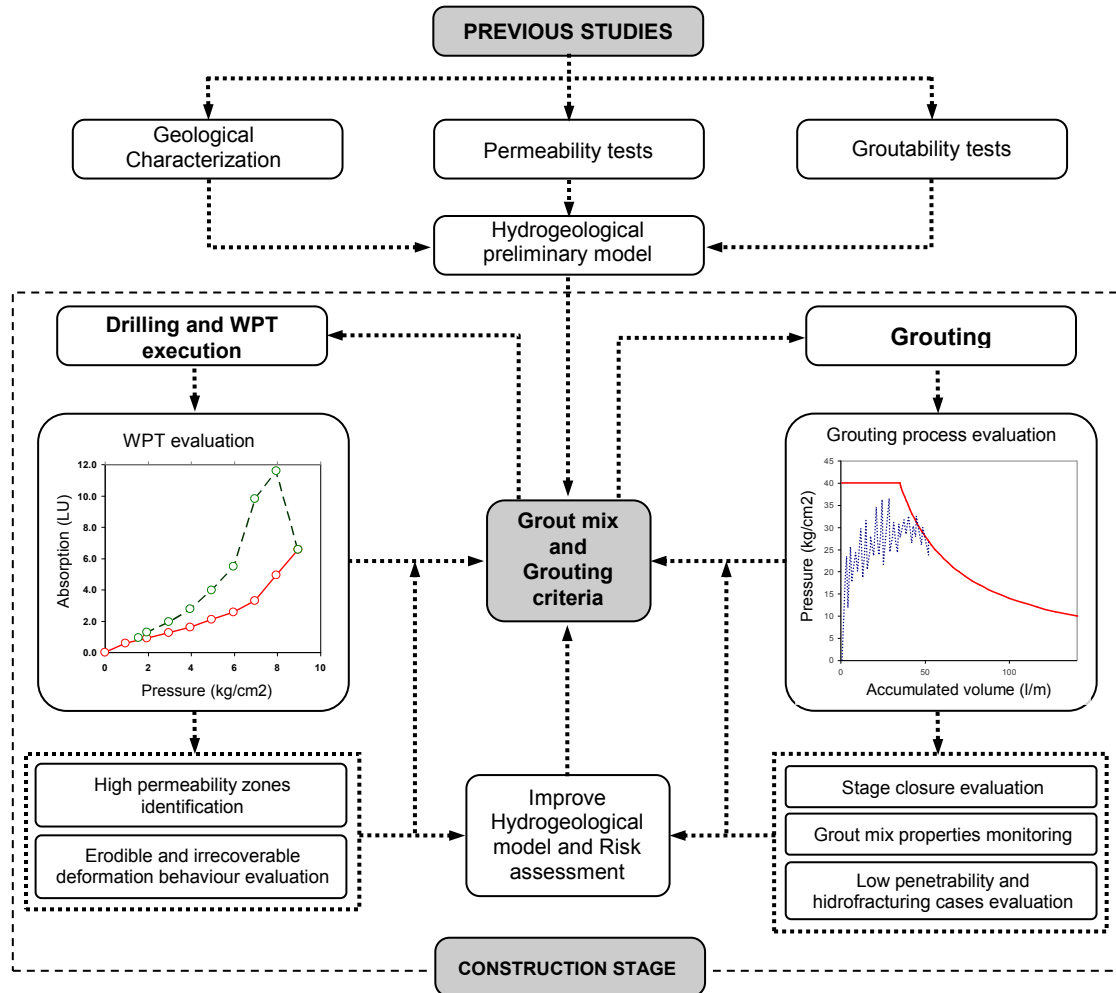
Figure 10. Grouting treatments design flowchart (adapted from Fransson *et al.*, 2008)

Based on previous experience related to grouting treatments in hydroelectric projects, the observational design methodology illustrated in Figure 10 is actually used in La Yesca dam.

The information generated during previous studies stage, provides the initial criteria and grout mix suitable properties; however, the evaluation of grouting and permeability results during construction stage, provide feedback to the geohydrological and geotechnical model,

that together with experiences generated during the process, resulted in criteria modification for grouting procedures and grout mix properties.

During construction stage are evaluated: WPT results; behaviour of grouted segments and its correlation with geological conditions; behaviour of grout mix properties in different seasons and under different manufacturing conditions; grout consumption evolution between stages; evolution of maximum pressure reached; and eventualities related to hydrofracturing or hydrojacking phenomena that produce adverse results during grouting.
