# A physical model study on site condition effect on seismic performance of storage tanks

Ali Shafaat<sup>1</sup> and Abbas Ghaladarzadeh<sup>2</sup>

2011 Pan-Am CGS  
Geotechnical Conference

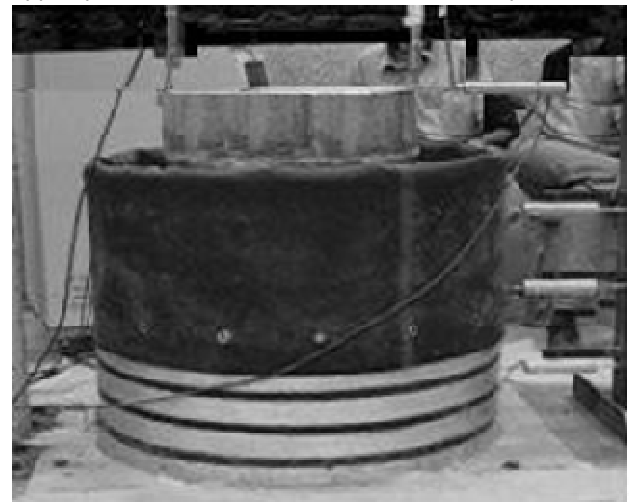
Figure 1. Instrumented model placed on the cylindrical storage laminated box

were 12mm in the prototype model, so they were both built in 0.1mm thicknesses. The tank was a cylindrical with 60cm diameter and 22cm height.

In order to reduce the side effect of the rigid walls of the soil box, a cylindrical laminated box designed for the experiment. The box was built of aluminum rings which had been separated by rubber straps. The laminated box was designed for both dry and saturated tests therefore, a rubber diaphragm was used to prevent water run out. The diameter of the cylinder is 100 cm and the height is adjustable due to numbers of rings and rubber straps. All the components are shown in the Figure 1. As shown in Figure 1, there are four aluminum rings below the rubber diaphragm which has extended above rings. The modeled storage tank is resting on the soil. All six linear

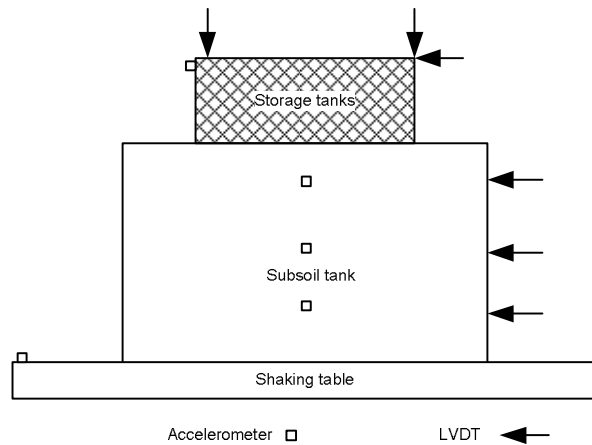
Figure 2. Instrumentation maps

variable differential transformers (LVDT) identical sensors -two vertical and four horizontal- are attached according to the instrument map given in Figure 2. The whole system is mounted on the shaking table deck.

As illustrated in Figure 2, the model and laminated box were instrumented. Since the test was dry, only two kinds of sensors were used: LVDT and accelerometer sensors. The data made it possible to measure different types of tank movement such as sliding, rocking and differential settlements. The laminated box movement and its interaction with the tank were also demonstrated.

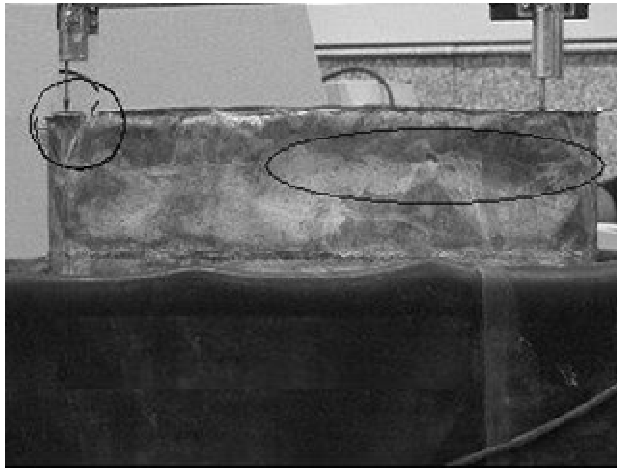
Figure 3. Diamond shape buckling in the first tank after 5<sup>th</sup> experiment.

For acceleration 0.1g to 0.2g no damage was observed. In the 0.3g acceleration, a slight slip occurred. In the 0.4g, diamond shape buckling was seen and repairing was required. In the fifth one (0.5g), the bulking spread on the wall of the tank. In the max acceleration (0.6g), diamond shape buckling established in which the storage tank needed serious repair. In Figure 3, the diamond shape damage is shown on the model tank which is on the laminated box.

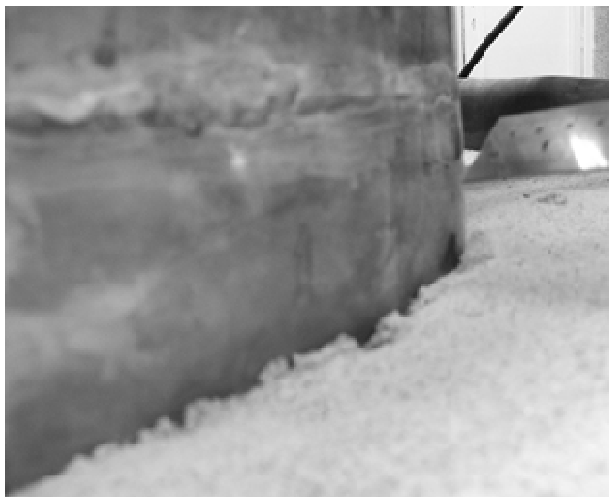
Figure 4. Slipping of the tank in the second experiment on the second tank.

No damage was observed in either the first or the second acceleration. In the third acceleration (0.3g), slight slip occurred. In the fourth acceleration, both diamond shape buckling and differential settlement happened. The fifth experiment made the settlement worse. The last acceleration caused significant settlement and spread

diamond shape buckling which made the tank useless. The slipping is shown in Figure 4.

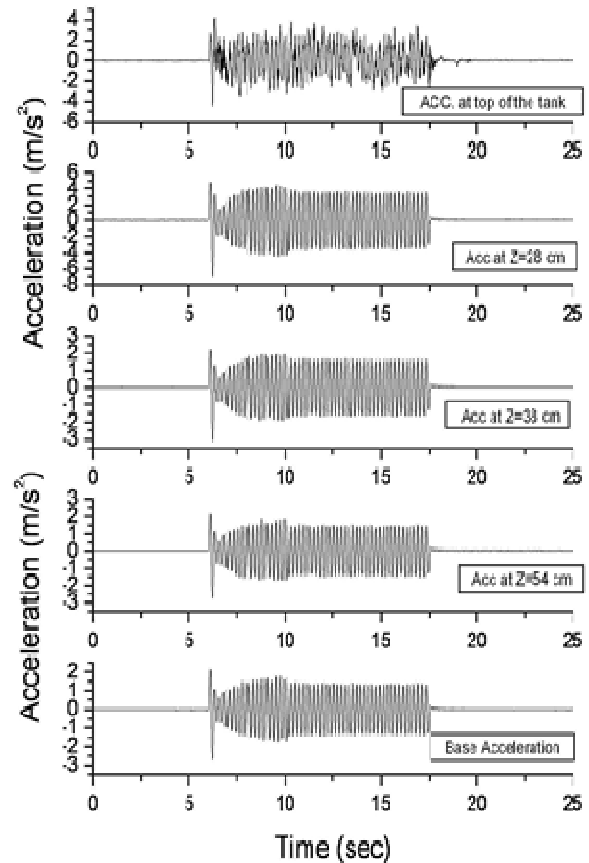
Figure 5. Records of accelerations in the second test on the second tank.

In Figure 5 records of accelerations in the second experiment on the first tank were plotted as an example.

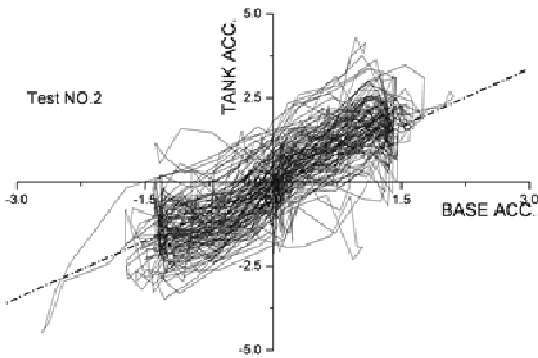
Figure 6. Acceleration at base versus acceleration on the tank in the second experiment on the second tank.

Figures 6 and 7 show results for the second experiment at base acceleration of.... Figure 6 shows the phase similarity between the acceleration at the shaking table deck and acceleration of the tank. As it can be seen, in lower accelerations the tank and deck have the same phases.

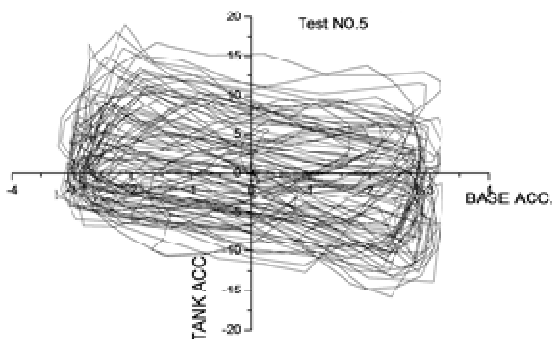
Figure 7. Acceleration at the base versus acceleration on the Tank in the fifth experiment on the second tank.

Figure 7 was plotted for the same accelerations but for a different experiment. It was the fifth experiment on the second tank and the frequency was higher and the waves had different phases. In other experiments in which sloshing occurred, same differences in phases were observed.

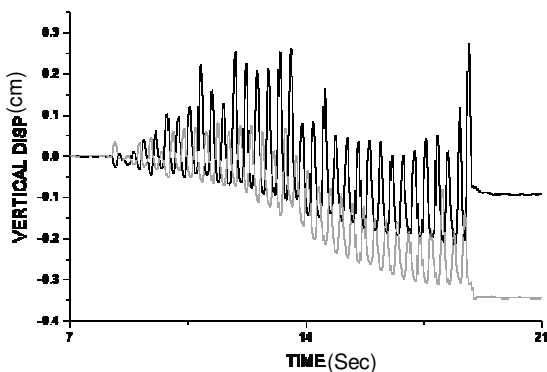
Figure 8. Vertical displacement versus time on the front of the tank (light line) and at the back of the tank (dark line) in the 5th experiment on the second tank.

In Figure 8, the vertical displacements of the two sides of the tanks are shown. The differences at the ends show differential settlement. They also show the uplifting of the tank during induced ground movement. These large displacements which also occurred during the experiment at both sides can cause problems with the connected piping system. In addition, accumulation of water in one side of the tank intensifies the problem of residual displacement.

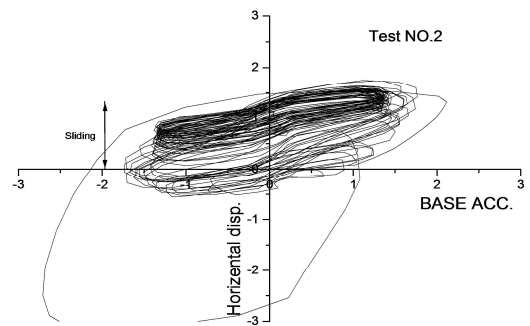
Figure 9. Base acceleration versus the tank horizontal displacement in the fourth experiment on the second tank.

In Figure 9, base acceleration against horizontal displacement of the tank is plotted. In lower accelerations the responses had the same phases, however in the higher accelerations, as can be seen in Figure 9, there were some phase lags. The results also show some tank slippage, as was previously shown in Figure 4. In higher accelerations a combination of slipping and differential settlement caused foundation problems.

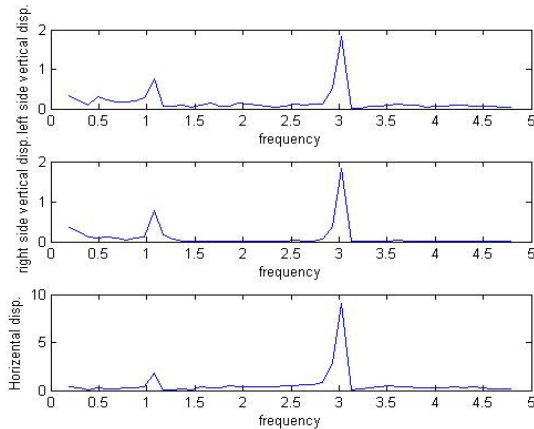
Figure 10. Fourier spectrum for fourth experiment on the first tank.

Both sloshing and impulsive movements of water have low frequencies. It has been shown in Figure 10 that there are two peaks, one for the induced movement around 3 Hz and another one around 1 Hz because of water movement. The Fourier spectrum has been plotted for the data which was produced in the fifth experiment on the first tank with the frequency of 3 Hz. There are two distinguished peaks which approximately happen at the frequencies of 3 Hz and 1 Hz. It would appear that the second peak is due to the water movement in the tank.

The Fourier spectrum has been plotted for the data which was produced in the fifth experiment on the first tank with the frequency of 3 Hz. There are two distinguished peaks which approximately happen at the frequencies of 3 Hz and 1 Hz. It would appear that the second peak is due to the water movement in the tank.

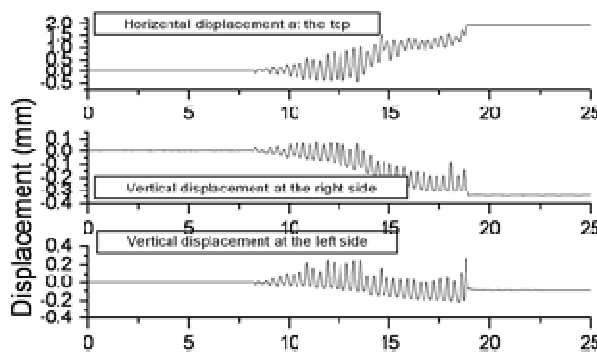
Figure 11. Horizontal and Vertical Displacements of the tank during the fourth experiment on the first tank.

All monitored settlements and slippages are shown in Figure 11 for the fourth experiment on the first tank with 0.4g acceleration. Both slipping and the differential settlement can be seen in this figure.
