# Jet Grouting for Mitigating Impact of Secant Pile Wall Installation in Close Proximity to Existing Building

Chu E. HO<sup>a,1</sup> and Aaron EVANS<sup>b,2</sup>

**Abstract.** Jet grouting was implemented to protect an existing building against the impact of adjacent secant pile wall installation located 2ft from the building edge. Sixteen vertical jet grout columns, 5ft in diameter and spaced at 47ins intervals, were installed at 1.5ft offset from the external face of the building to form a continuous grout wall to underpin the basement foundations. As the secant pile wall was located in close proximity to the row of underpinning jet grout columns, subsequent casing installation would be problematic having to drill through partially grouted and partially ungrouted soils. The unbalanced drilling would lead to significant pile deviation and cause damage to the completed underpinning jet grout columns. To overcome this, an additional row of jet grout columns was introduced along the secant pile wall line at the primary pile positions to provide full coverage of grouting for the drilling platform. A range of column diameters from 5 to 6.5ft was formed to ensure effective interlock

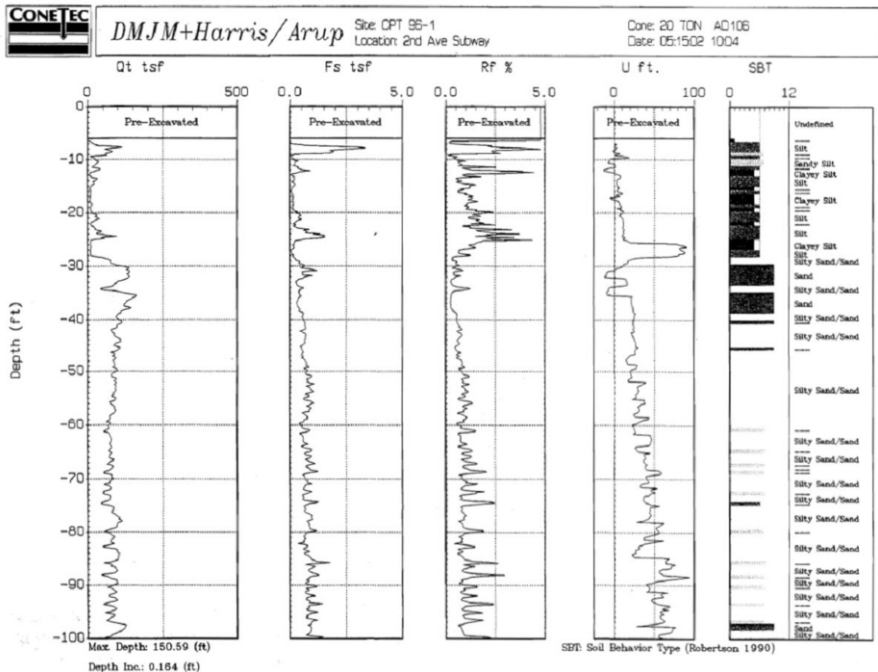
Ancillary 2 was located adjacent to a 4-story building. The ground surface was generally level at EL+111 to EL+112ft. The subsurface comprised fill, soft organics, loose to medium dense silty sands and highly sensitive glacial deposits of varved silt and clay that extended to depths greater than 120ft. Figure 1 shows typical soil conditions in the vicinity of the site based on cone penetration test CPT 96-1. As can be seen, the cone tip resistance ( $Q_t$ ) remained largely unchanged with depth, averaging about 80 to 100tsf below 30ft depth within the silty sands and varved silts/clays. Water table was about 10ft below ground.

**Figure 1.** Soil strength profile based on CPT 96-1.

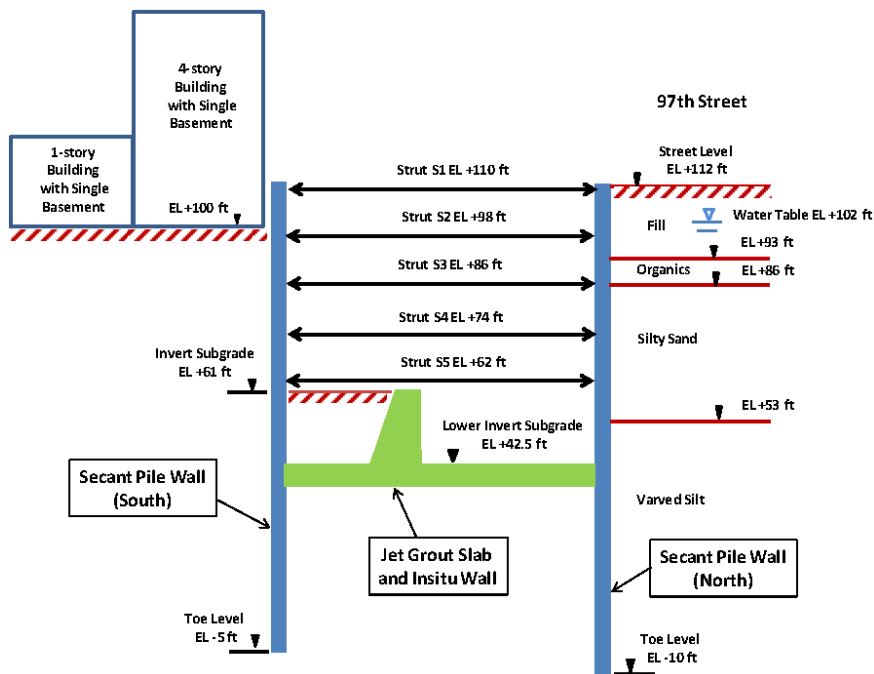
Figure 2 shows the excavation support scheme at Ancillary 2. The secant pile wall consisted of overlapping drilled shafts 34.5ins in diameter and spaced 23.5ft apart. Primary piles were cast with 1000psi plain concrete, whereas secondary piles were cast with 4000psi concrete with a W18x258 lbs/ft structural steel core beam installed at their centers. All primary piles were constructed to EL+27ft (85ft depth). The secondary piles were constructed to between EL-5ft to EL-10ft (117 to 122ft depth). The clear distance between the secant pile wall and the adjacent 4-story building was only 2 feet.

Figure 2. Excavation support system for construction of Ancillary 2.

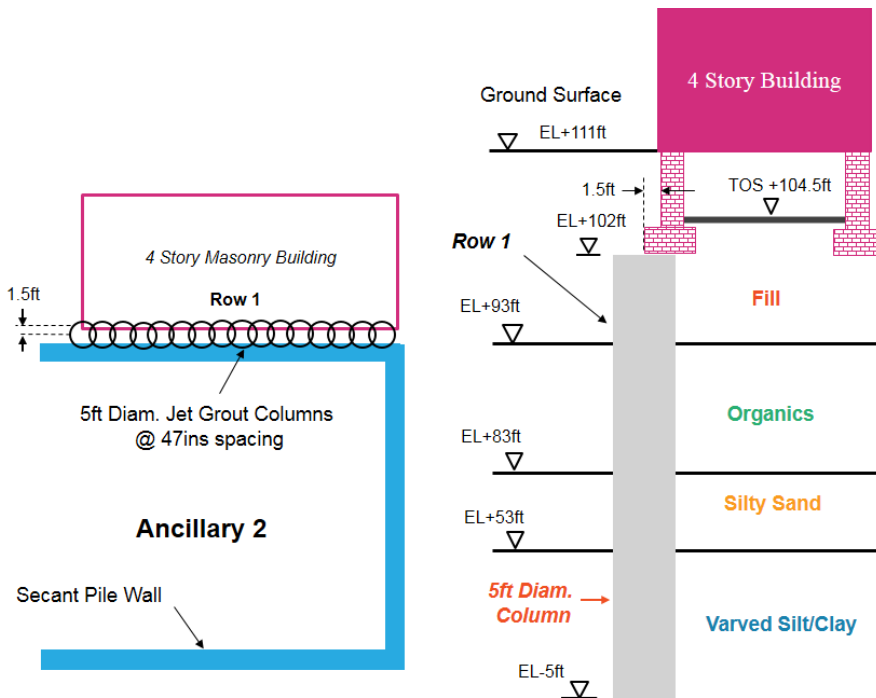
Figure 3 shows the jet grouting scheme adopted for underpinning the adjacent 4-story building.

**Figure 3.** Jet grout underpinning scheme (Row 1).

The proposed underpinning scheme involved installing sixteen vertical overlapping jet grout columns to form a continuous grout wall below the building foundation up to the toe elevation of the secant pile wall at EL-5ft. The jet grout columns were 5ft in diameter and spaced 47ins apart, matching the spacing and position of the adjacent secondary secant piles. In order for the jet grout columns to undergird the footings as much as possible, the column centerlines were set at 18ins offset from the external face of the building. This would result in a theoretical jetting reach of 12ins behind the foundation wall for a 5ft diameter column. Due to uncertainty in the dimensions of the footings, it was conservatively assumed that the footing extended 6ins beyond the outer face of the foundation wall. For this arrangement, a net contact area of 685 square inches between the footing base and jet grout column could be achieved. Based on the total dead and live load of 14.1kips/ft acting at the foundation level, an average bearing stress of 81psi was obtained for the contact area. A 28-day jet grout strength of 400psi was specified for design, giving an allowable bearing pressure of 100psi.

For the basic underpinning jet grout columns (Row 1), grouting was executed in two stages: Stage 1 from EL+95ft to +EL+102ft (bottom of footing) and Stage 2 from EL-5ft to EL+96ft. The intention of Stage 1 grouting was to tighten up the soils near the ground surface and immediately surrounding the footing in order to limit potential spoil entry into the existing basement, as well as improving stability of the borehole for more

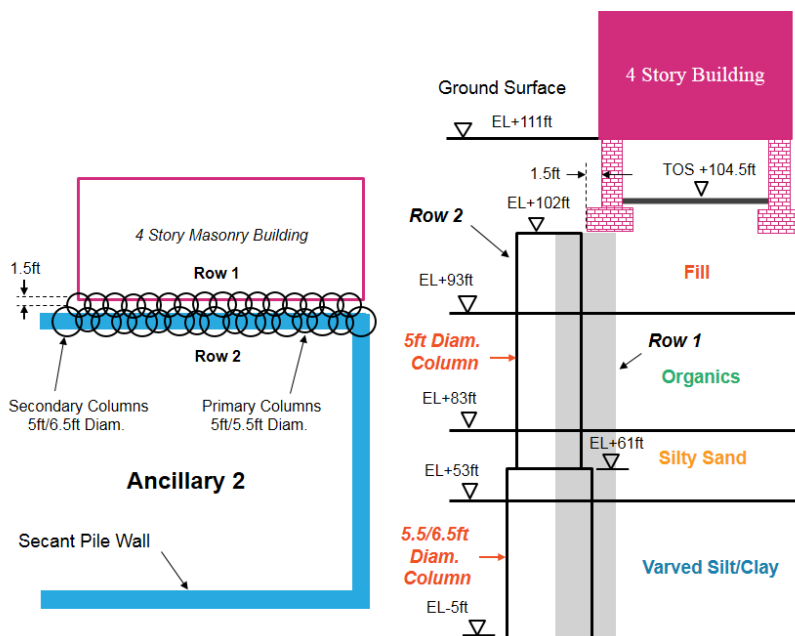
In the course of developing the underpinning design, the Contractor highlighted possible constructability issues relating to installation of the secant piles alongside the adjacent building. Due to close proximity of the secant piles, the casing shoe would be cutting partially into completed jet grout columns and partially into ungrouted soil. This would cause potential deviation of the casing during installation of the secant piles and may result in damage to pre-installed jet grout columns underpinning the footings. To overcome this, an additional row of jet grout columns was introduced along the proposed secant pile wall line to create a balanced platform (Figure 4).

Figure 4. Additional row of jet grout columns (Row 2) for stabilizing secant pile drilling.

Seventeen additional jet grout columns were installed at the designated primary secant pile positions located 47ins apart. Column diameters were nominally 5ft over the upper 41ft, extending from the footing down to the Ancillary 2 excavation level at EL+61ft. Below this level and up to the secant pile toes at EL-5ft, the column sizes alternated between 5.5ft (for primary columns) and 6.5ft (for secondary columns). Smaller grout columns were used in the upper sections to avoid excessive trimming of hardened jet grout within the exposed face of the excavation. The enlarged column sizes at the deeper elevations were necessary to ensure that overlap between jet grout columns was still attainable for an anticipated column deviation of 1%. The respective secondary jet grout columns would be formed after the two adjacent primary columns have been completed. This innovative approach allowed the secant piles to be drilled from a firm platform through consistent material for better verticality control during pile installation.

In the case of the outer row of jet grout columns along the secant pile wall (Row 2), a 10ins diameter hole was advanced directly to the toe elevation at EL-5ft and grouting was executed in one continuous up-stage to the footing elevation. Tables 2 and 3 summarize the jetting parameters for the primary and secondary jet grout columns respectively. Jetting was carried out using a single 6.5mm diameter nozzle. Compressed air of 10 to 13 bars was utilized in this case to form the larger columns. A water-cement ratio of 0.86 by weight was adopted to produce a grout mix with specific gravity of 1.58.

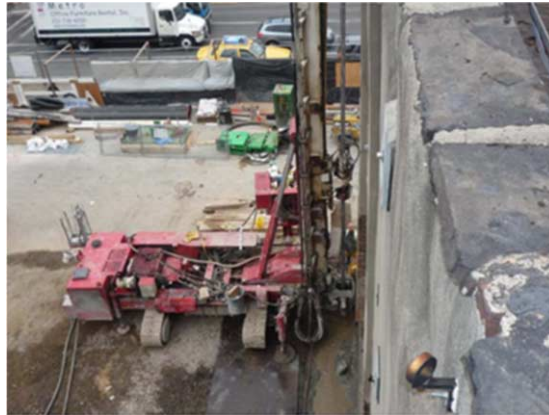
Jet grouting was performed using a Casagrande C-14 drill rig and Tecniwell TW400/S high pressure triplex pump (Figure 5). An 89mm diameter Jet Plus monitor was used in conjunction with a 114mm diameter drill rod. A 10ins diameter borehole was predrilled and cased to the bottom elevation of the adjacent footing to maintain effective spoil removal during jetting. The drill string was then lowered and progressed using a slightly smaller bit size within the casing and then reamed out, using water as the flushing medium. Jetting parameters were developed based on the results of initial jet grouting field trials on site using CYLJET electric resistivity measurement methodology for evaluation of in situ column dimensions in the various soil strata [8, 9]. Continuous observation of jetting parameters was achieved using a Jean Lutz LT3 monitoring system. Drilling rod inclination was measured using a ShapeAccelArray (SAA) tool.

**Figure 5.** Jet grouting adjacent to existing building.
