The paper was published in the proceedings of the 12th Australia New Zealand Conference on Geomechanics and was edited by Graham Ramsey. The conference was held in Wellington, New Zealand, 22-25 February 2015.

Mitigating the risk of ageing piling equipment and foreign migrant work force by full scale pile testing in Cabinda, Angola

T. E. B. Vorster¹, Aurecon South Africa (Pty) Ltd

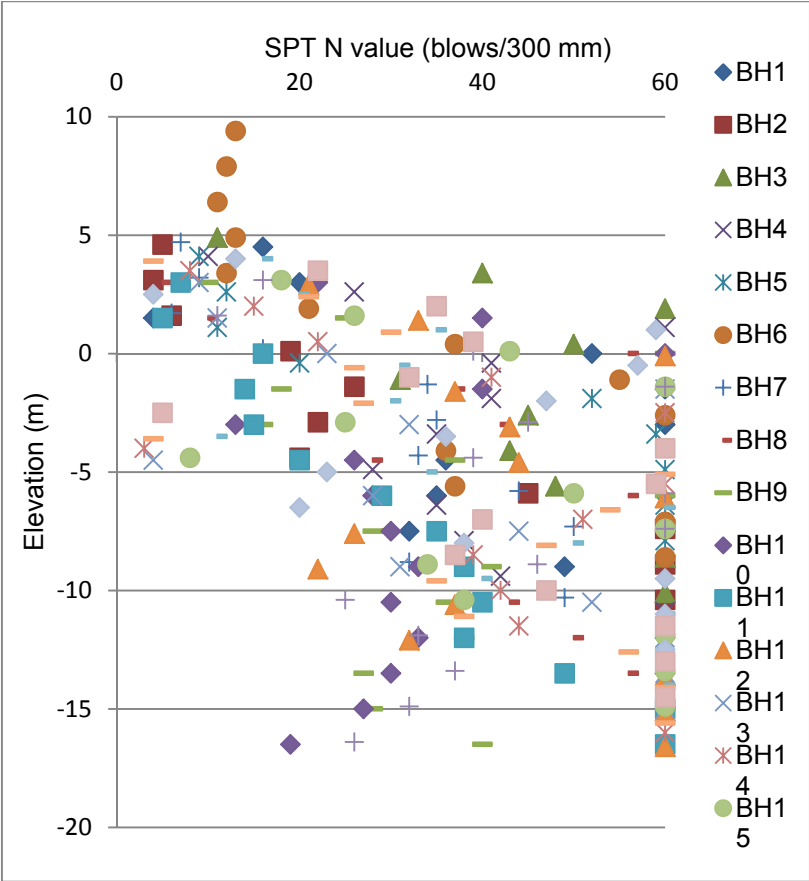
Figure 1. SPT data indicating variability in consistency

Significant variation was observed in consistency across the boreholes (Figure 1). The “softest” ground conditions relative to other areas on site appeared to be in the wetland zone. From the SPT

data it is possible to identify a soft zone located between depths of -1.5 m and -4.0 m. It was expected that this soft zone could be problematic during pile installation resulting in pile borehole collapse. The wetland area is characterised by standing water and is covered by approximately 2 m of high plasticity, organic sandy clay. The groundwater level across the site is located at approximately 0.5 m below ground surface. Notwithstanding the particular wetland area, it is not practical to accurately map varying zones of consistency to specific locations on site. For this reason it was decided to evaluate the data across the site as one data population.

installation process and to a lesser effect the variability in ground condition. This is postulated because a larger variation may have been expected had it been linked strongly to variation in ground conditions in relation to the data shown in Figure 1. For design purposes a value of 59 kPa was proposed. (4) The ultimate load was achieved at settlements of approximately 2.1 % to 3.5% of pile diameter (typically 12 to 21 mm). (5) At ultimate load the back-analysed shaft: end-bearing load ratio achieved values ranging from 84%:16% and 78%:22%. (6) At loads of approximately 1126 kN (the second load step in the test sequence) the load ratio in all three test piles was 99%:1%, which means that the piles carried the load primarily in shaft friction. At 1687 kN load, the test piles are estimated to carry between 3.5% and 13% of the load in end-bearing. As an indicative value, end-bearing is considered negligible below 1126 kN load.

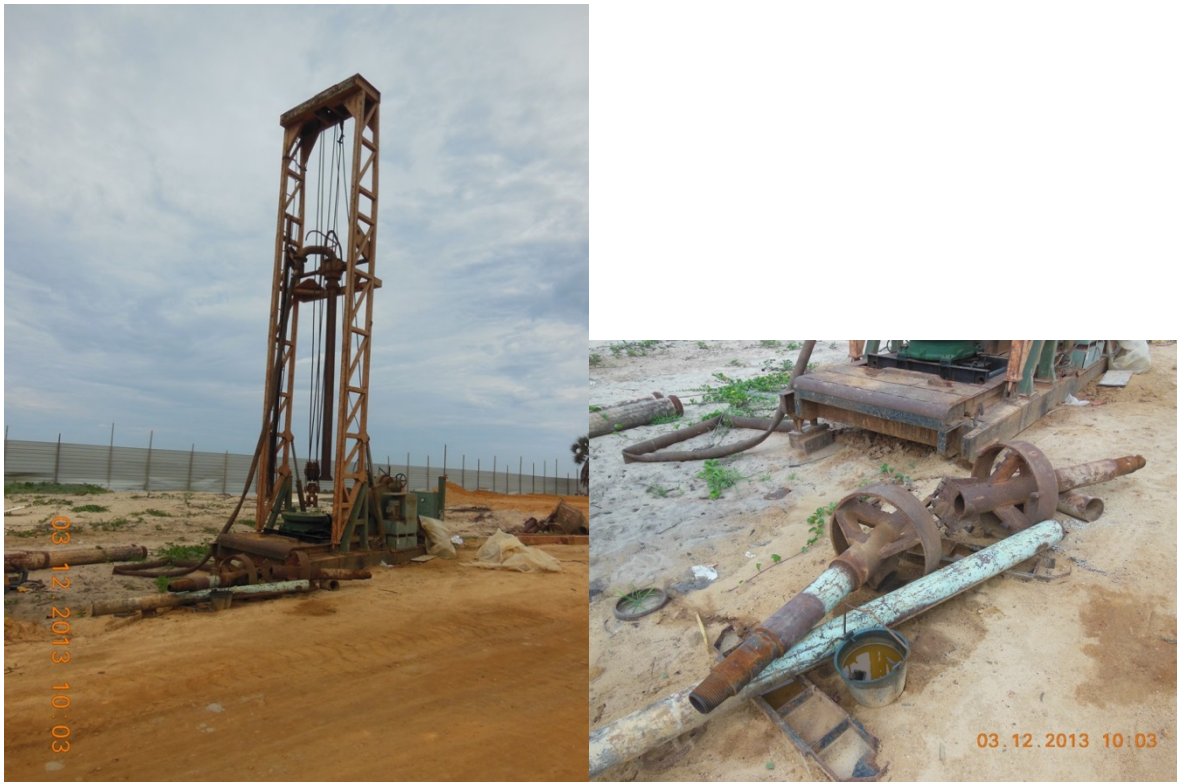
Figure 2. Piling rig (Jintai GPS-15) and drill bit used for test pile installation

Very often in Angola the plant available for pile installation is old and derelict. At this particular site in Cabinda it was no different. The plant proposed to be used comprised of a derelict Jintai GPS-15 piling rig. The rig is manually operated, with the locus of control for pile installation residing entirely with the operator. The piling rig and drilling tool are shown on Figure 2. There was a very real concern about the state of the plant, the competence of the work force, the repeatability of pile installation and the reliability of the pile design in relation to how the pile could be installed. On this basis it was decided to conduct a series of full-scale pile load tests to verify the design and installation procedures.

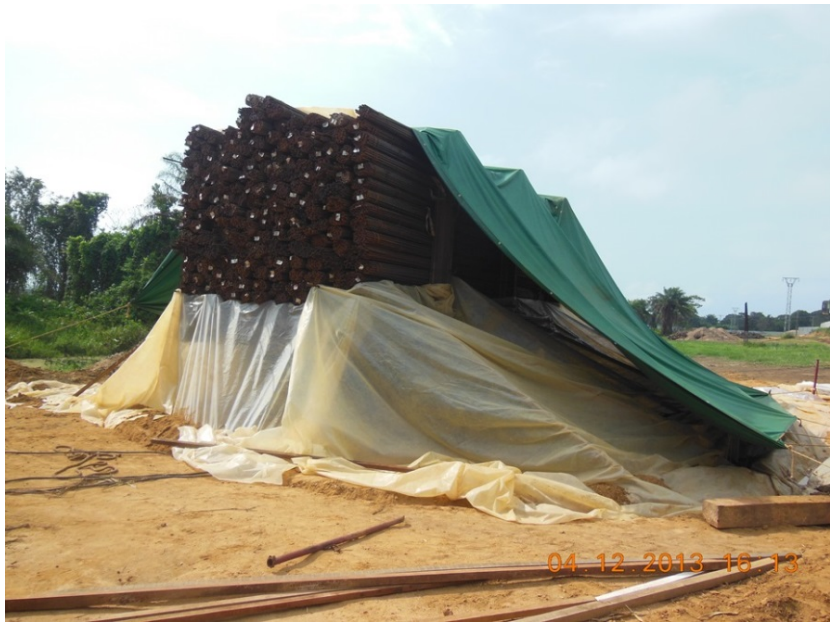
Figure 3. Kentledge (reinforcing steel stacked to 500 tons) setup completed

(5) Following curing, a load test frame and kentledge comprising 500 tons of steel reinforcing stacked onto a level surface and bound together, was constructed as shown in the figure below. Settlement is measured using 4No. linear variable differential transducers (LVDTs) referenced to a reference plate. Load is applied using a hydraulic jack and pressure is measured on a 100 MPa Bourdon-type pressure gauge with 1MPa resolution (approximately 129 kN). The influence of the load arrangement on the jack was limited by setting the jack into the ground by approximately 1 m and by having the load beam spaced wide apart (approximately 5 m). Readings from the pressure gauge is taken manually, while settlement is measured to 0.01 mm resolution via electronic data collection system. Load is increased or reduced using an electrical motor controlled by a manual switch. The entire test setup was shaded in an effort to shield the instruments from changing atmospheric conditions. (6) A load-unload sequence of 8 No. equal loading steps to 4500 kN and 4No. equal unloading steps to zero was proposed by the contractor to conform to ASTM standards to achieve the estimated ultimate failure load of 4500 kN.
