A risk based assessment of the punch-through potential of jack-up barges

Mark Skinner¹ CEng MICE, MIPENZ and Timothy Mote² PhD, PG, CEG.

ABSTRACT

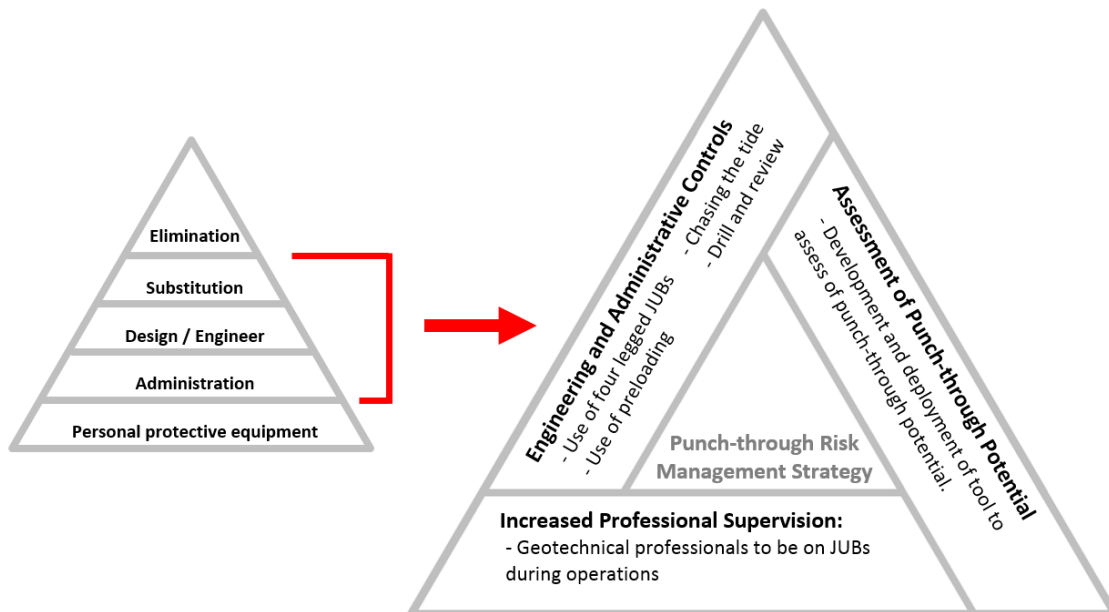
Figure 1. Risk controls and risk management strategy

Following the 2010 incidents the Client revised their risk management strategy and introduced additional risk controls. The aim of the risk management strategy was to ensure that the risk of punch-through was reduced to a level deemed to be as low as practically possible – a common industry aim. The strategy comprised three control areas, which when implemented together would reduce the risk of punch-through. The control areas were derived following consideration of the commonly adopted hierarchy of risk controls and the three control areas adopted are shown on the left and right of Figure 1 respectively. The Assessment of Punch-through Potential was one of the three areas of control.

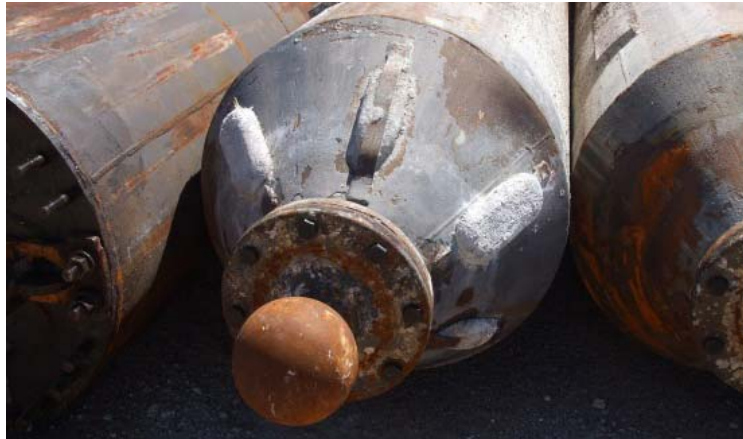
Figure 2. Jack-up barge leg configuration (Image © Client)

The first stage of the project comprised the back analysis of the 2010 punch-through incident. During the early campaigns the JUB legs did not have spudcans attached, and were used as configured in Figure 2. The ends of the legs were broadly conical, with a 240 mm diameter sphere at the tip.

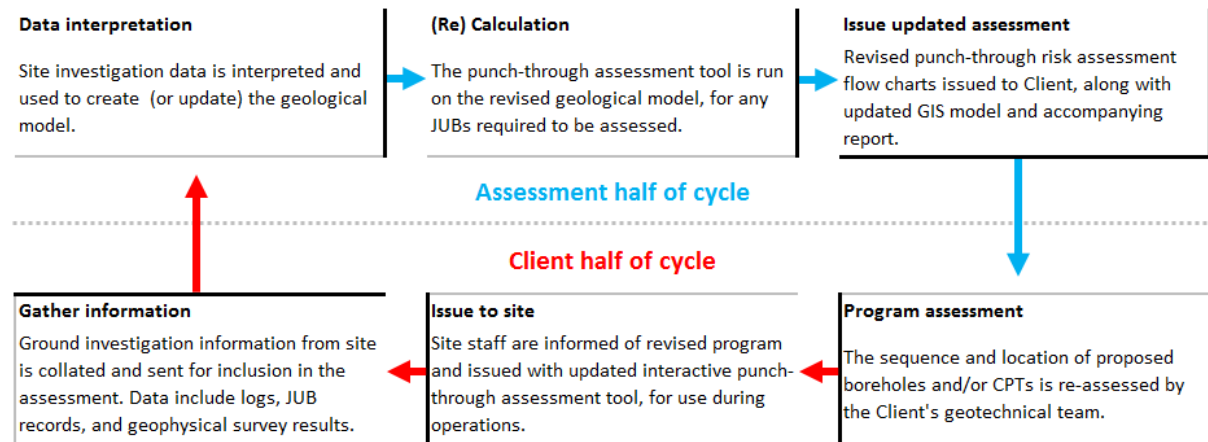
Figure 5. (Above) The assessment updating cycle

Upon receipt of new ground investigation information the geological model was revised to include the new data, the punch-through assessment was re-run, and the site flow charts were re-populated with the new results. The updated information was then sent back to the Client for use on site. The cycle of updating is shown in Figure 5.
