The paper was published in the proceedings of the 12th Australia New Zealand Conference on Geomechanics and was edited by Graham Ramsey. The conference was held in Wellington, New Zealand, 22-25 February 2015.

Performance of sewer pipes with liner during earthquakes

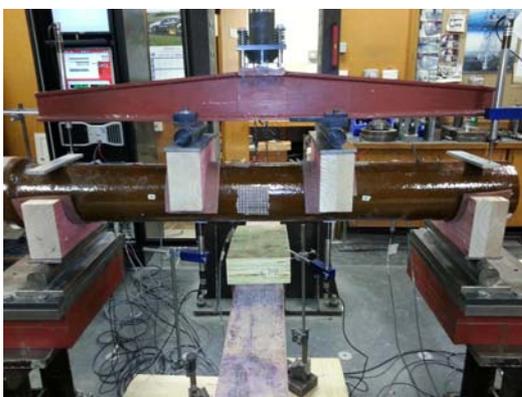
Figure 2. (a) Test set-up for the 4-point load test (Sample 1); and (b) location of sensors (Sample 2).

For the four-point load test, the pipe surface was first prepared by sand blasting and de-greasing to provide a good bonding surface for the strain gauges which were installed at pre-defined locations. The pipe specimen was then placed on wooden cradles which rested on the support stands of the MTS test machine. A thin rubber material was placed between the pipe and wooden cradle to prevent line failure along support sections.

The centre of the pipe was approximately aligned below the force actuator of the MTS, with the load spreaders adjusted so that all four supports were at the middle-thirds of the pipe length (see Figure 2a). Linear variable displacement transducers (LVDT) were also installed at pre-defined locations (see Figure 2b). All sensors were connected to the data acquisition control unit. The downward deflection was applied at a controlled rate, and the test was stopped when the maximum deflection limit of 300mm was reached or when the pipe or AM-liner had completely failed, whichever came first. Video recording with grid references were also used for visual representation of the pipe deflection.

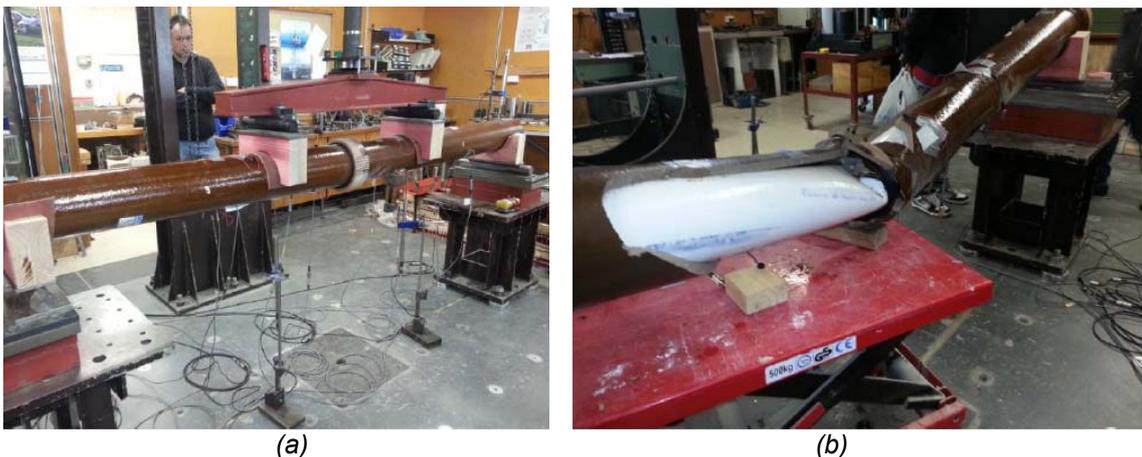
Figure 6. Photos of load test for AM-lined sewer pipe: (a) before the test; and (b) after the test

It should be mentioned that the quality of results may have been compromised due to debonding of the AM-liner from the pipe walls. During testing, the AM-liner had slipped with respect to the pipe wall by about 80mm. This would have also decreased the amount of strain experienced by the AM-liner and it may have failed earlier if debonding had not occurred.
