Repairing Christchurch City Council owned retaining walls damaged by the Christchurch and Canterbury earthquakes

3 CUNNINGHAM TERRACE RETAINING WALL CASE STUDY

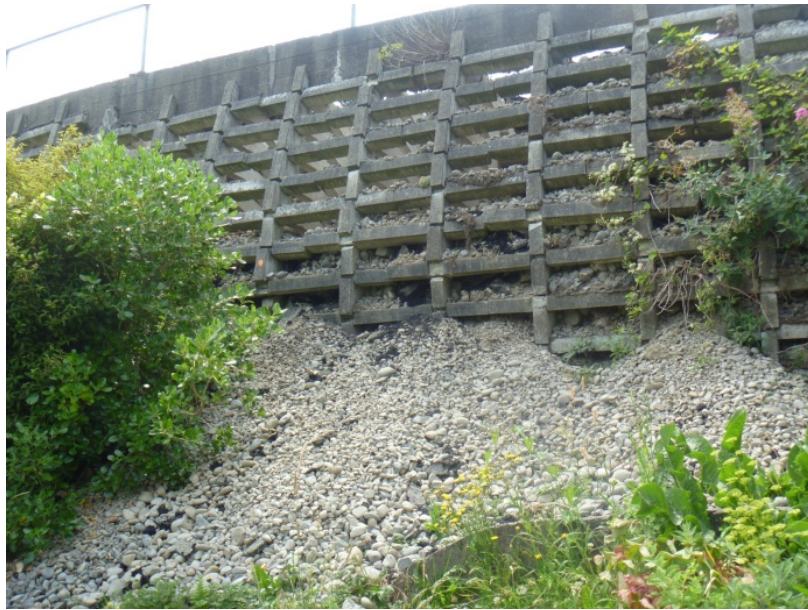
The wall is 75m long and up to 4.8m high. The existing wall consisted of two sections of crib wall and three sections of mass concrete wall. The crib lost more fill with each aftershock and was badly deformed. The mass concrete sections were propped with railway irons prior to the earthquake. The road above the wall was closed due to the degree of deformation and loss of stability (Figure 1).

Figure 1. The damaged Cunningham Terrace retaining wall

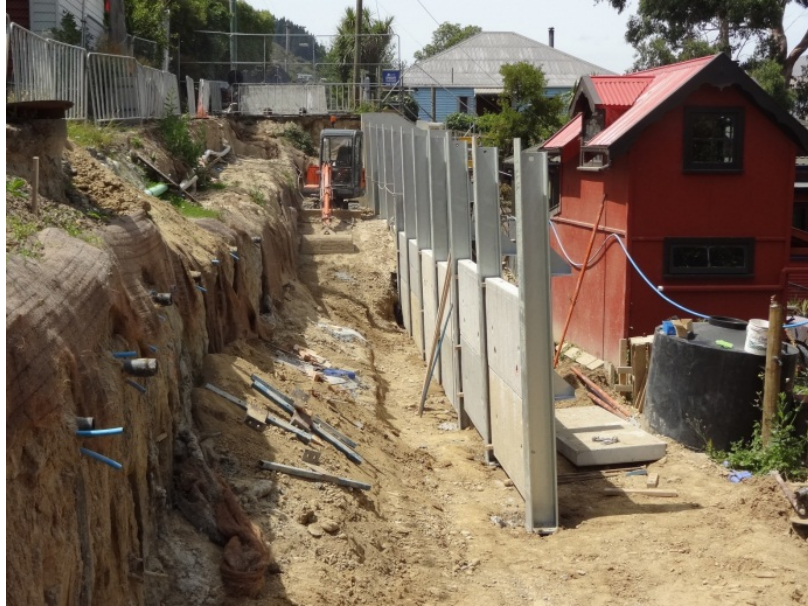
Figure 3. The partially constructed Cunningham Terrace retaining wall

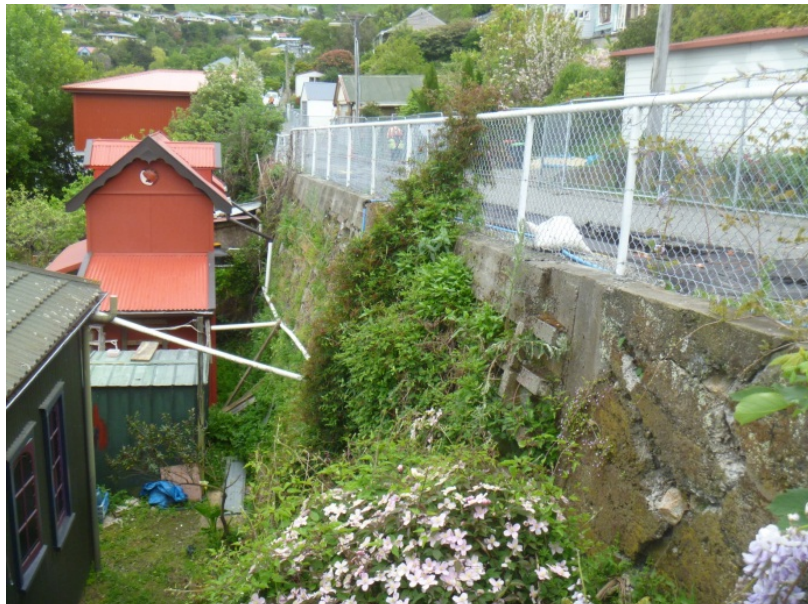
Figure 4. Cunningham Terrace retaining wall before demolition showing the confined site

As can be seen in Figure 4 the site was particularly narrow. This is not uncommon in these hillside residential areas. The wall on the right of the photograph was demolished and replaced without removing any of the buildings which can be seen on the left of the photograph. In addition the road

behind the wall contains water infrastructure and other buried utilities. Overhead cables also travel along this road.

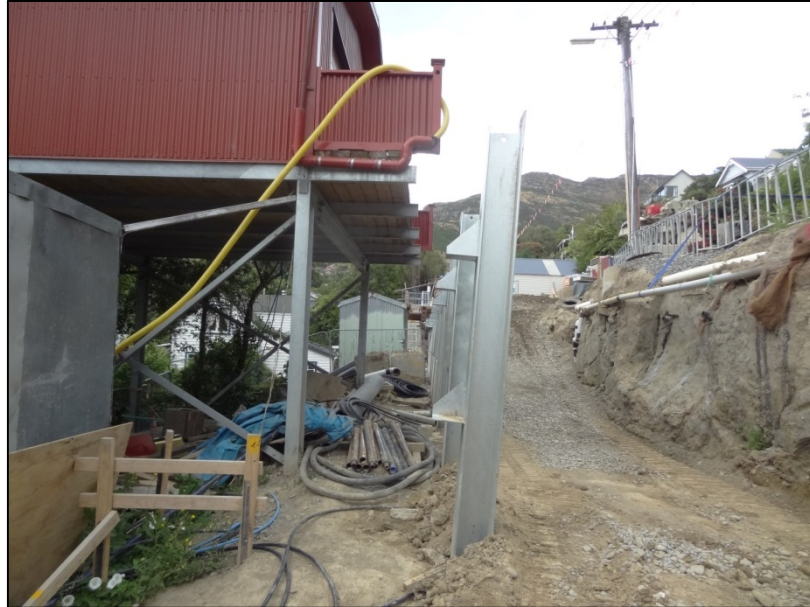
The alignment of the top of the wall is slightly different to what was there before due to the reduced rake of the wall. There is a garage on stilts on the low side of the wall and the new wall alignment would result in a 0.5m gap between the garage and the road. This can be seen in Figure 6. To remedy this access had to be provided without relying on the private structure for support. Therefore a cantilever access was built from the top of the wall as part of the capping beam.

Figure 6. The gap created by the new wall alignment
