The paper was published in the proceedings of the 12th Australia New Zealand Conference on Geomechanics and was edited by Graham Ramsey. The conference was held in Wellington, New Zealand, 22-25 February 2015.

Geotechnical reconnaissance of the damage triggered by liquefaction of the Christchurch Formation following the February 2011 earthquake

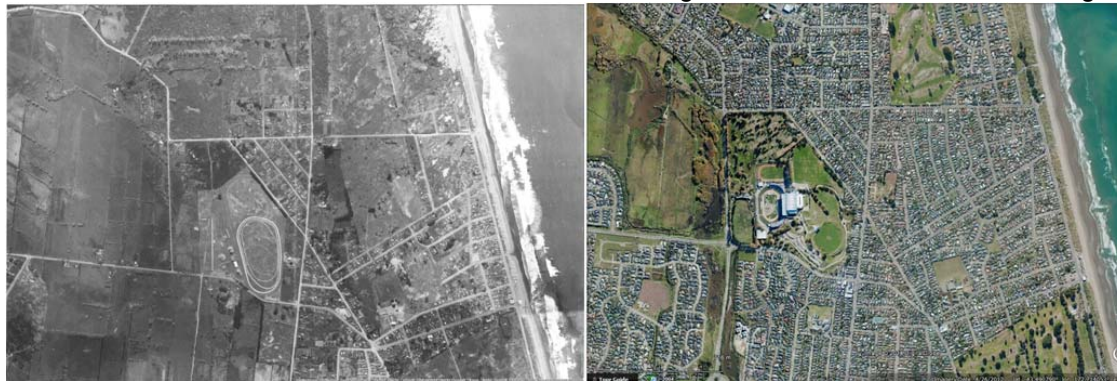
Figure 3. 1941 and present day aerial photographs of area of study (images available from Canterbury Maps and Google Earth)

A survey of the Christchurch aerial maps from as early as 1941 suggests that when east Christchurch was eventually settled, it was initially an agricultural and sand dune area. Aeolian ripples in the sand dunes are noticeable features in the earlier aerial photographs, but as the area evolved to become a more residential area, the dunes more inland were no longer noticeable. This is shown in Figure 3.
