The paper was published in the proceedings of the 12th Australia New Zealand Conference on Geomechanics and was edited by Graham Ramsey. The conference was held in Wellington, New Zealand, 22-25 February 2015.

Pull out resistance of soil nails in continuous auger drilled holes

H.J. Maclean¹, A. Campbell², M.R Thomas¹ and S. Tjokro¹

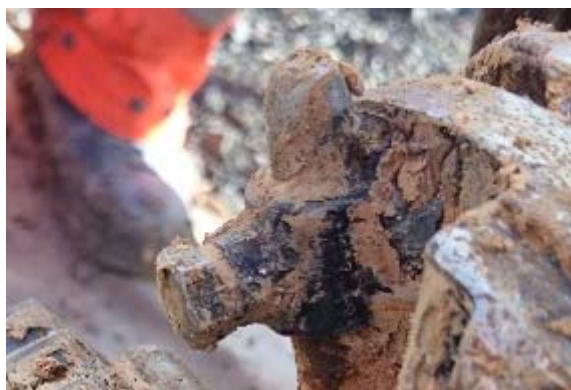
Options to reduce the nail spacing or make the nails longer to achieve the required capacity were limited due to site boundary constraints. The constructor (Brian Perry Civil) developed a specialised tool comprising an adjustable ‘permanent spike’ which was welded to the drill head as shown in Figure 2. This tool creates a groove down the length of the hole which is around 15mm deep and 20mm wide (Figures 3 and 4). All six pull out tests on nails installed in the grooved auger holes achieved the required design grout to ground bond capacity. Figure 5 shows a typical load-displacement plot for one of the nails in a grooved auger hole.

Figure 2. Adjustable spike on the drill head

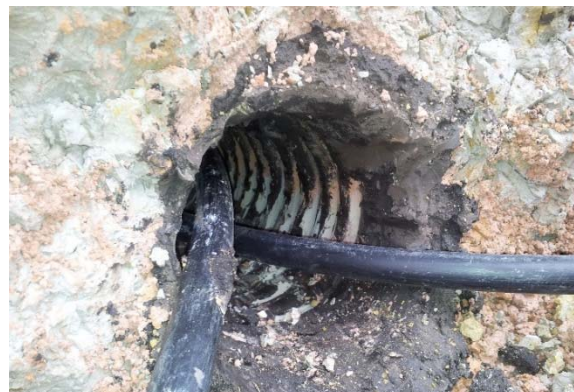
Figure 3. Grooved auger hole

It is considered that the low pull out resistance in the ungrooved auger holes in alluvium is likely to be the result of pull out failure occurring in softened soil smeared onto the side of the hole as soil cuttings are pushed back up the hole by the continuous auger. Two key observations support this conclusion. First, a layer of softened soil was observed on the grout column of one of the failed nails (Figure 9) which was pulled out of the ground (pulling the nail may have contributed to the observed soil smearing). Secondly, a number of nails encountered a thin, black, organic soil layer at depth. During drilling it was observed that the black soil from depth was smeared over the in situ orange coloured soil in the upper part of the hole (Figure 3).

It was also observed that the grooving tool cut through the black smear layer very effectively, exposing natural ground in the groove created (Figure 3). Variability in the pull out results for the ungrooved auger holes (38kPa to 63kPa) may reflect the variable nature of the alluvium, with some tests located in material more susceptible to strength loss when being reworked and smeared during drilling.

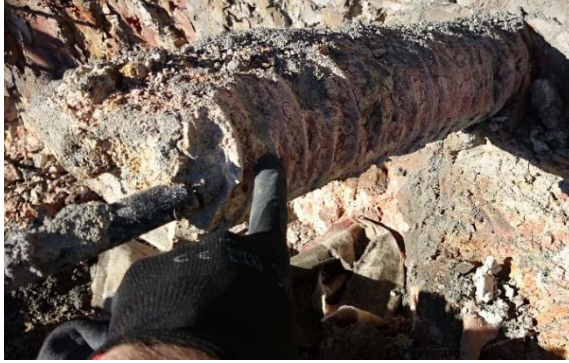
Figure 4. Ribs on the exposed grout column

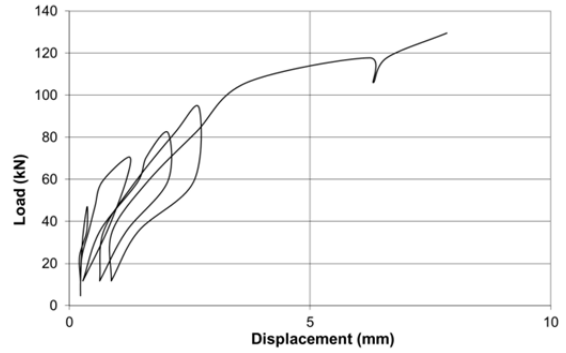
Figure 5. Load-displacement plot for a grooved auger hole (Ch7741m RW603)

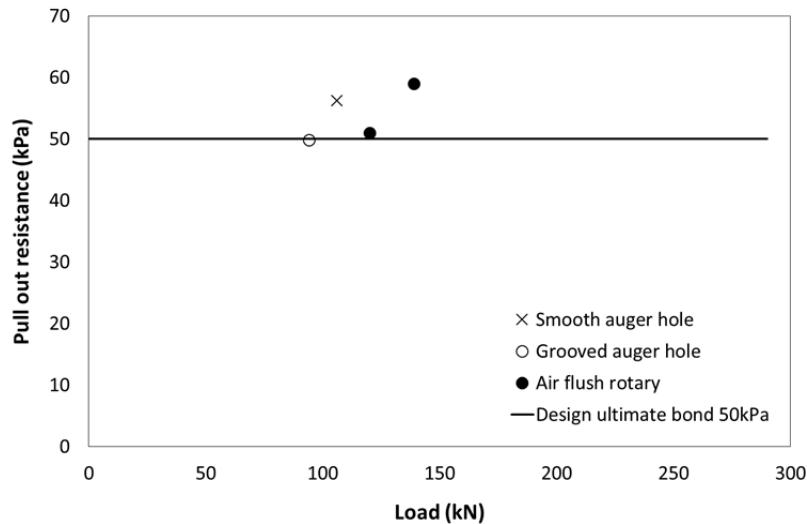
Figure 7 shows that the limited number (4No.) of pull out tests in residual soil which all resulted in similar and acceptable pull out resistance values.

Figure 7. Pull out resistance in residual ECBF soil

The pull out resistance (τ_{ult}) obtained from each of the pull out tests in the alluvium and residual soil is shown on Figures 6 and 7 respectively.

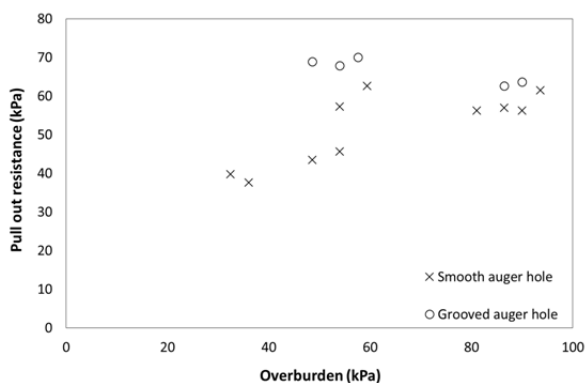
The effect of overburden on pull out resistance in the alluvium has been considered. Figure 8 shows pull out resistance for nails in the grooved and ungrooved auger holes plotted against overburden pressure. Results generally show an increase in pull out resistance with increasing overburden for the ungrooved holes and no significant relationship for the grooved holes. It is considered that soil smear (discussed in Section 6.2) is likely to be having a significant and variable effect on pull out resistance, making it difficult to make a meaningful assessment of the influence of overburden pressure.

Figure 8. Pull out resistance relative to overburden pressure in alluvium

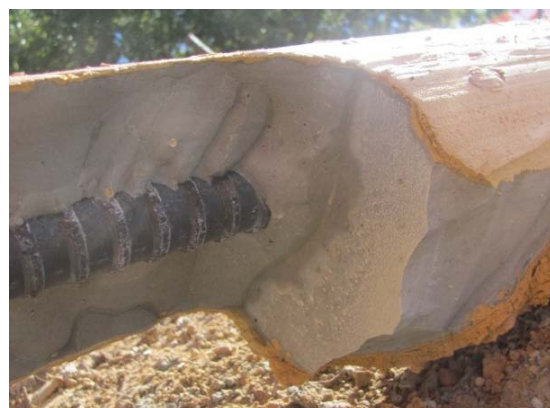
Figure 9. Soil smear on the pulled [ungrooved] grout column

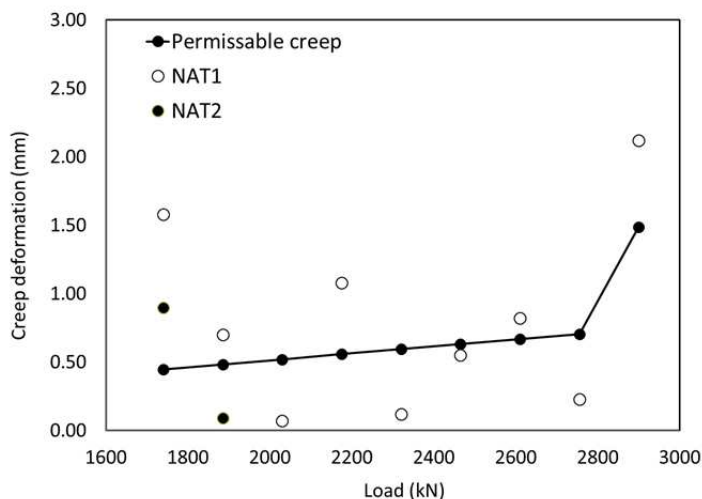
Figure 12 shows the calculated permissible creep values compared to the measured creep deformation for the two auger drilled anchors. The values shown in Figure 12 are for the third load cycle, in which creep deformations were measured over a five minute duration for different load increments representing 60% to 100% of the test load. The creep at 100% of the test load was measured over a longer 15 minute duration. Only two values are shown for Anchor NAT2 as failure occurred. It is noted that excessive creep deformation had already occurred at lower loads during the first two load cycles.

Figure 12. Creep deformation of the augered anchors (NAT1 and NAT2) for the third load cycle
