The paper was published in the proceedings of the 12th Australia New Zealand Conference on Geomechanics and was edited by Graham Ramsey. The conference was held in Wellington, New Zealand, 22-25 February 2015.

Muldoon's corner realignment: Design and construction of fill embankments and retaining walls

J. H. Duxfield¹ and P. Brabhakaran²

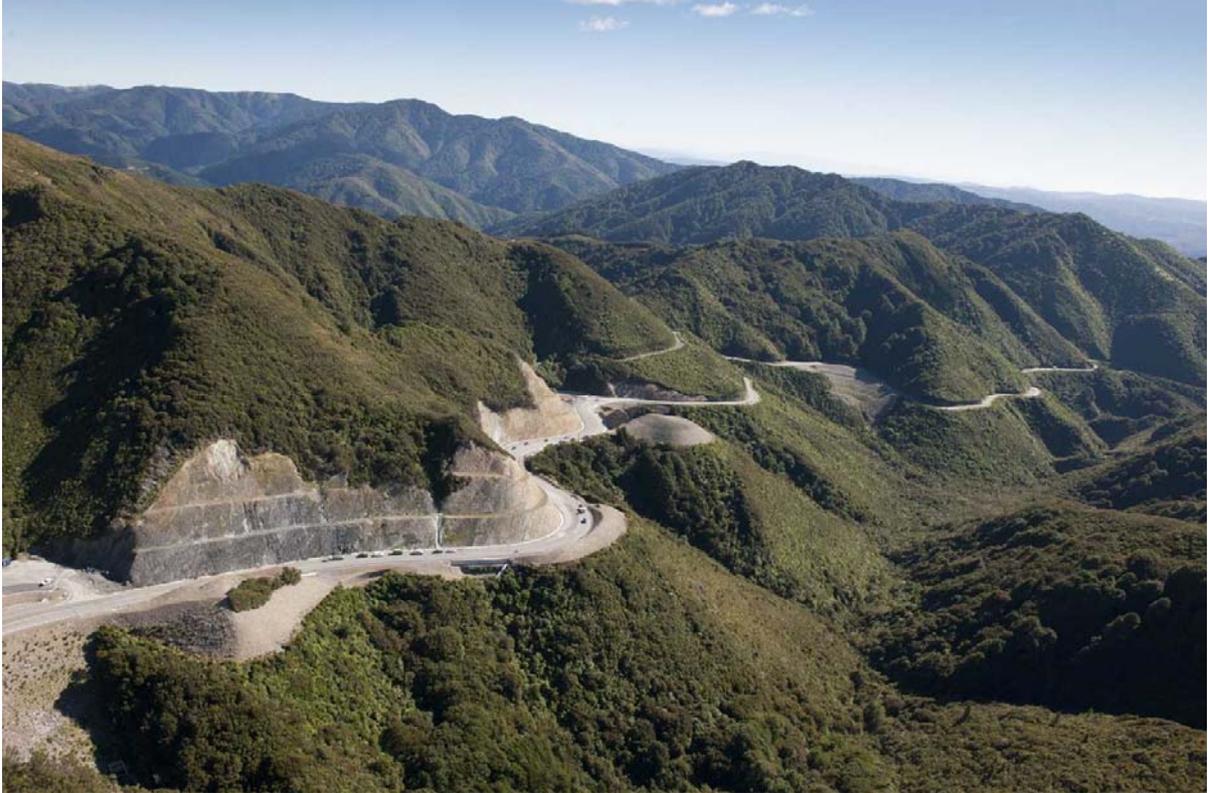
Figure 1. Overview of the Muldoon's Corner Realignment Site

The New Zealand Transport Agency (formerly Transit New Zealand) commissioned Opus International Consultants to carry out design and construction management for the realignment of a section of State Highway 2 on Rimutaka Hill Road in rugged mountainous terrain, see Figure 1. The road realignment, involving substantial earthworks with approximately 230,000 m³ of rock being excavated to form 55 m high cuts and 45 m high reinforced fill embankments, significantly increase the road resilience in major earthquake events. Several retaining walls which were vulnerable to failure under earthquake events were either upgraded or replaced to ensure adequate performance and resilience of the new road.

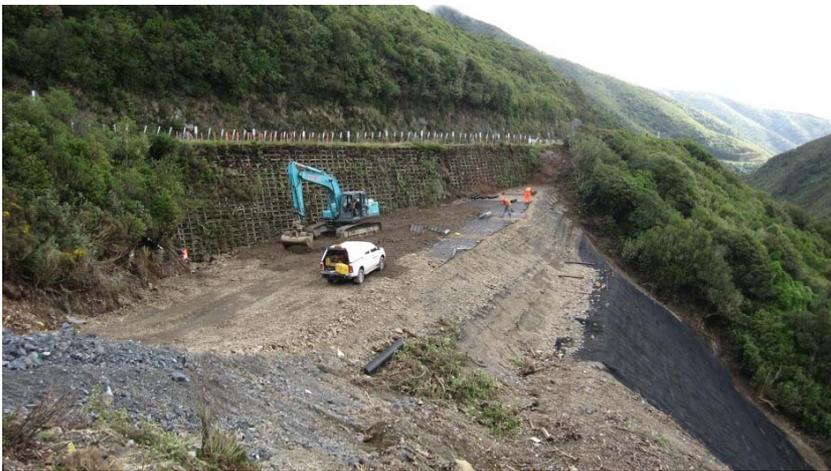
Figure 3. Construction of Reinforced Soil Embankment at the Realignment Site

The 45 m high RSE at the main site was constructed in front of an old crib wall above a deeply incised gully, see Figures 2 and 3. This RSE was put to innovative double purpose - to carry the road embankment without the fill extending down the slope into the stream, as well as buttressing the high crib wall with a steep cliff below. An earlier design concept involved a bridge across the deeply incised gully instead of the RSE design. By using the 45 m high RSE, the construction cost was substantially reduced. RSEs are also more resilient than bridge structures in an earthquake event as they are more flexible and less vulnerable to failure and will take less time to recover. The embankments were designed in such a way that stability is ensured under normal static conditions (FOS > 1.5) and under large storm events (FOS > 1.0). Limited displacement of less than 200 mm was accepted in large earthquake events.

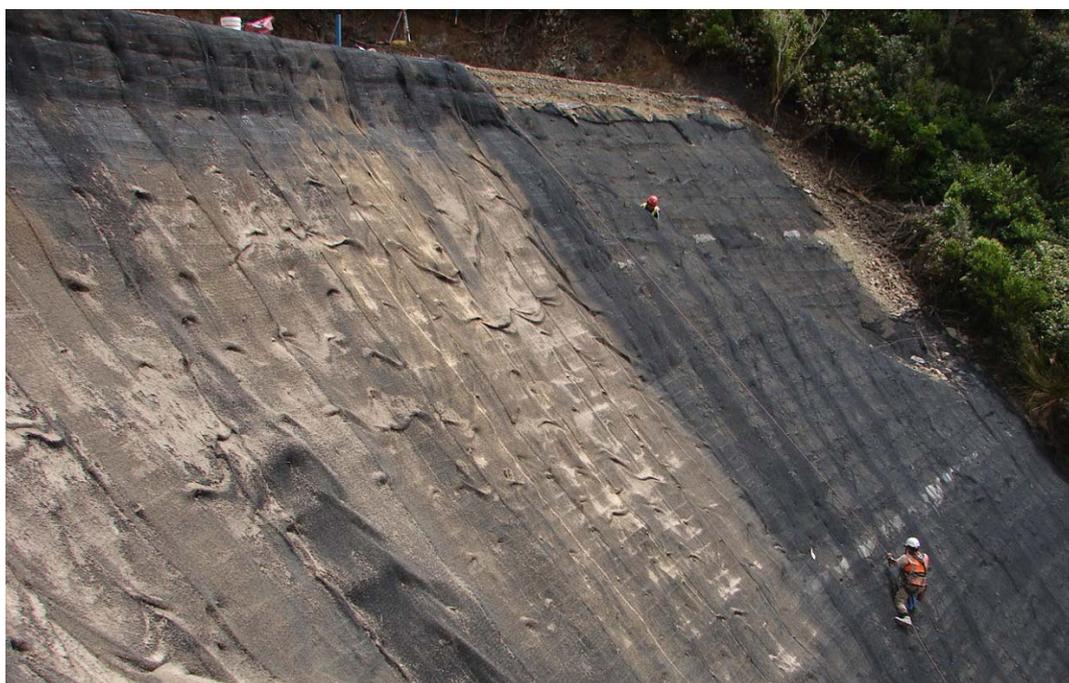
Figure 4. Installation of Erosion Protection Mat on the Face of Reinforced Soil Embankment

Geogrid reinforcement made of high density polyethylene (HDPE) was used as the primary and secondary reinforcements for the RSEs. It was considered that HDPE geogrid is relatively low cost and able to provide satisfactory durability and robustness against damage, given the selected fill were gravels derived from excavated competent rocks from the cuttings within the site. The geogrid was predicted to provide an adequate design life exceeding 100 years (FHWA, 2000), although these grids have not been in use for such a long period yet. The primary geogrid was placed at 1 m vertical intervals with appropriate length to ensure internal and external stability as well as displacement performance of the embankments during a large earthquake. To prevent locally shallow failures, secondary geogrid of 3 m in length was placed midway between the primary geogrid at the slope face. At the 45 m high embankment, additional soil reinforcement comprising high strength woven geotextile was placed at every 5 m interval vertically to provide extra resisting strength in all directions.

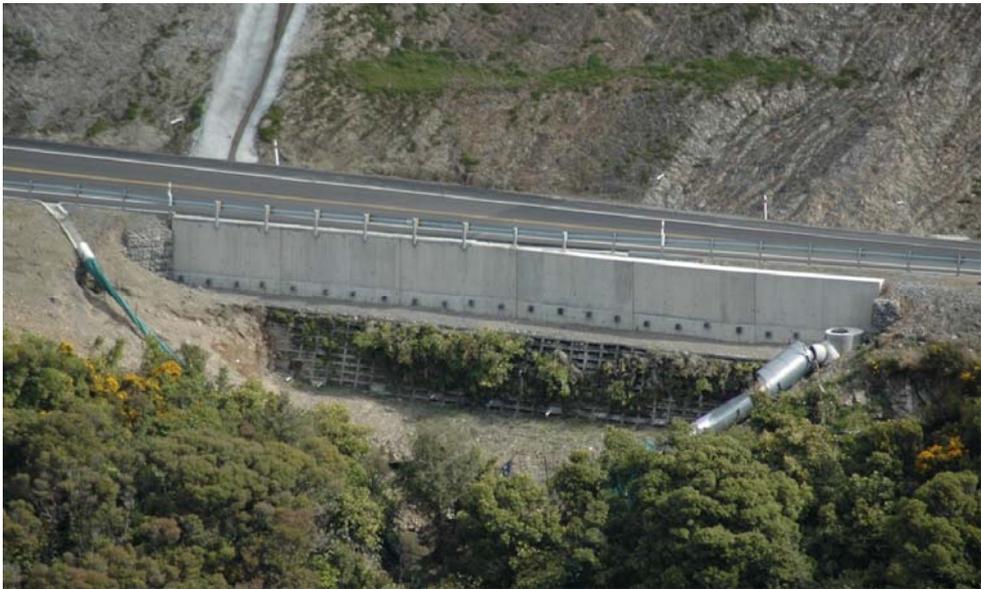
Figure 6. Replacement of an Old Crib Wall with an Anchored Soldier Pile Wall

An old crib wall of about 30 m in length and 6 m exposed height below the realignment was replaced by an anchored soldier pile wall with a concrete facing, see Figure 6. The new soldier pile wall was able to resist the design earthquake loads and to retain an extra thickness of fill for the new road construction. The wall consists 25 reinforced concrete piles at 1.2 m spacing. Each pile is of 600 mm in diameter and about 10 m in length. The piles were socketed 4 m into the bedrock and tied-back by rock anchors. The new wall was constructed behind the existing crib wall, of which the top couple of meters were removed for the new wall construction.

There was a high risk of failure of the old crib wall in storm or earthquake events. Stability analysis showed that the old wall was marginally stable under the existing static conditions. Any storm events that would cause significant temporary increase in groundwater level could cause the wall to fail. The wall would also fail by overturning in earthquakes. Due to its close proximity to the new road alignment, failure of the wall would cause damage to more than one lane of the new road. The disruption to the road users and the expected cost of repairing the wall would be substantial. By replacing the old wall with the new soldier pile wall during construction of the realignment, the road resilience was greatly improved. The approach also resulted in substantial cost savings and minimised disruption to traffic compared to procuring the wall replacement under a separate contract.
