Strengthening of heritage tunnel portals

J.C.R. Spinks

ABSTRACT

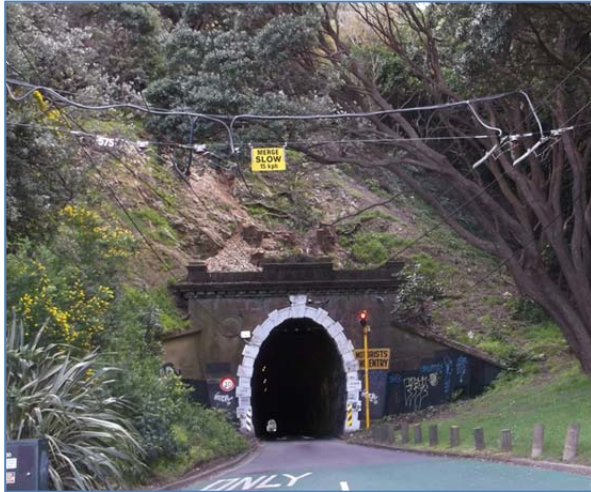
Figure 1. The current eastern portal with wingwalls either side

The eastern portal is surrounded by steep (50 to 70 degree) cut slopes within highly weathered Greywacke. The insitu rock is very closely jointed with some unfavourable joints extending out of the slope. The rockmass is very dilated rock mass and a number of shallow translational failures extend along the southern cut slope.

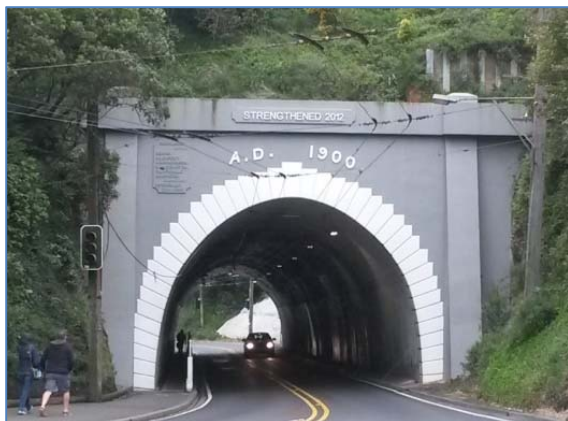
Figure 4. Portal post strengthening

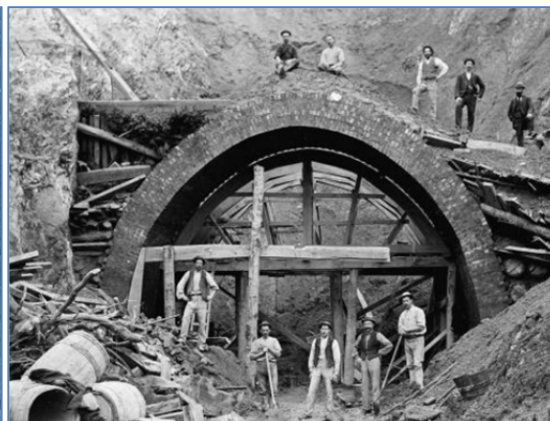
Figure 5. Historic photo of portal
(Courtesy of National Archives)

The investigation, design and construction of the Karori Tunnel seismic strengthening scheme was undertaken over a three year period from 2011 to 2013. The tunnel portals are illustrated in Figure 4 and 5 below.
