# Reassessment of Subsidence Risk, Edward South Lode, Waihi Mine, New Zealand

**Summary:** Initial assessments indicated that the risk of voids migrating to the surface from the Edward South stopes of the old Martha underground mine at Waihi could be high. However, three new holes drilled above the stopes confirm a good quality rock mass and an absence of voids. These investigations have enabled a reassessment and consequent reduction of the risk of sinkhole subsidence in this area from high to low risk.

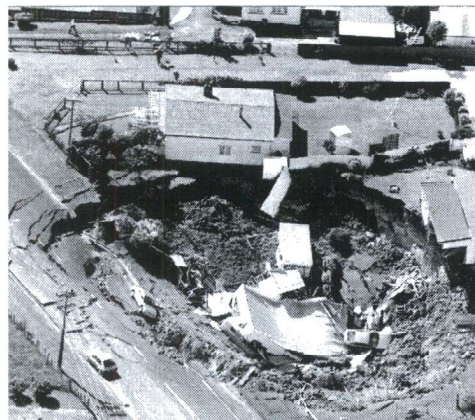
Figure 1. The 13 December 2001 sink hole at Barry Road, Waihi

A sudden collapse crater 40 m in diameter originating from the old underground mine stopes occurred in 1999 near an occupied part of Waihi. It placed in danger several houses and a main street. This crater occurred close to similar crater which formed in 1961. The 1999 collapse resulted in subsurface investigations and risk assessment studies being commissioned by the Hauraki District Council. In December 2001 a further 50 m diameter collapse crater formed in a residential area, swallowing a house, but fortunately without injuring its five occupants (Figure 1). Two other houses were perched on the crater rim. The 2001 collapse led to an acceleration of work to identify the potential hazard posed by the old underground workings at Waihi.

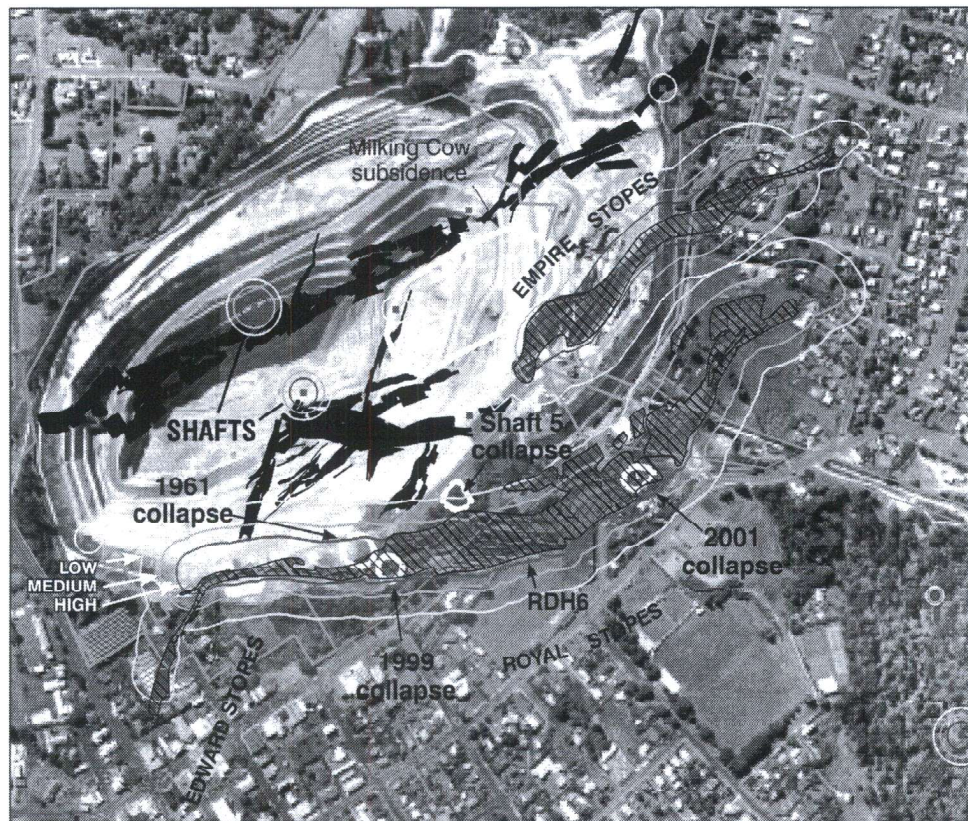
Figure 4. Probabilistic ground subsidence hazard zones overlying mine stopes and shafts

has been removed from the southern end of the Edward South stopes to the point where stope ED259 (Figure 5) increases suddenly in height and volume. The extent of the revised low hazard zone is shown on Figures 4 & 5.

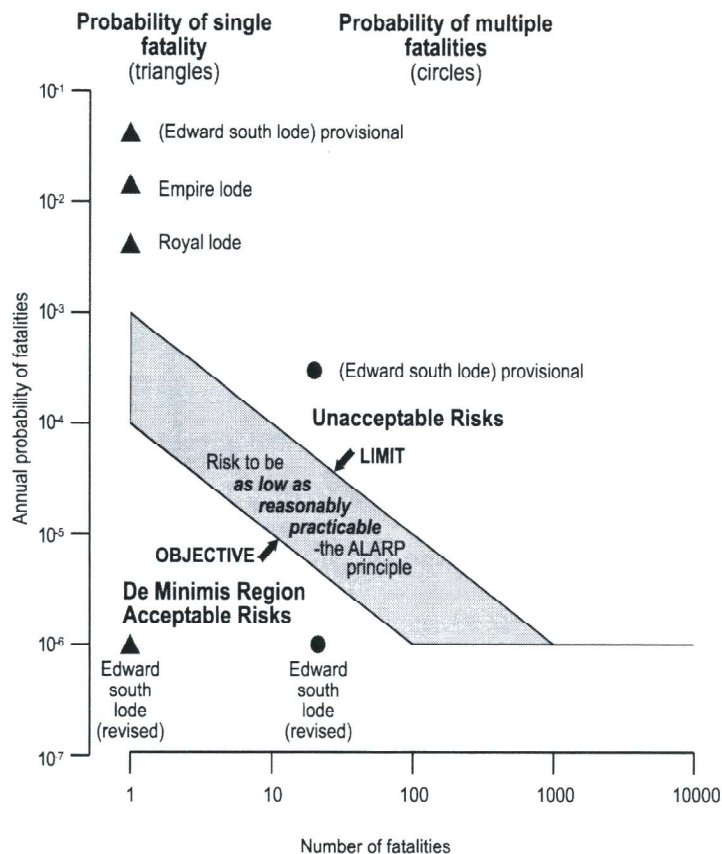
Figure 6. Comparison of risks

**Societal Risk.** The factory/warehouse building located within the Edward South lode low hazard zone was occupied by up to 88 people until recently. The annual probability of a collapse at any point on the Edward South lode is estimated to be  $8 \times 10^{-6}$  (column C of Table 1). Assuming a severe case where there are 90 people working in the area of a 40 m diameter collapse, and that if a collapse occurs there will be a 20% fatality rate. The 90 people are there 8 hours per day, 5 days per week. Then there is an annual probability of less than  $8 \times 10^{-6} \times \frac{8}{24} \times 5 \times \frac{52}{365}$  that there would be 18 fatalities, or  $<1.9 \times 10^{-6}$ . This gives a point on the ANCOLD (Australian National Committee on Large Dams) derived societal risk diagram (Figure 6) which is within the acceptable risk area.

**Individual Risk.** As noted there is a 20% probability that a future sinkhole might cause one fatality and the occupants are there 24 hours per day, then individual risk is calculated as in Table 1 and plotted on Figure 6.
