The paper was published in the proceedings of the 9th Australia New Zealand Conference on Geomechanics and was edited by Geoffrey Farquhar, Philip Kelsey, John Marsh and Debbie Fellows. The conference was held in Auckland, New Zealand, 8 - 11 February 2004.

Landslides and other ground damage caused by the M_w 7.2 Fiordland earthquake of 22 August 2003

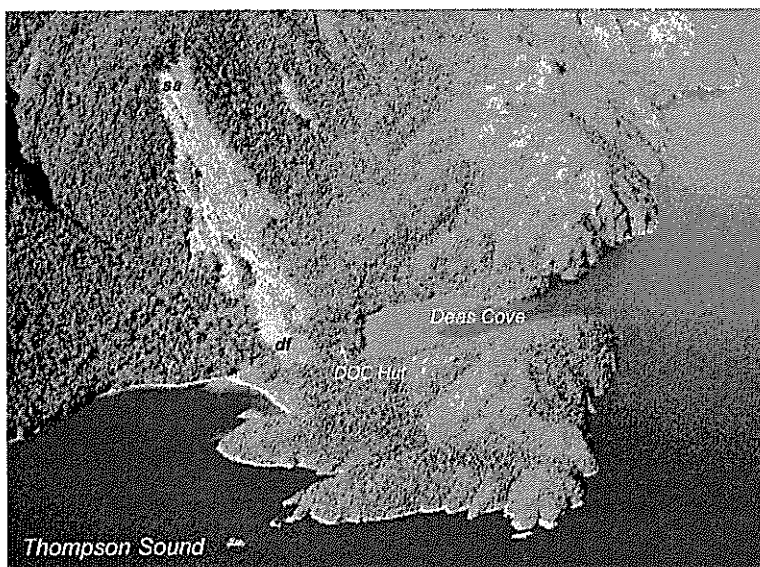
Figure 3. Aerial photo of the large ($\sim 625,000 \text{ m}^3$) debris slide at Deas Cove in Thompson Sound (Slide 1 in Figure 2). The landslide is $\sim 1150 \text{ m}$ long, and has a vertical fall of 500 m from the source area (sa) to the debris flow (df) at the slide toe. The landslide toe extends to within 50 m of the DOC hut (in small clearing bottom right) but did not damage it. Air photos taken in the 1980's indicate that this large slide in weathered granite and regolith is a reactivated and retrogressively enlarged former landslide area.

One of the largest bedrock and regolith landslides occurred at Deas Cove in Thompson Sound, where slide debris travelled $\sim 1150 \text{ m}$ down a $35\text{--}40^\circ$ slope to within 50 m of a Department of Conservation hut (Figure 3). In Gold Arm of Charles Sound, a large rock wedge slide in gneissic bedrock caused a $1\text{--}2 \text{ m}$ high tsunami (wave) which damaged a nearby helipad, and shorelines on the opposite (northern) side of the sound (Figure 4).

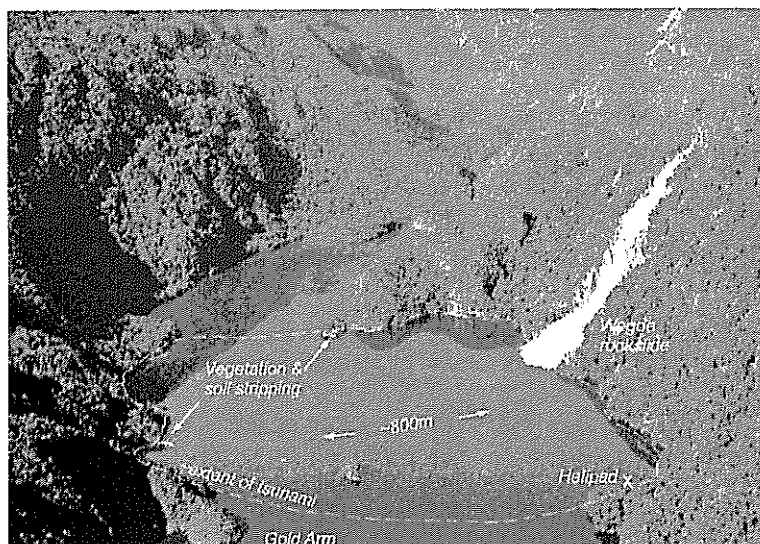
Figure 4. Aerial view of the large ($\sim 200,000 \text{ m}^3$) rock fall/wedge slide in Gold Arm of Charles Sound (Slide 2 in Figure 2). The vertical fall is $\sim 350 \text{ m}$ on a 40° slope. This slide caused a small tsunami (wave) which travelled $\sim 800 \text{ m}$ across the sound, where it damaged vegetation and soil up to $4\text{--}5 \text{ m}$ above high tide level on the northern side, and stripped vegetation off a small island. It also damaged a helipad $\sim 250 \text{ m}$ west of the slide (bottom right). Areas of weathered rock adjacent to the slide, and a pre-existing debris cone at the site, show this is also an old slide area that was reactivated and enlarged by the earthquake.

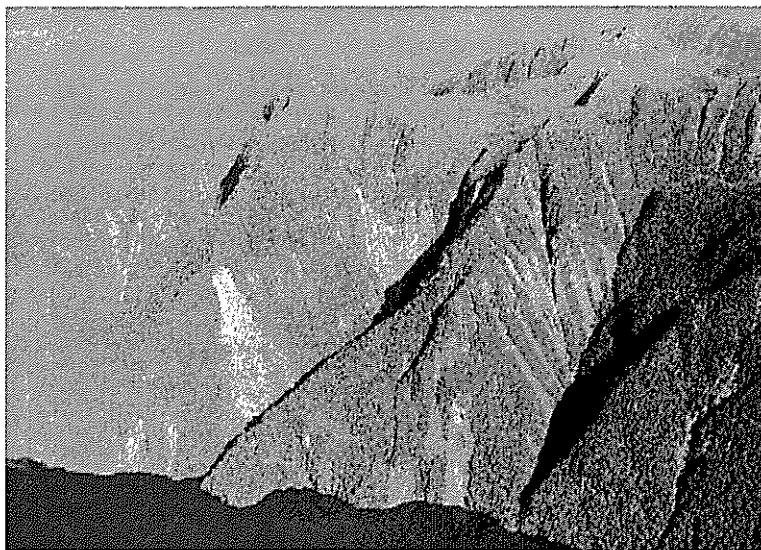
Figure 5. Aerial photo showing large rock fall debris slide (centre left—Slide 4 in Figure 2) and multiple shallow narrow debris slides on steep (45-50°) slopes of side streams on the south side of Nancy Sound. Such multiple small slides were common in the epicentral area. The preferential landsliding seen here on northwest-facing slopes was general across the landslide affected area (see Figure 6).

There was also clear evidence of aspect-controlled landsliding on some slopes. The multiple rock and debris slides in the outer parts of Nancy Sound (Figure 5) showed preferential landsliding on north to northwest facing slopes. Preliminary field mapping shows that this was general across the area most affected by landsliding, with approximately 62% of the landslides occurring on north and west-facing (** E-SSW) slopes and fewer slides on east and south-facing slopes (Figure 6).

Our studies after the earthquake have clearly shown that superficial landsliding was indeed widespread, but the shaking intensity was evidently below the threshold required for very large bedrock failures and mountain collapses in Fiordland. As expected, the landslides triggered by the 22 August earthquake decreased in number and size with distance from the epicentre. Figure 2 shows that the greatest density of landsliding, and indeed many of the larger landslides, occurred within 25 km of the area of the mainshock fault plane determined from GPS observations. Near the epicentre a few small 3rd-order alpine catchments of about 5 km² in area had up to 20% of the slopes affected. High-density landsliding also occurred on the steep coastal slopes nearest the epicentre. In general, however, the landslide density in the entire affected area was low, with the largest percentage of the affected area having only isolated, individual slides. In alpine and many coastal catchments with the highest density of slides, there was a distinct locational preference for the northerly facing slopes, with 62% of the landslides occurring on north and west (N–SSW) facing slopes (Figure 5 and 6).

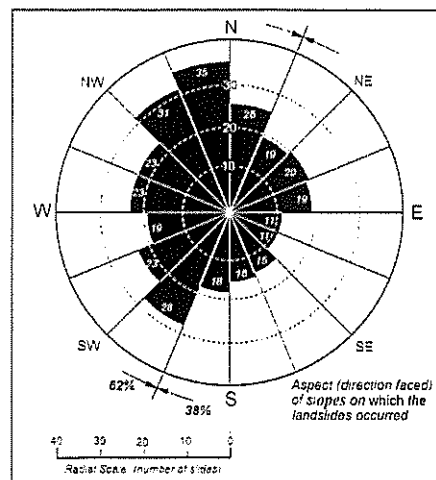
Figure 6. Rose diagram showing landslide directions relative to slope aspect.

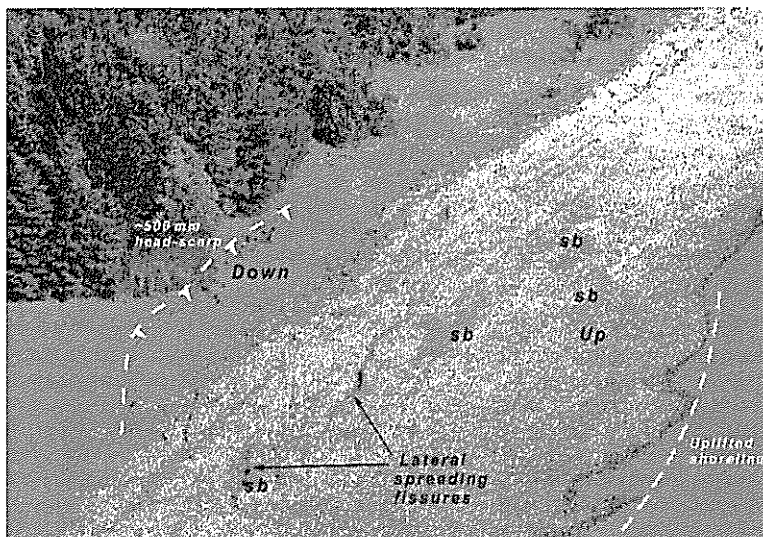
Figure 7. Shallow rotational slump and lateral spreading failure, with sand boils (*sb*) and fissuring on the shore of Lake Te Anau about 400 m west of the lake Control Structure. The affected area is –20 m long and 15 m wide, and has a 500 mm head scarp (in grassed area left) and several extensional fissures (300–400 mm wide and up to –10 m long) in beach gravels, from which fine sand and water was ejected. The back of the slumped area dropped –500 mm, while the slide toe at the lake edge was raised a similar amount, forming a low ridge on which sand boils formed.

Soil liquefaction effects (sand boils and small-scale lateral spreading) were observed in many places, particularly at the southwest end of Lake Te Anau (Figure 2). Although widespread, these effects were mostly localised in areas of saturated fine sandy alluvium and were generally minor compared to other large earthquakes in New Zealand (e.g., Napier, 1931, Inangahua 1968, and Edgcumbe 1987, – Hancox *et al.* 1997). A spectacular liquefaction feature was observed on the southwest shore of Lake Te Anau, about 400 m west of the Te Anau Control Structure (Control Gates in Figure 2). At this location a liquefaction-induced lateral spread and shallow rotational slump uplifted an area of lake shore about 20 m long and 15 m wide (Figure 7). This failure is interesting because of the combination of rotational and lateral spreading failure modes that are demonstrated, although it did not cause any significant or long-lasting damage to the lake shore. The coarse alluvium in which failure occurred suggests that finer and more susceptible sandy materials underlie the beach gravel deposits at this location. A similar feature with an unusual cluster of underwater sand boils occurred on the right bank of the Waiau River –100 m downstream from the Control Structure.
